*Certified Sustainable Cable Maintenance*

## Cable Maintenance Guide for implementation in a life extension program

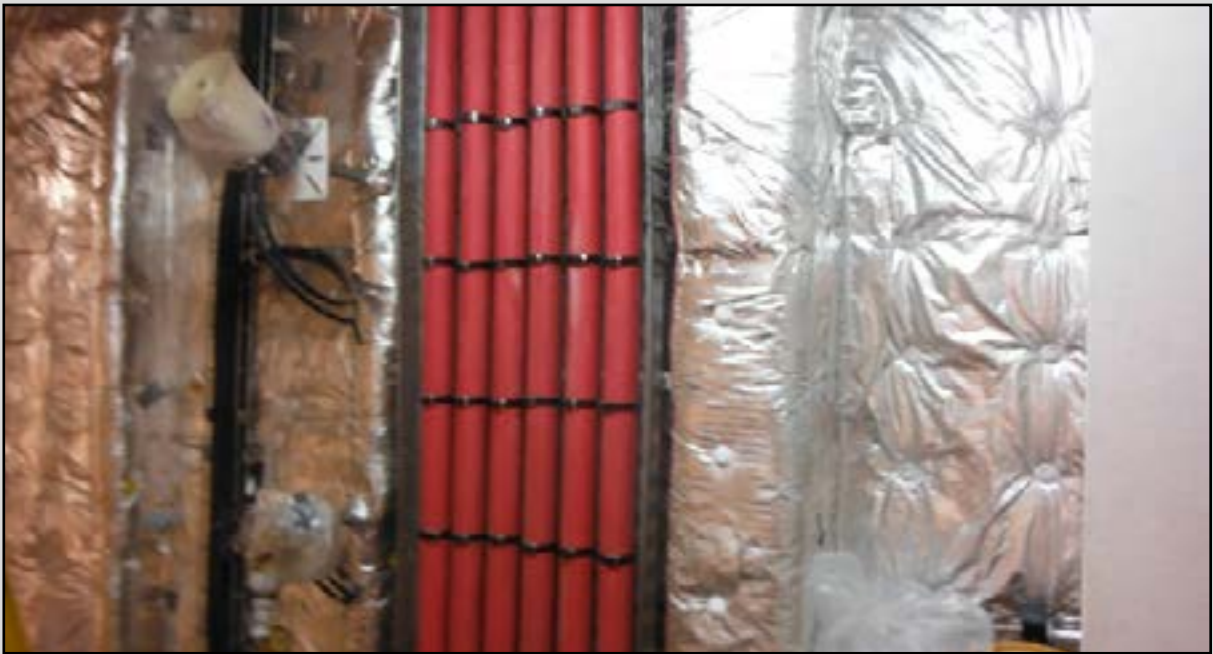
A1 New / good condition cable unbleached, dust covered for internal areas

Cables in this condition do not require any maintenance. Fire protection properties and lifetime extension would be increased by application of FS coating systems at this stage.

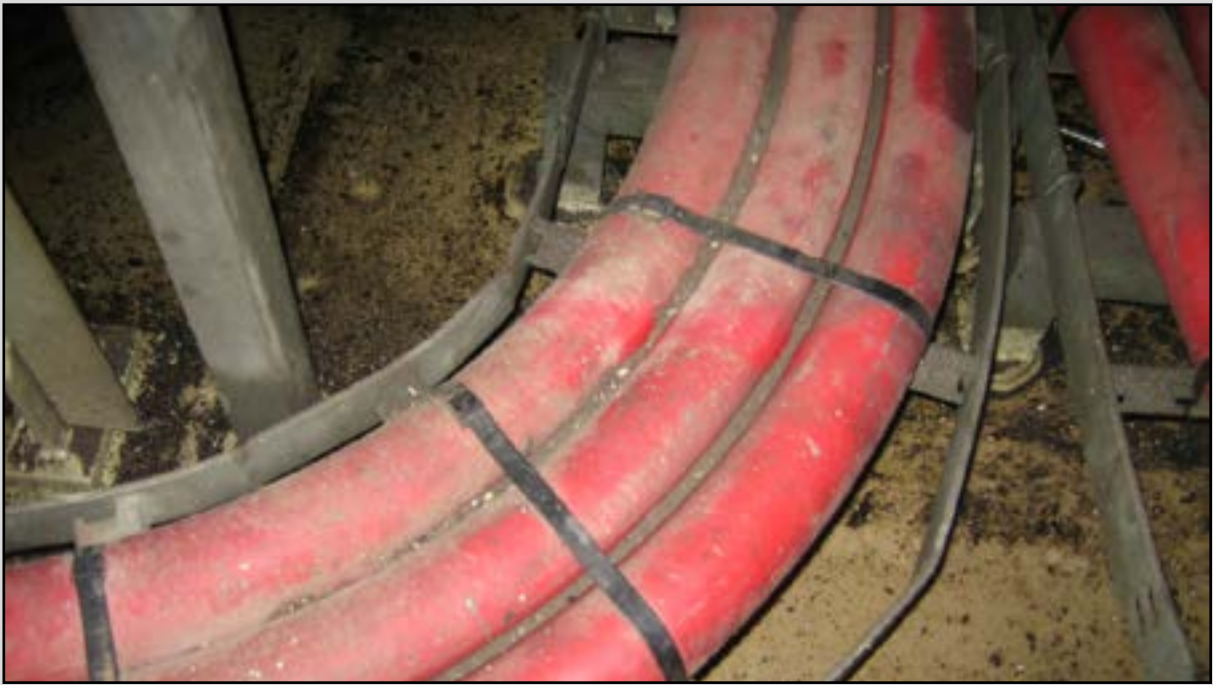
B1 Good appearance but with surface contaminates; Guano, moss, cement water-based drilling mud

Cables in this condition do not need to have any maintenance, however HP water blasting could be considered if contaminates build up in thickness possibly affecting the cooling properties of the sheath. Some cables could be bleached by Guano.

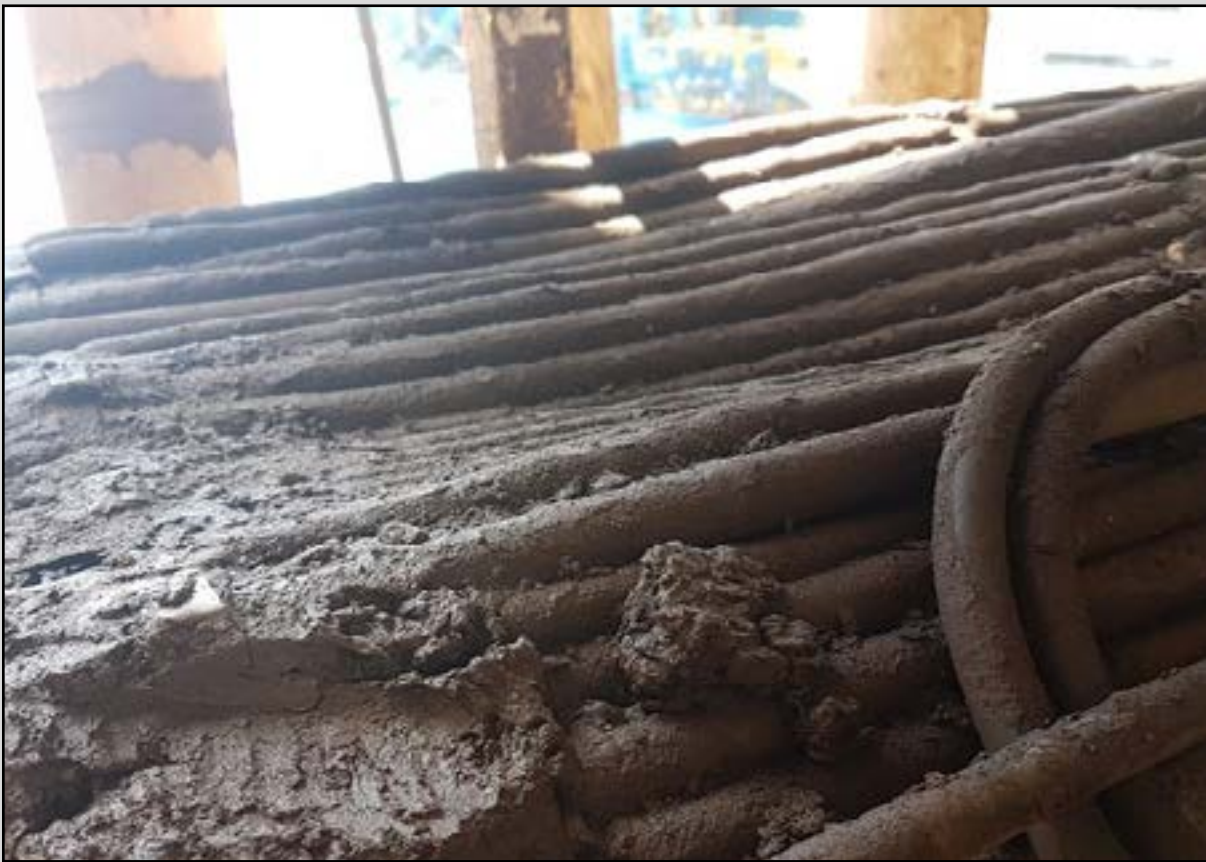
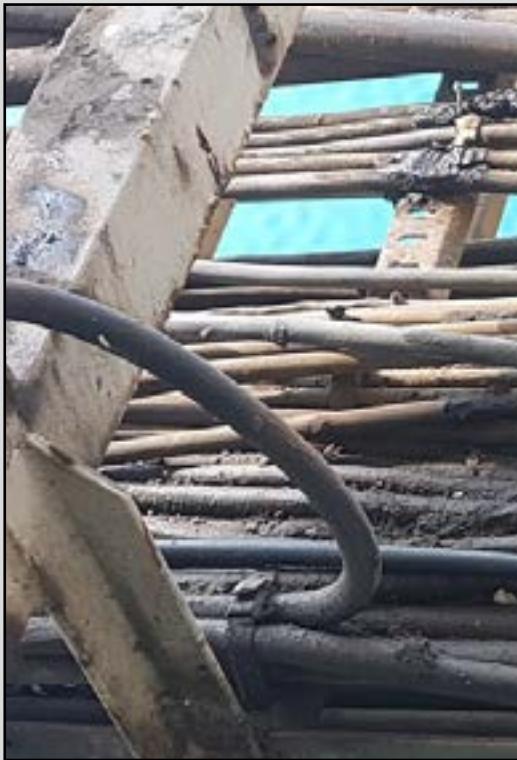
C1    **Good appearance but with surface contaminates that may degrade the sheath: Acids, Oil based drilling Mud's, Hydraulic fluid, Gas Turbine / Compressor oil, grease & oil based paints**

Many hydrocarbon-based chemicals could react with the cable to soften the outer sheath hydraulic fluid & compressor oil being of particular concern. It is advised to clean the cables using HP water and a degreaser like rig wash.

Attempt to pinch the sheath, if you can move it from the core, then chemical softening has already started. Washing and degreasing the cable may halt this process but the cable has already lost a high percentage of its protective capabilities: I.e. Low Smoke emission, insulation value, dielectric strength.

It is advised to coat the cable with FS5 at this stage to restore / enhance the lost properties of the sheath and to protect the sheath from further chemical degradation.

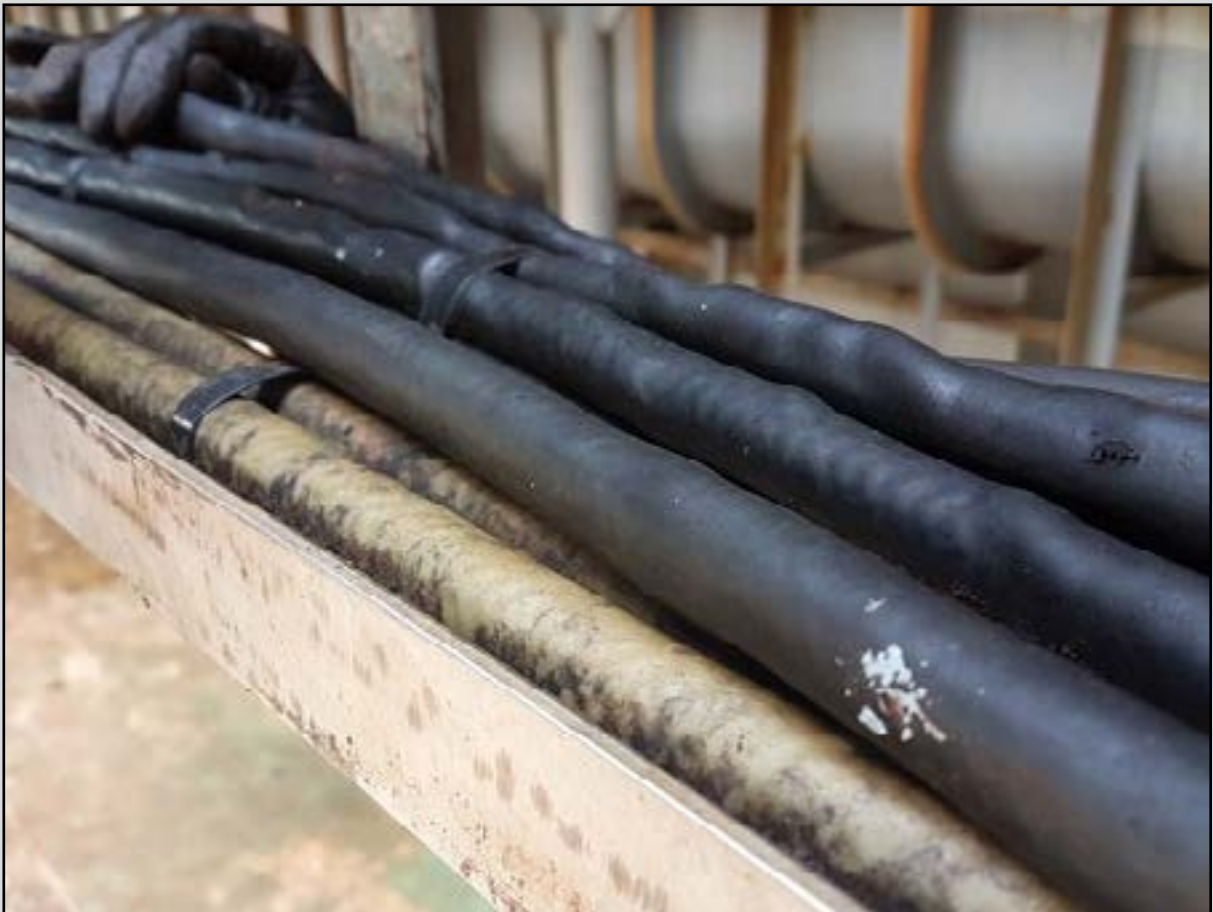
C2    **Damaged sheath softened or even wrinkled sheath due to contaminates**

Washing and then coating the cable with FS5 may be considered if wrinkled is still minor however, we would advise that FS carry out a survey and advise the correct course of action at this stage. The sheath can be fully stripped off and a new one installed utilizing our FS17 repair tape and FS5 coating system.

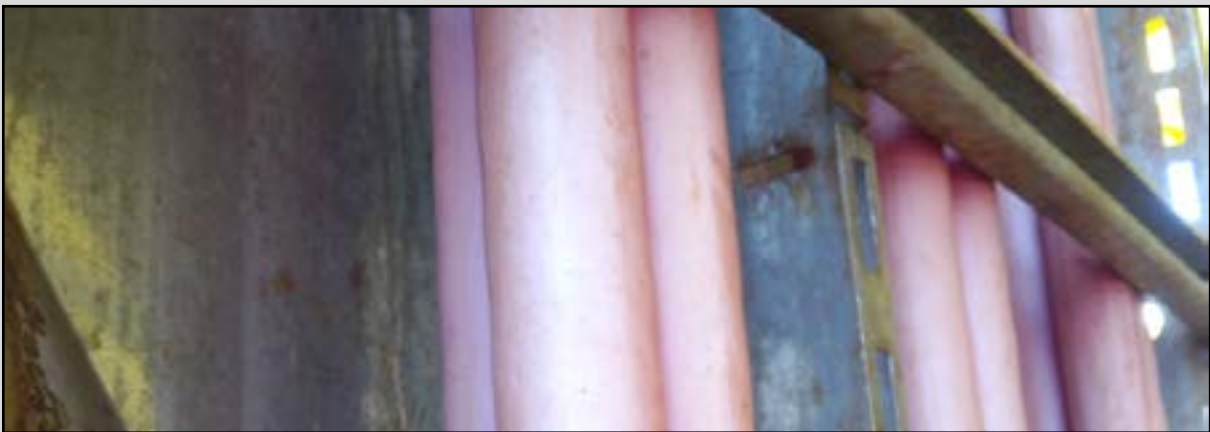
**UV1    Colour faded (bleached) but not chalking**

Red, yellow and blue cables tend to be affected by UV exposure worse than black or grey coloured cables. The first sign of UV degradation is loss of colour. This could indicate that the sheath material is at the first stage of UV affected breakdown.

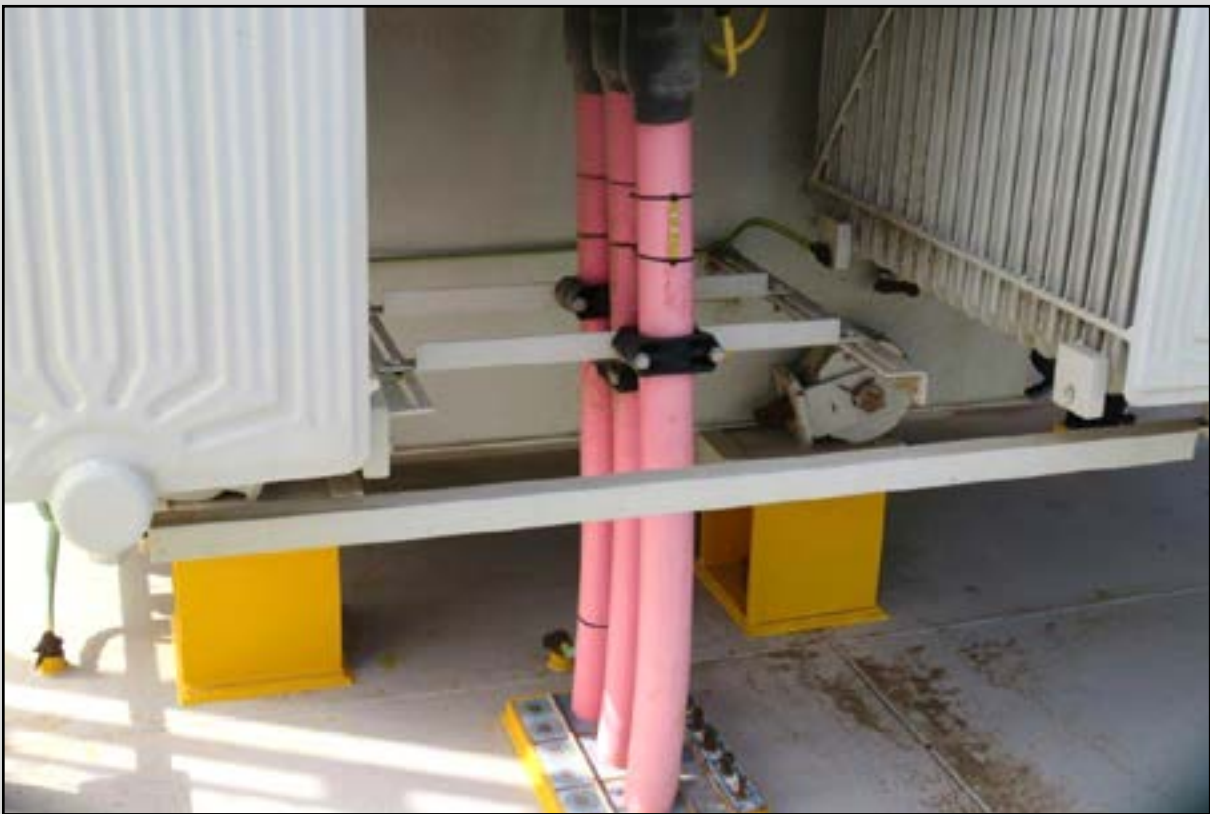
**UV2    Colour faded & chalking**

Rub your gloved finger over the cable, if it comes away with a chalk like residue and the area that you have just rubbed is slightly shiny then chalking has started. This is a sure sign that the sheath material is beginning to break down. Life expectancy of the sheath at this stage is dependent upon thickness and quality of the remaining sheath. Erecting shade to cover cable runs may be considered or covering cable tray runs with covers. Application of FS5 at this stage will totally halt the UV aging of the cable.

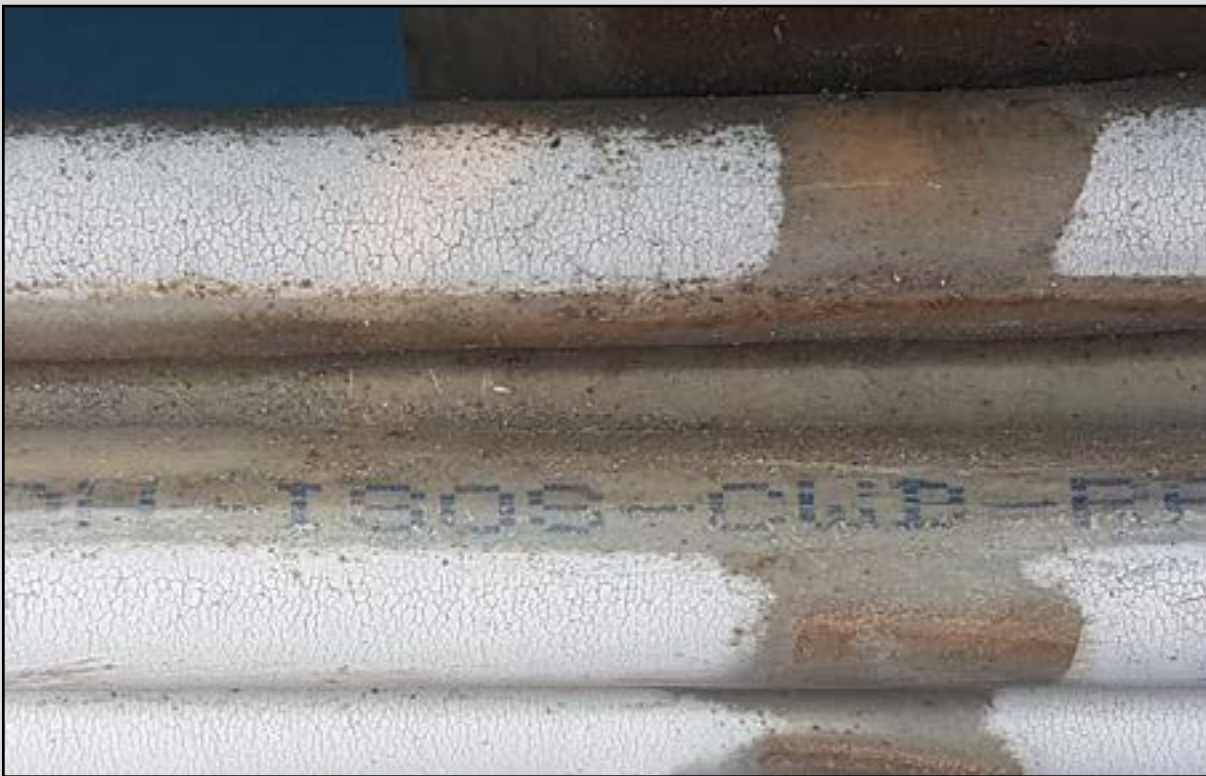
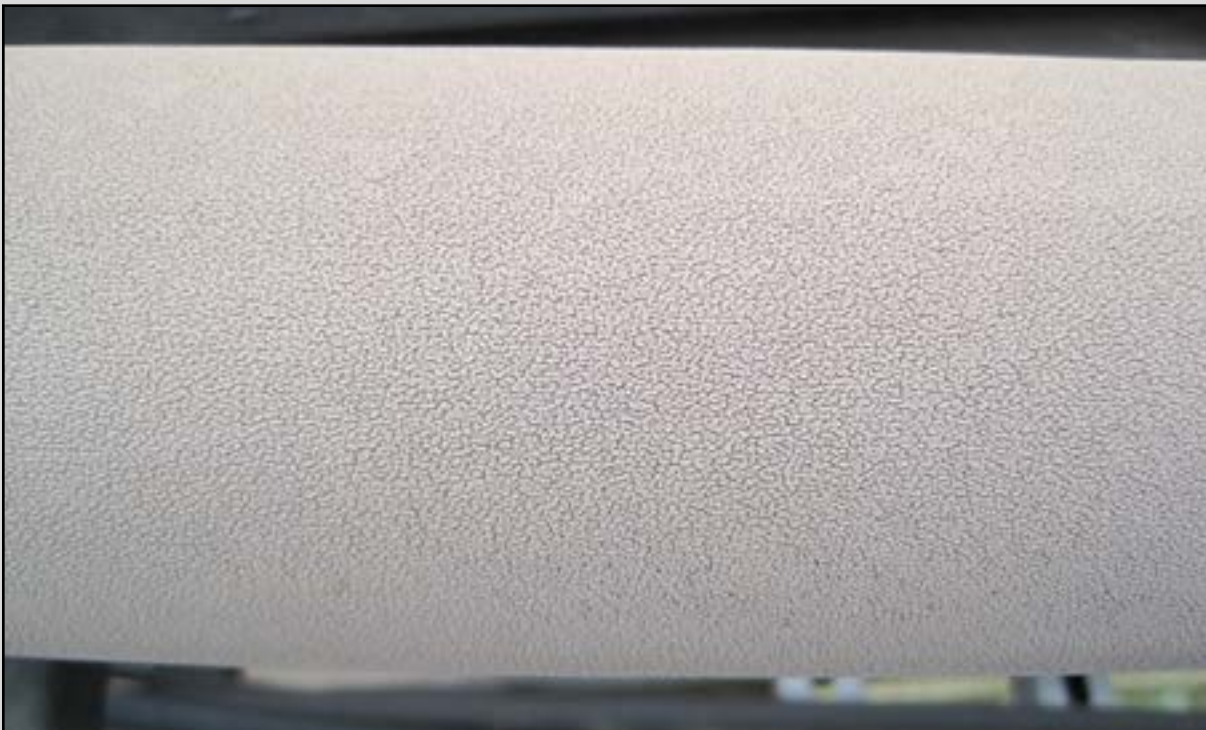
UV3    Perishing started

Perishing or micro cracking of the cable sheath can occur at anytime after chalking has been noted. This may not be visible to the naked eye; a digital photo of the sheath can be taken, and by zooming in, micro cracking, if present, will be noted. Life expectancy of the cable at this stage could be anywhere between 18-36 months before the sheath fully cracks. At this stage many of the cable sheaths properties; dielectric strength and insulation values, have lowered considerably. Application of FS5 at this stage will totally halt aging of the cable and restore its lost properties.

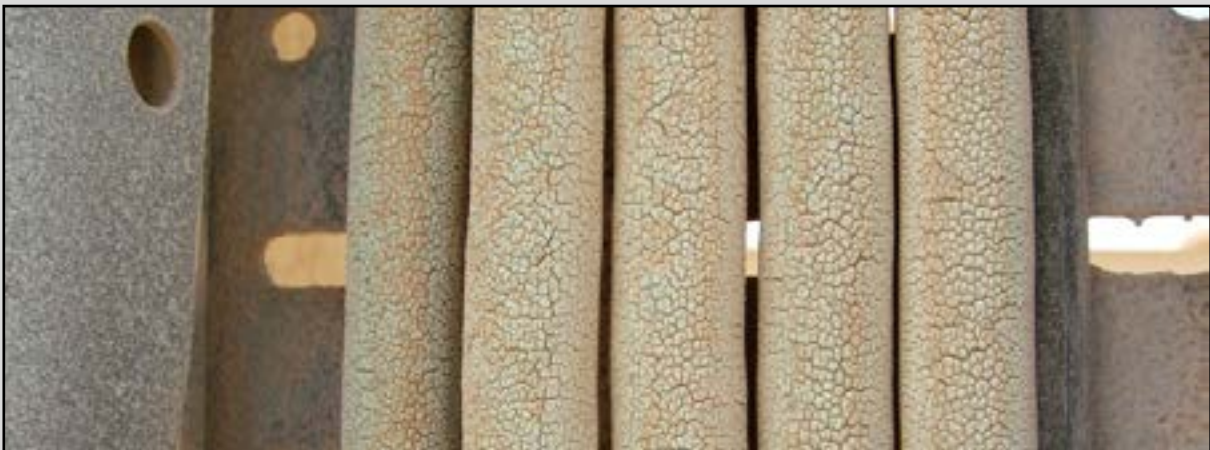
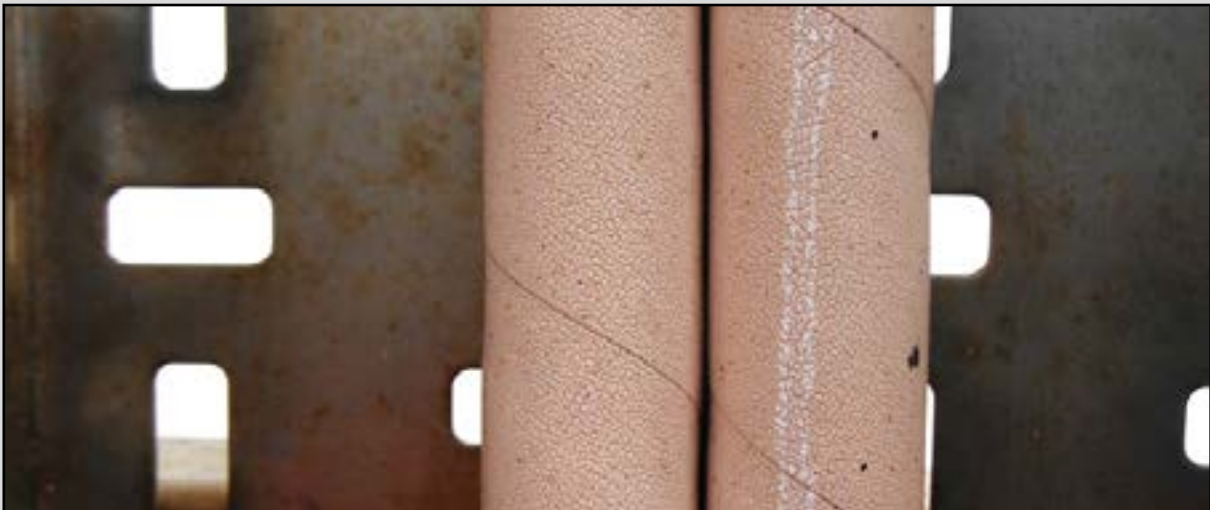
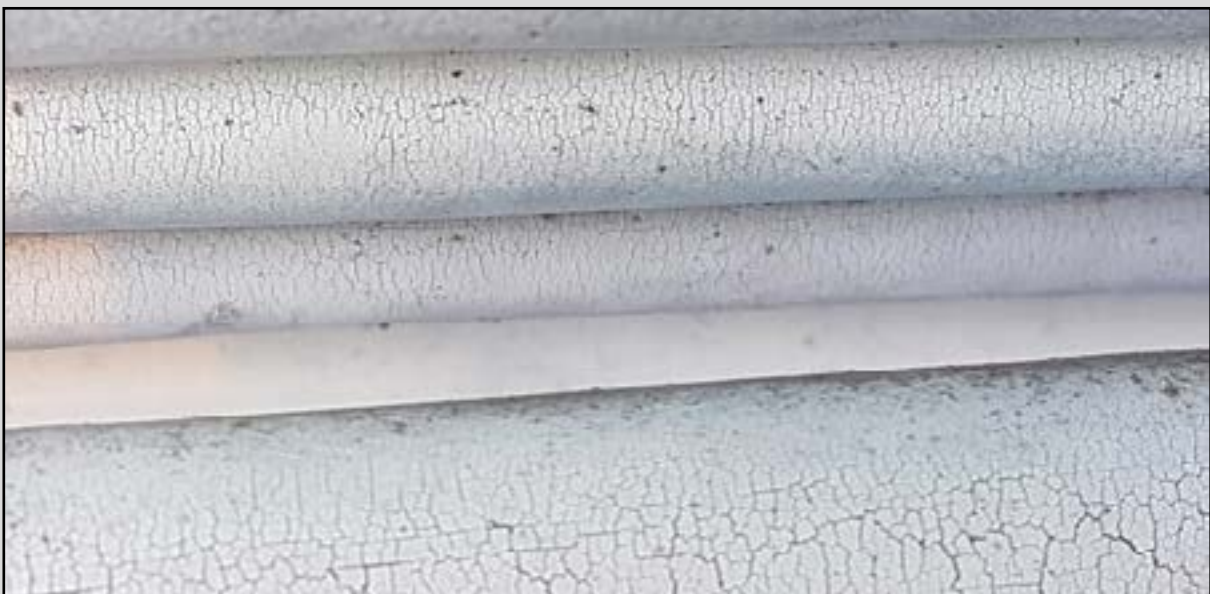
UV4    Heavily Perished

Cracks in the cable sheath will be fully visible to the naked eye but have not yet reached the armour or inner core. The sheath material may be very brittle and most of the cables dielectric strength and insulation value may have been lost. FS5 coating may need to be combined with an underlay of FS17 repair tape in places to restore the properties of the cables, depending upon how brittle the sheath material is.

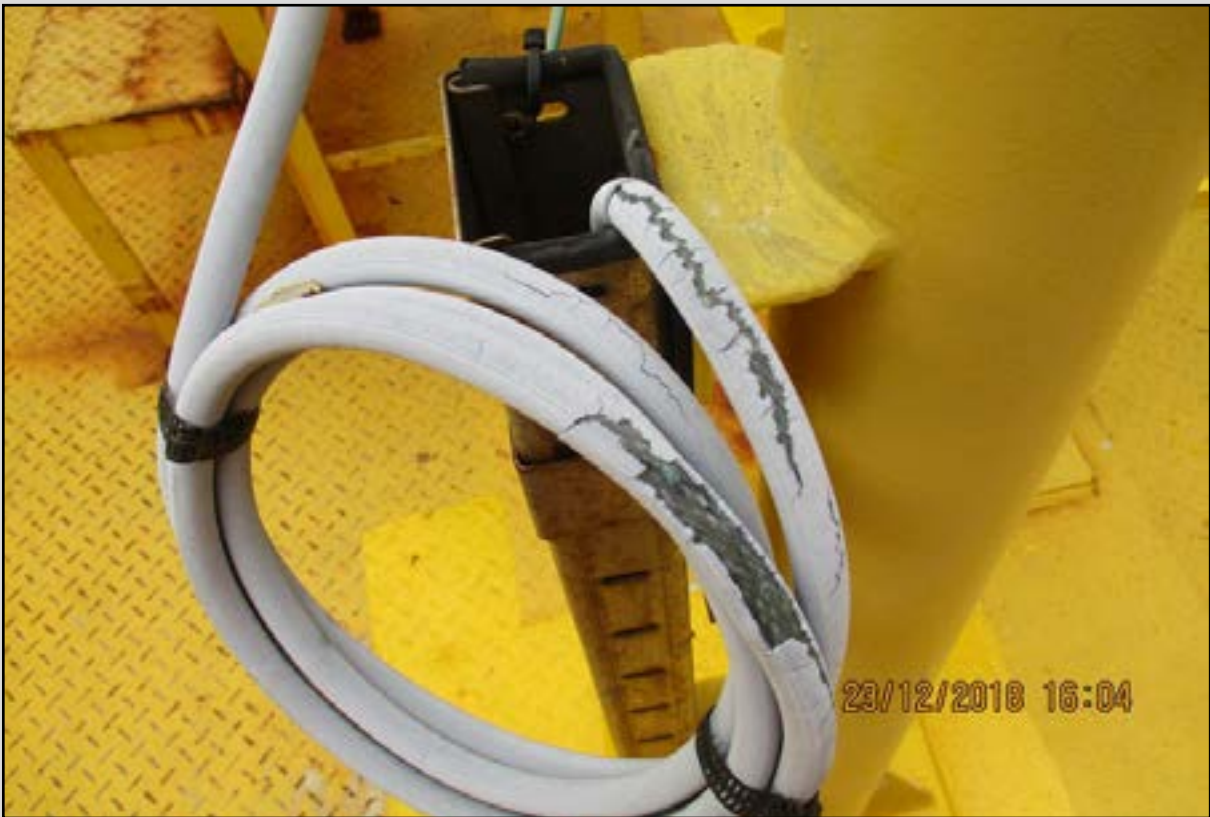
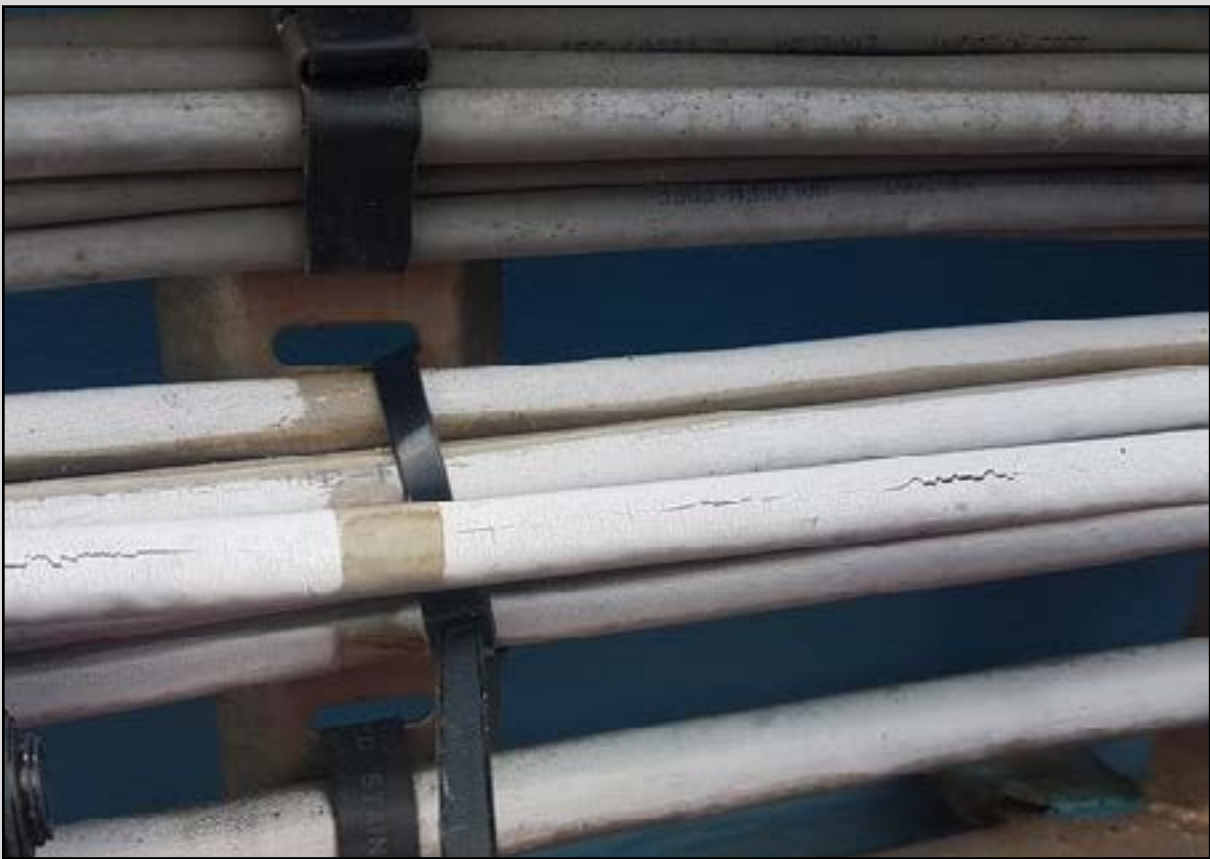
UV5 Cracked sheath

Inner armour or inner sheath (if present) is now exposed, and the cable is now a major safety concern for hazardous (gas) areas. Fire Security offers various repair options at this stage, depending upon site conditions and operational constraints.

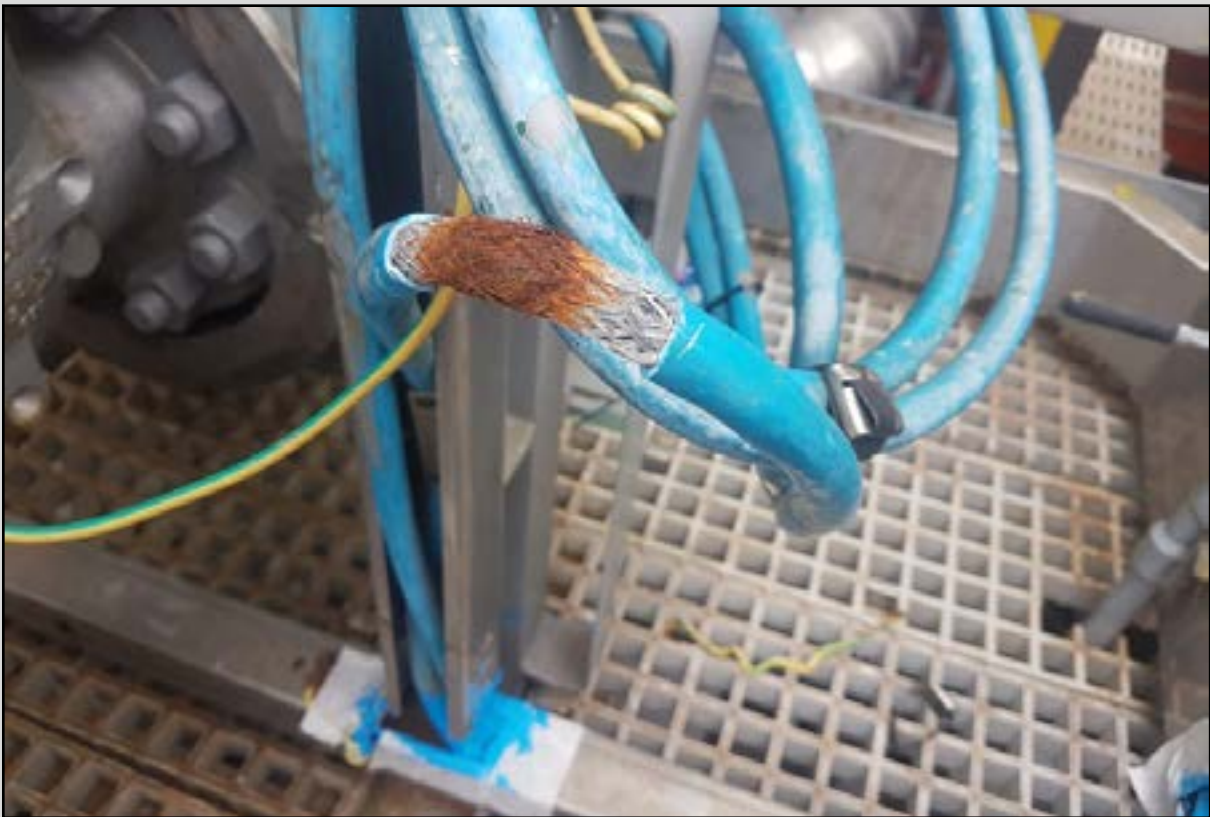
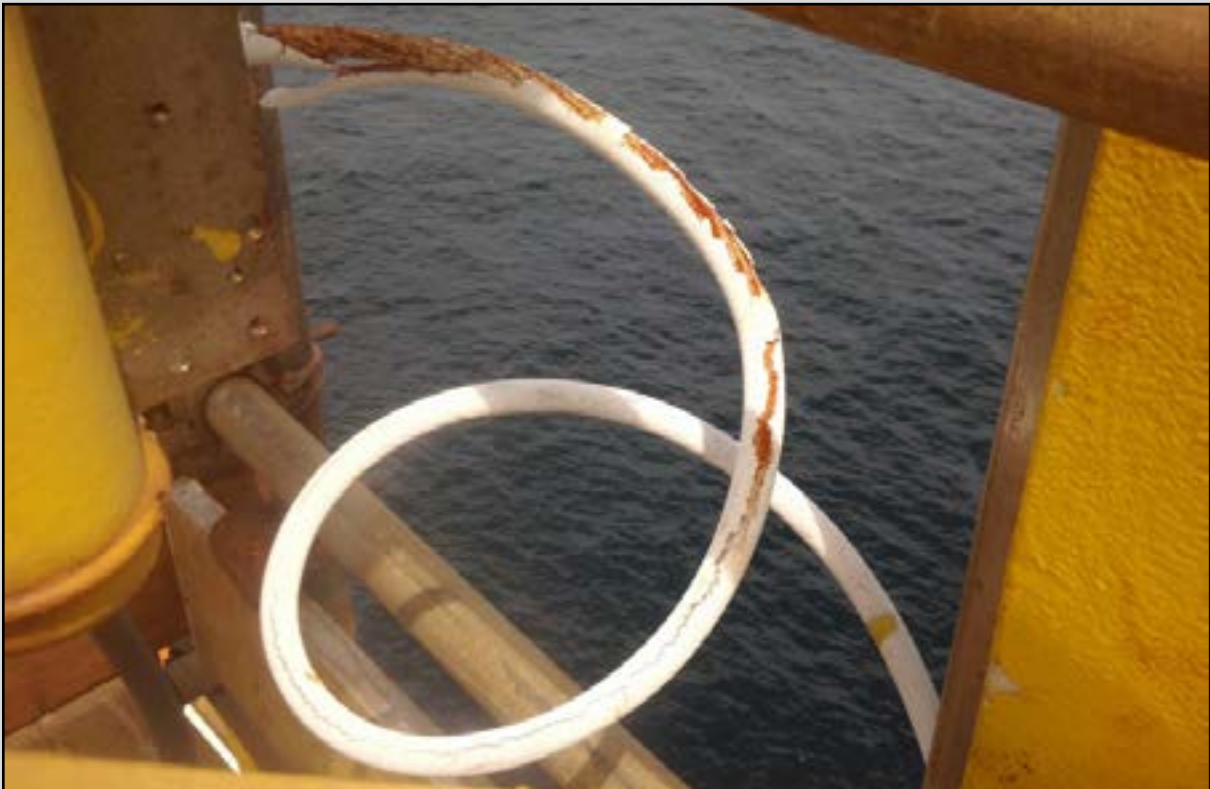
UV6 Cracked sheath, rusting armour

Inner armour or inner sheath (if present) is now exposed and the cable is now a major safety concern for hazardous (gas) areas. Rust streaking may be noted on the cable sheath and possible bulging of the sheath near cracks due to the rust expanding. Fire Security offers various repair options at this stage depending upon site conditions and operational constraints.

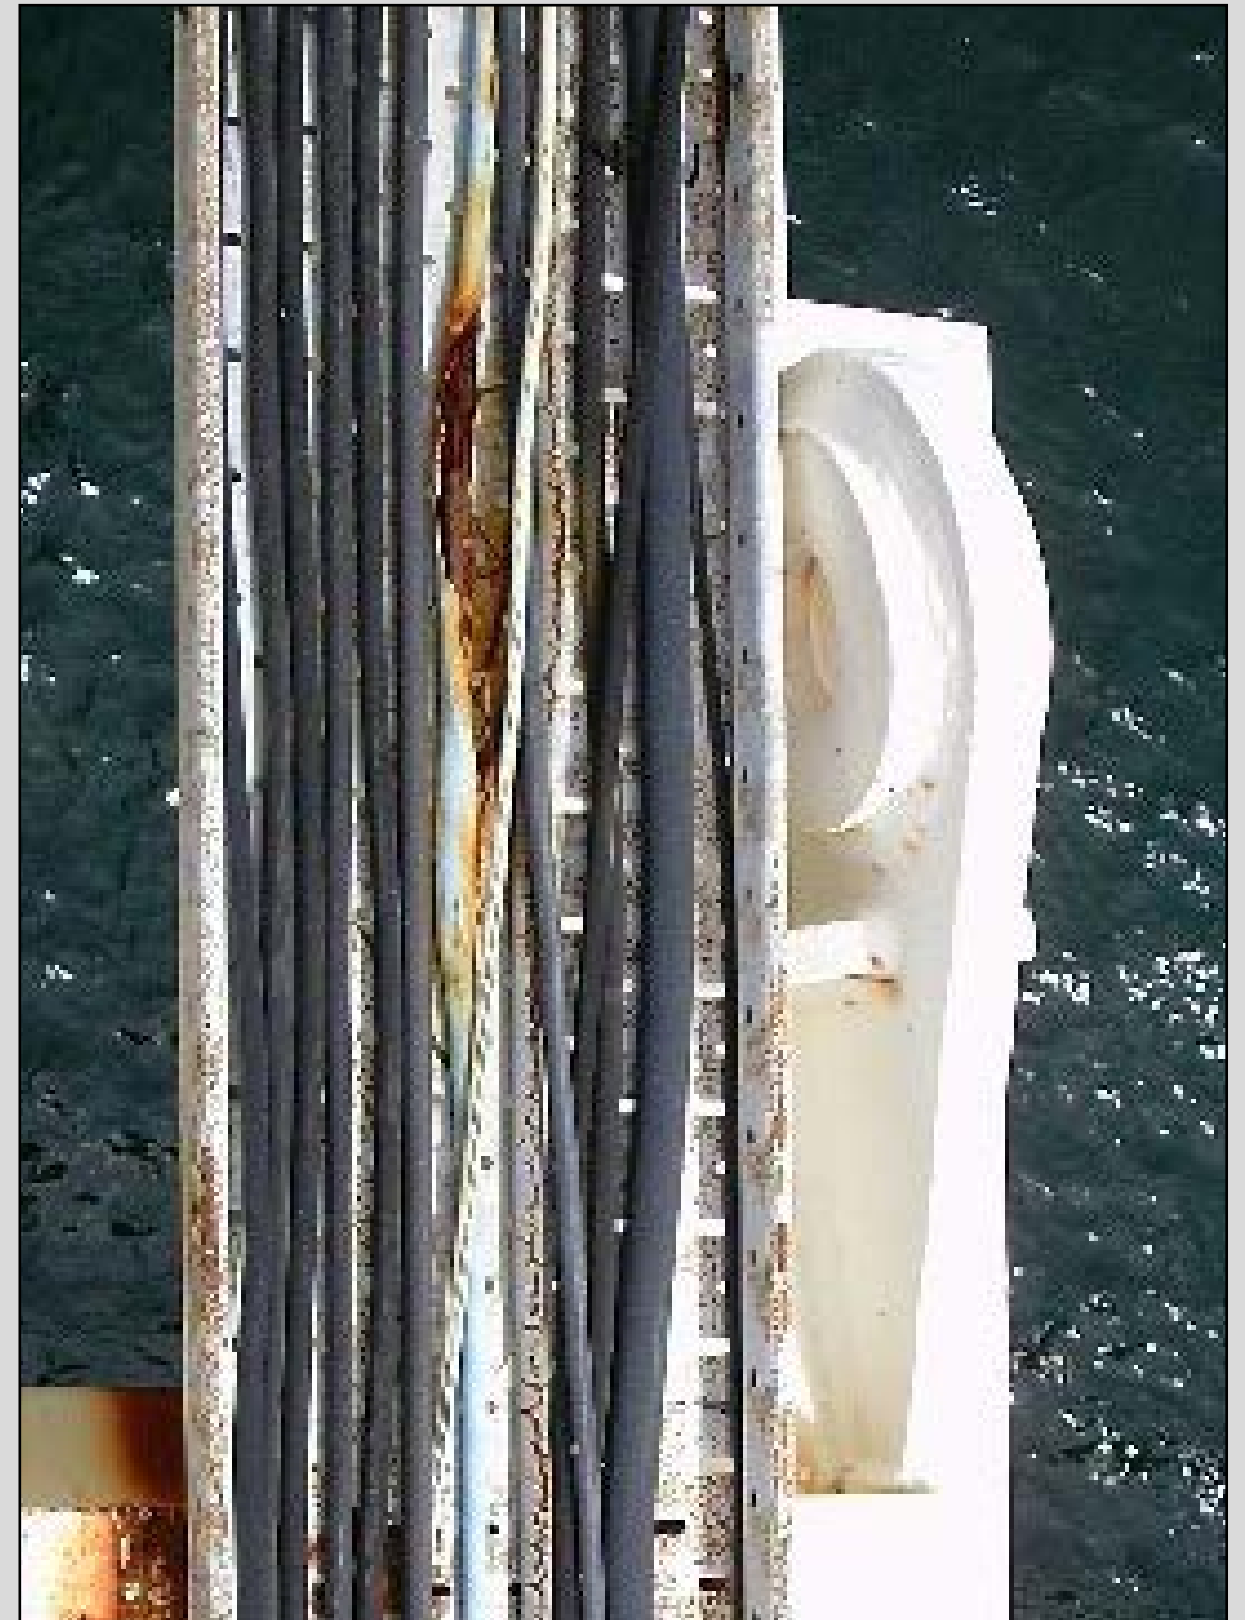
UV7 About to expose inner core

Fully failed outer sheath, stained with rust (if armour is present), and exposed inner core. At this stage, an HV cable should be considered beyond repair. If the client carries out megger testing and is happy with the results, then LV or Instrumentation/ control cables could be repaired (Not recommended for plant shut down or other critical operational cables).

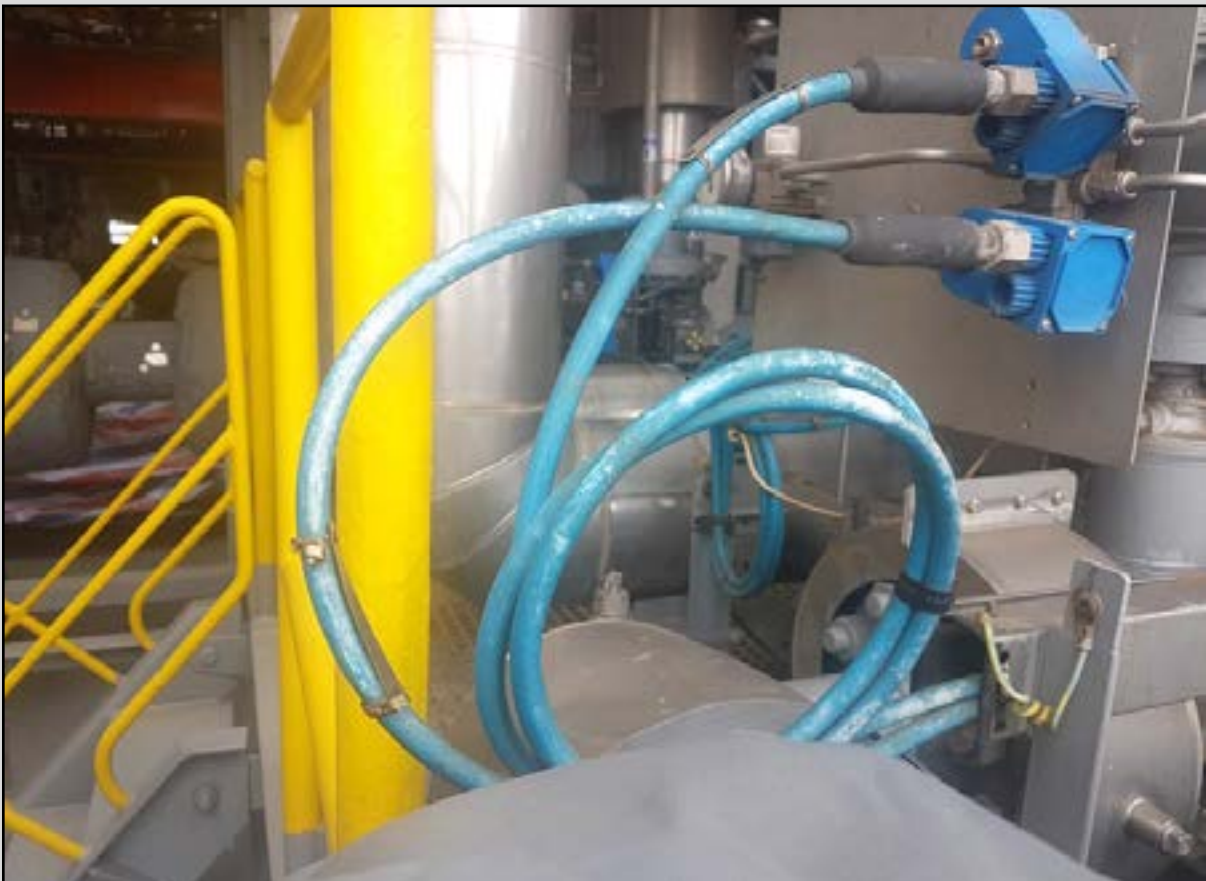
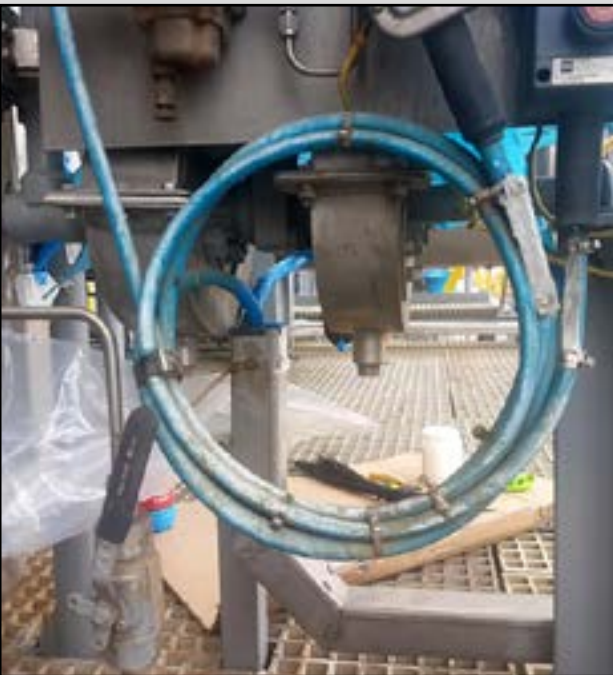
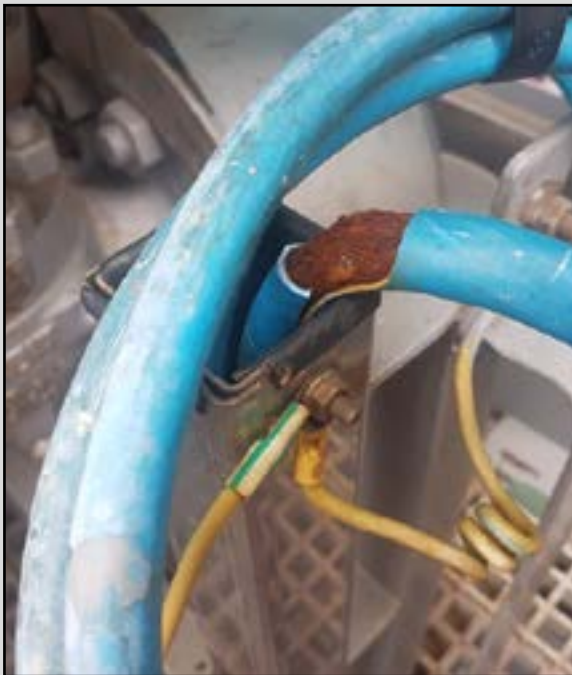
**QC1** Early ageing cable due to manufacture mishap, UV Exposed, may be graded on UV 1-7 scale

Fire Security offers various repair options for this, depending upon the extent of aging, site conditions and operational constraints.

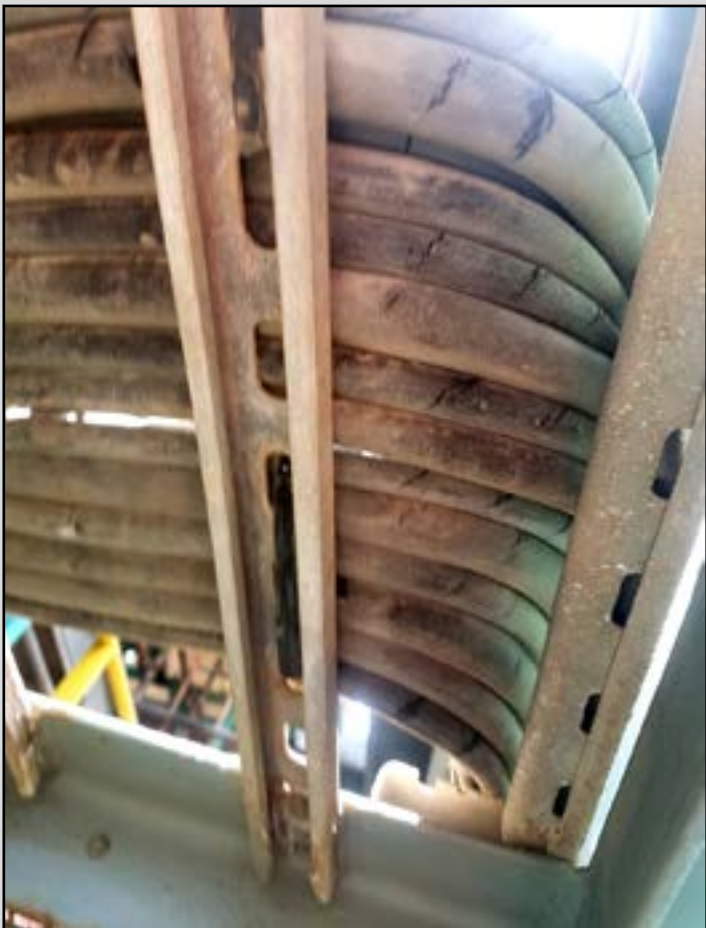
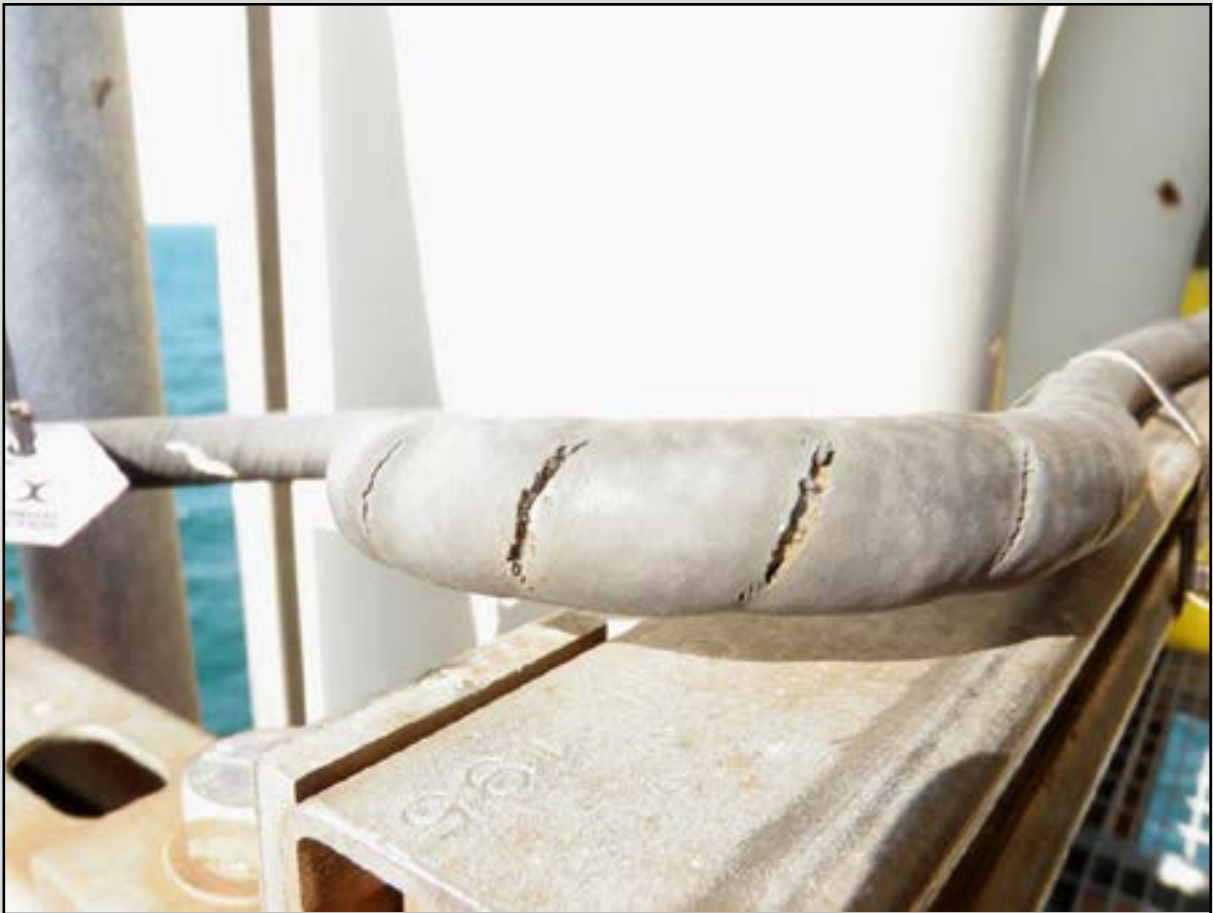
**QC2 Stress cracking, mostly on tight bends (Usually Transverse)**

Transverse cracking normally found on the outside of cables on tight bends.

For small diameter cables; Cover with FS17 Tape, coat with FS5.

For large diameter cables, Fill with FS21, repair with FS17 Tape, coat with FS5.

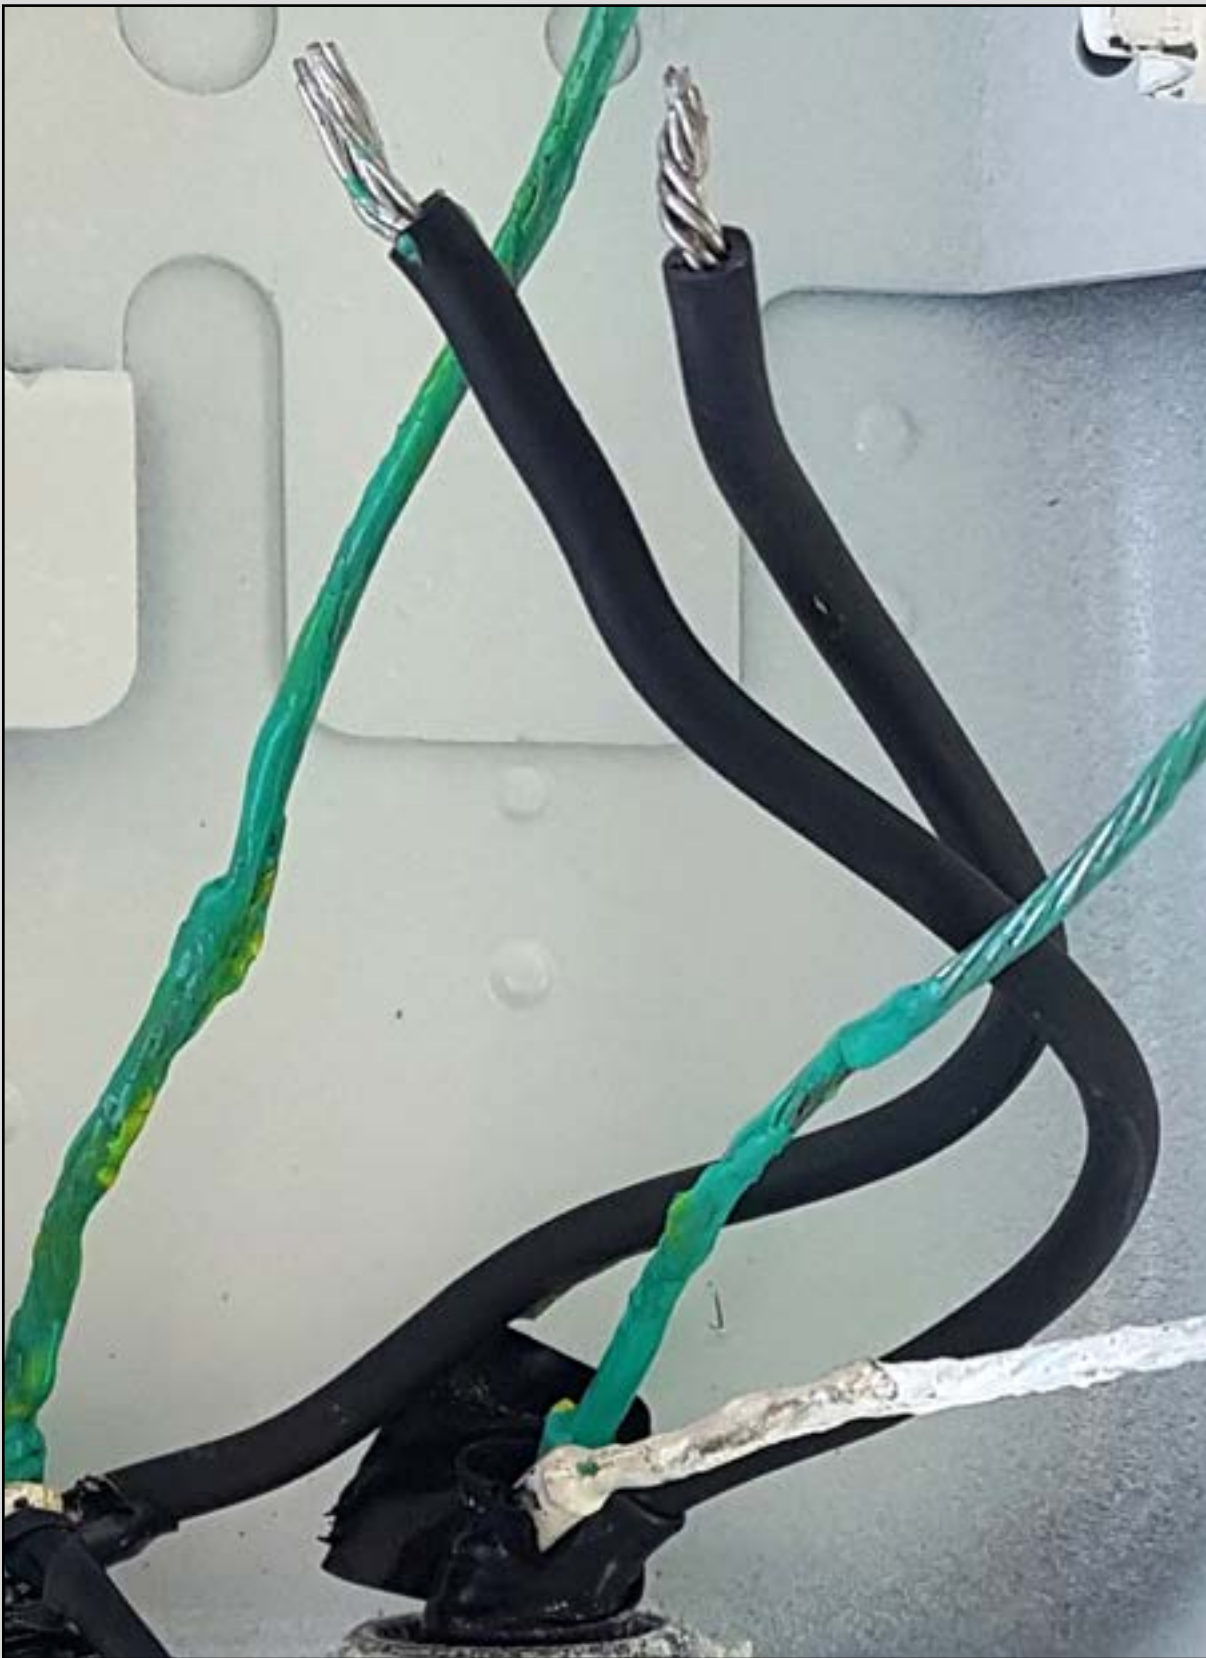
**QC3 Sheath material turning to a soft 'gum' like consistency**

Similar to chemically affected cable sheath, the material can be 'pinched' and even 'picked' off the sheath, and sticks like chewing gum to the fingers.  
FS has so far only come across this type of breakdown on exposed inner core wire sheaths at termination points. Options include coating the area with FS5 or slipping a pre-prepared colour coded sheath over the affected section.
