*Certified Sustainable Cable Maintenance*

## Cable Maintenance Guide for implementation in a life extension program

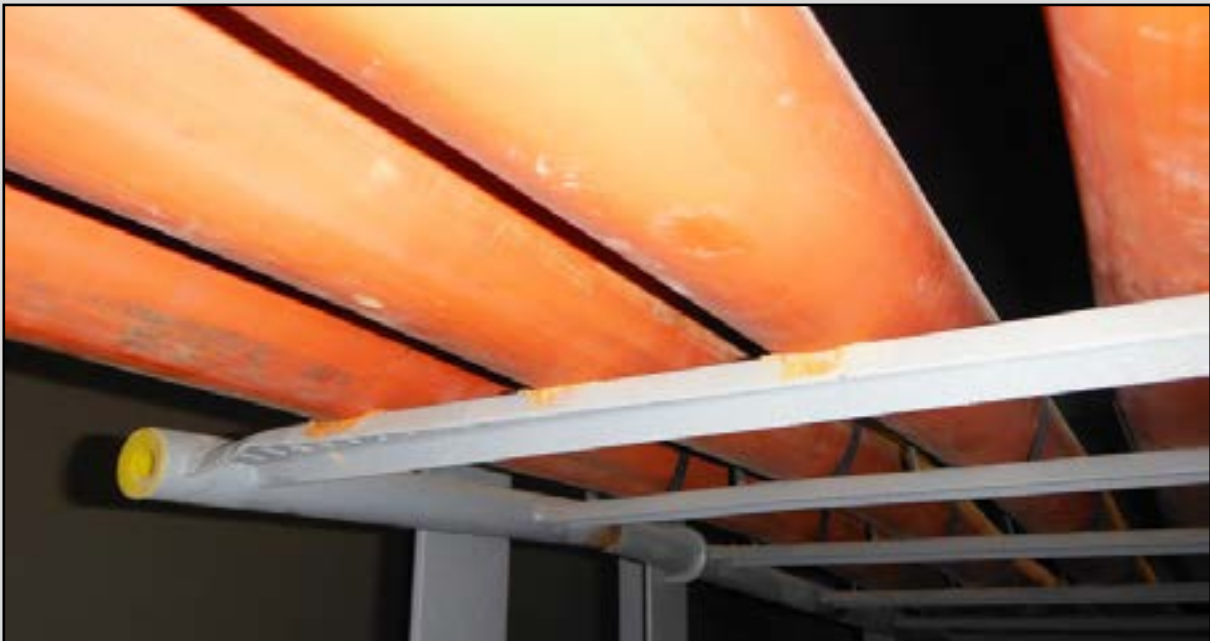
**M1 Impact / Chaffing (mechanical damage) damaged outer sheath**

Cable sheath is either split by impact or worn down by repeated rubbing (chaffing) of the cable against a hard surface. FS17 Tape repair of area and coating with FS5. Friction protection in the form of rubber mats or Teflon sheeting to be installed to prevent further chaffing.

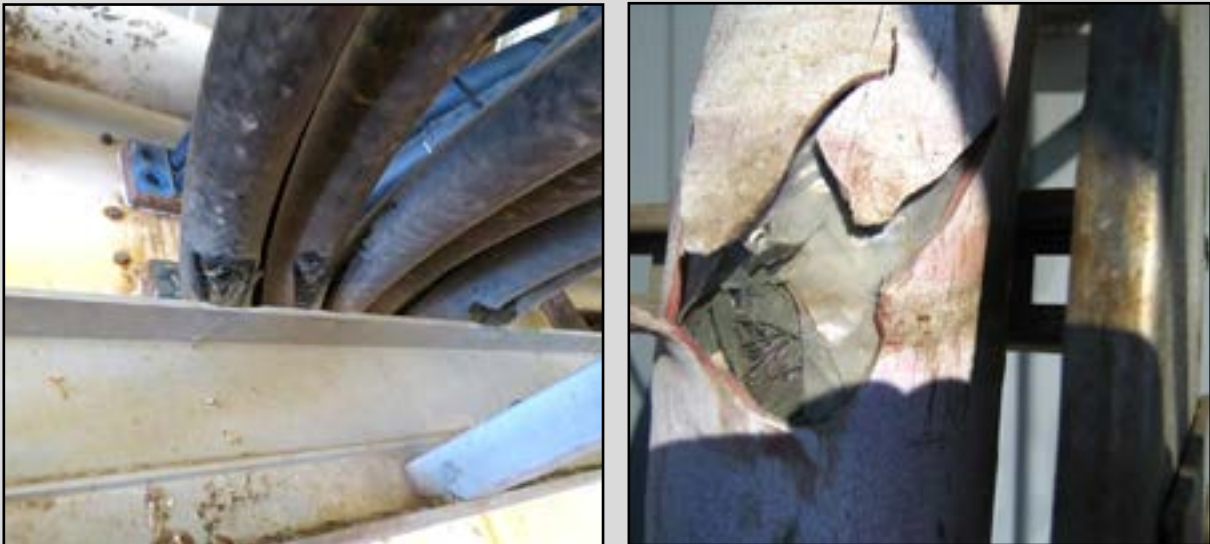
**M2 Impact / Chaffing (mechanical damage) fully thru the sheath into armour**

Cable sheath is either split by impact or worn down by repeated rubbing (chaffing) of the cable against a hard surface, the damage has extended to the armour, but the inner core is still intact.  
FS18 Shielding tape repair of armour, FS17 tape repair above this, and coating with FS5. Friction protection in the form of rubber mats or Teflon sheeting to be installed to prevent further chaffing.

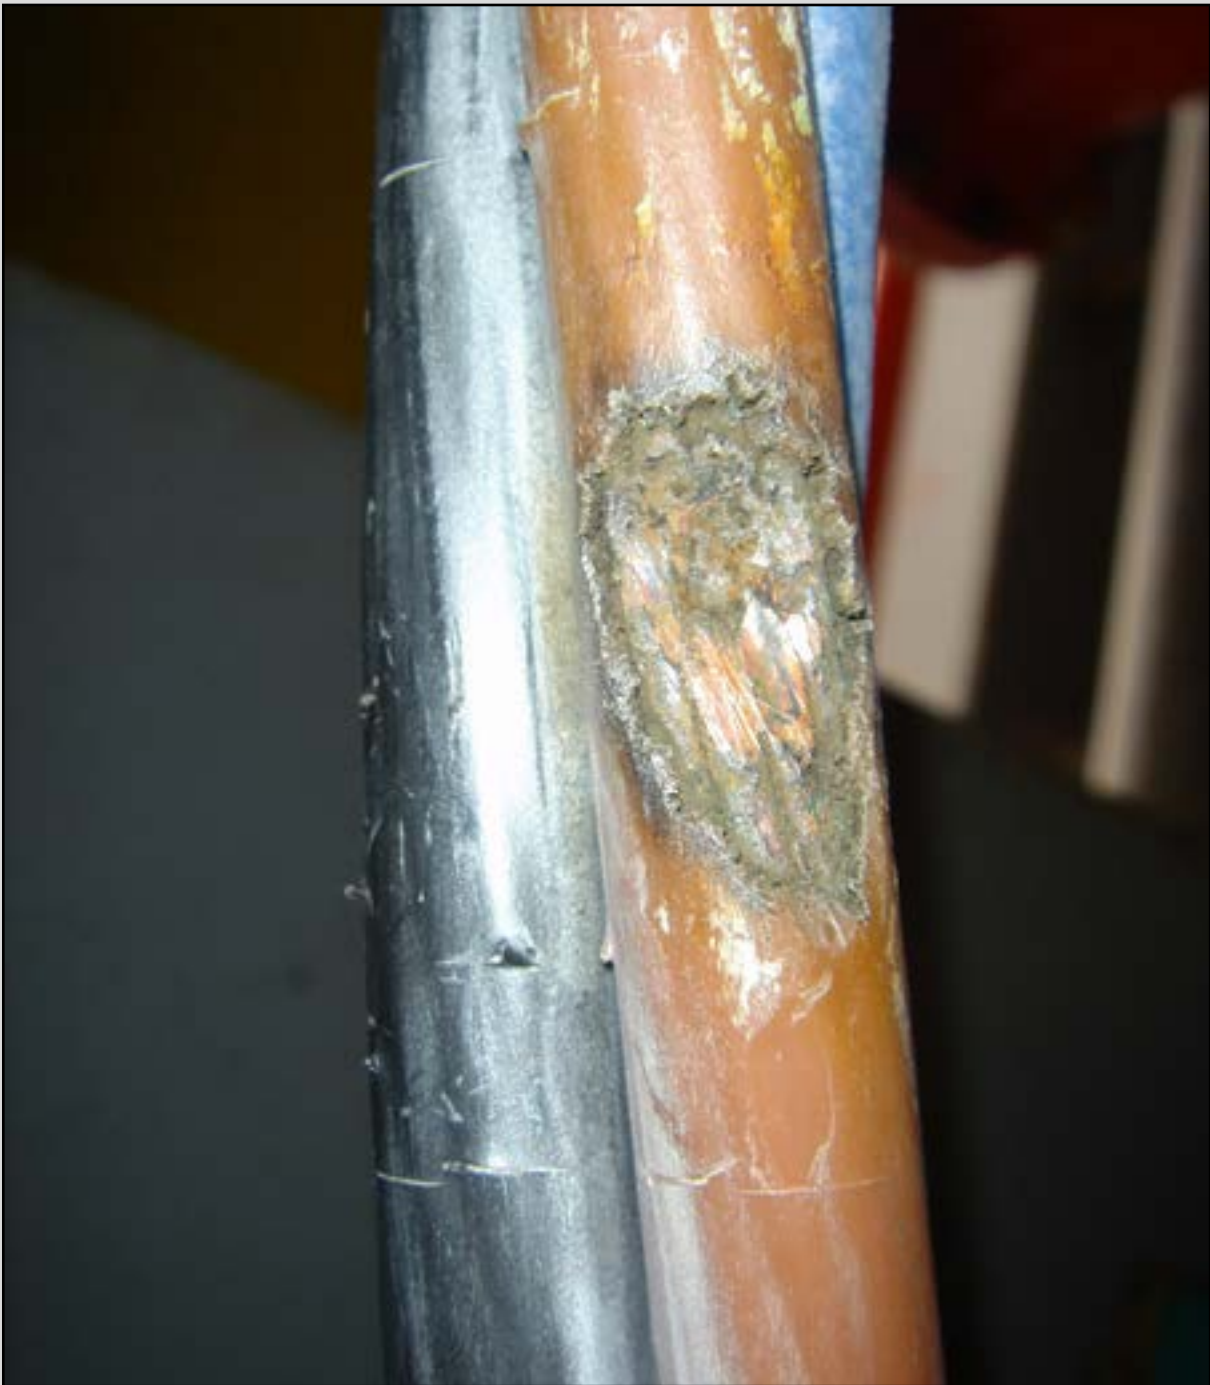
**M3    Impact / Chaffing (mechanical damage) into inner core**

Cable sheath is either split by impact or worn down by repeated rubbing (chaffing) of the cable against a hard surface, and damage has extended past the armour and into the inner core.

If the client carries out megger testing of the cable and is happy with the results, then the repair of LV & instrumentation cables may be carried out as for M2 condition cables. This is not recommended for HV or Plant shut down / operationally critical cables.

FS18 Shielding tape repair of armour, FS17 tape repair above this, and coating with FS5. Friction protection in the form of rubber mats or Teflon sheeting to be installed to prevent further chaffing.

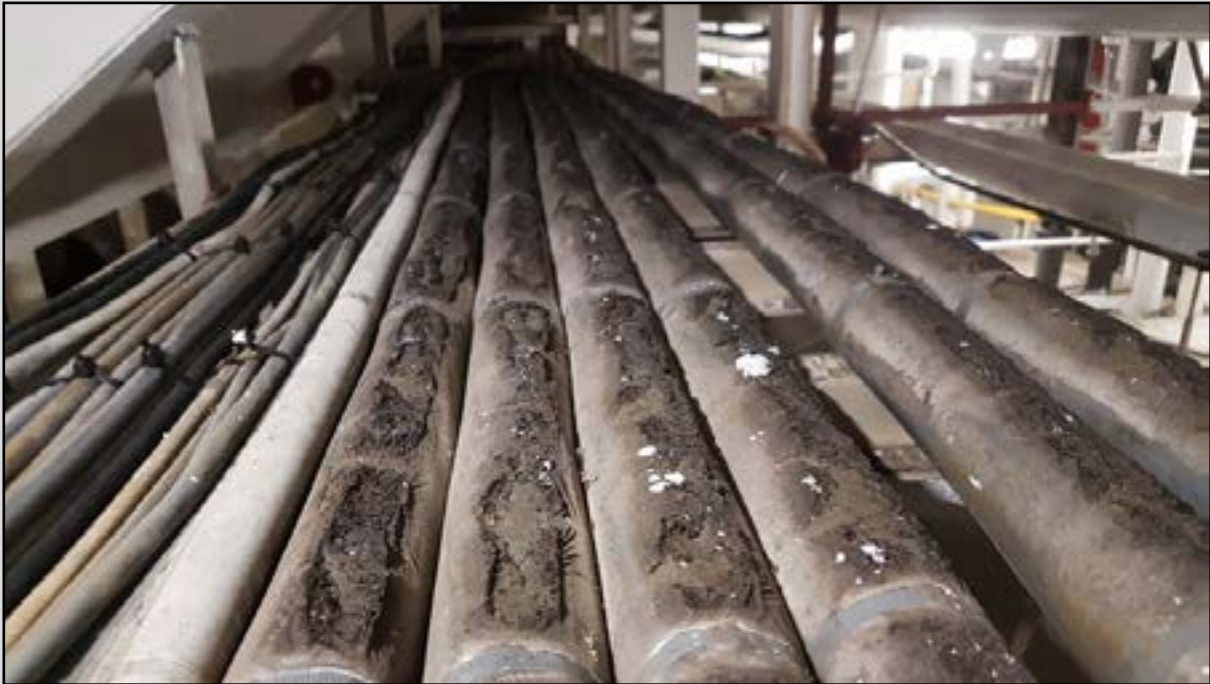
**H1    Heat affected cable, sheath is misshapen and / or brittle**

Sheath material has partially melted and then re-hardened. If the client is convinced that the inner core is not affected, then repairs to the outer sheath can be carried out. FS17 tape repair and coating with FS5

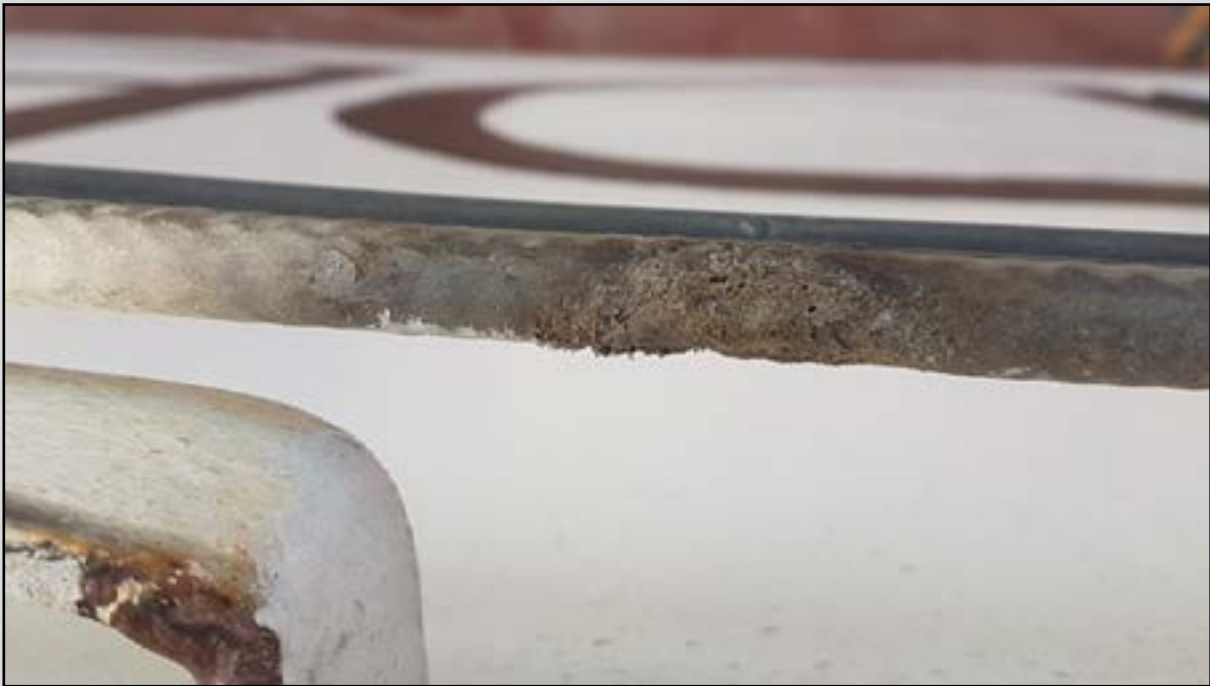
**H2    Heat affected cable, the sheath is charred, possibly with burn thru spots to armour**

Cables that have been affected by fire but are still capable of operation. FS17 tape repair and coating with FS5.

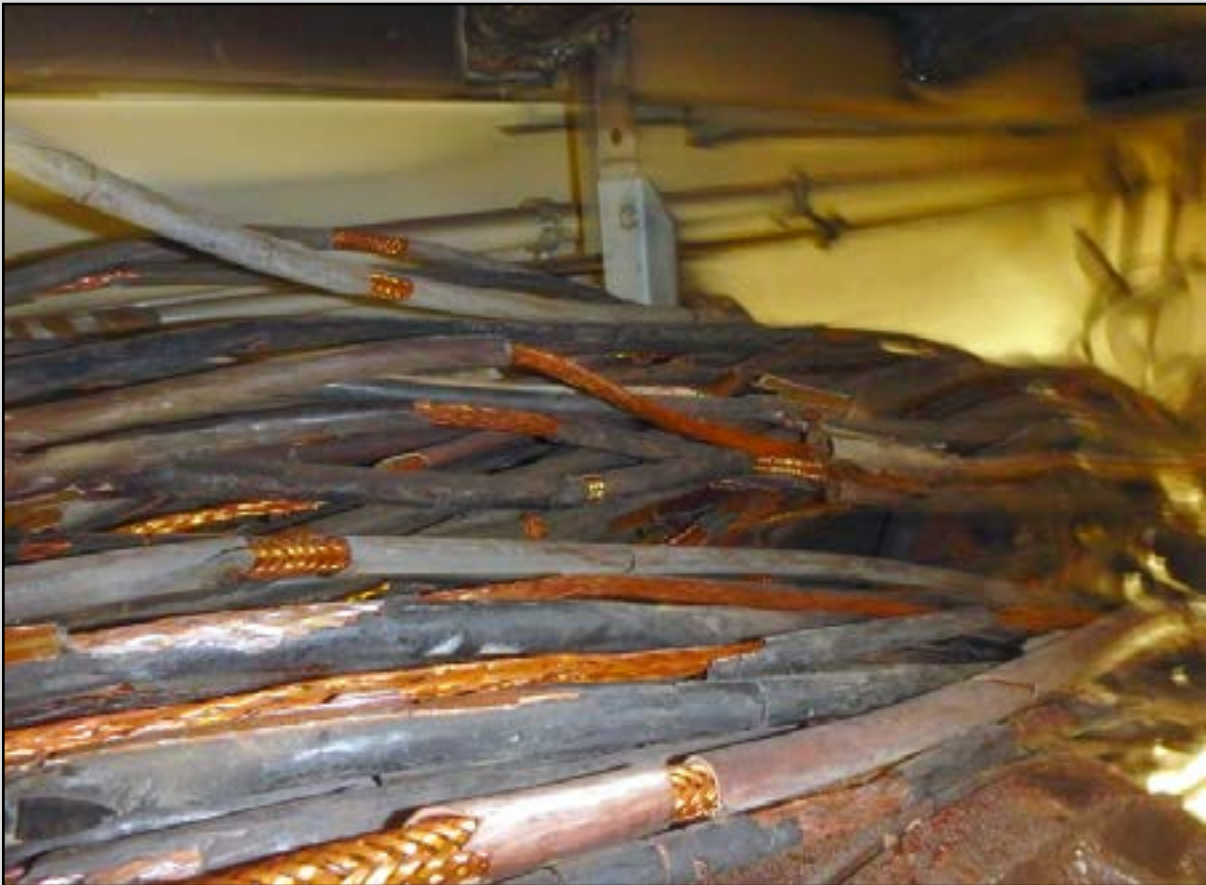
H3 Heat affected cable, the sheath is fully compromised, armour may be discoloured but is still intact, core unaffected

Cables that have been affected by fire but are still capable of operation.  
FS17 tape repair and coating with FS5.

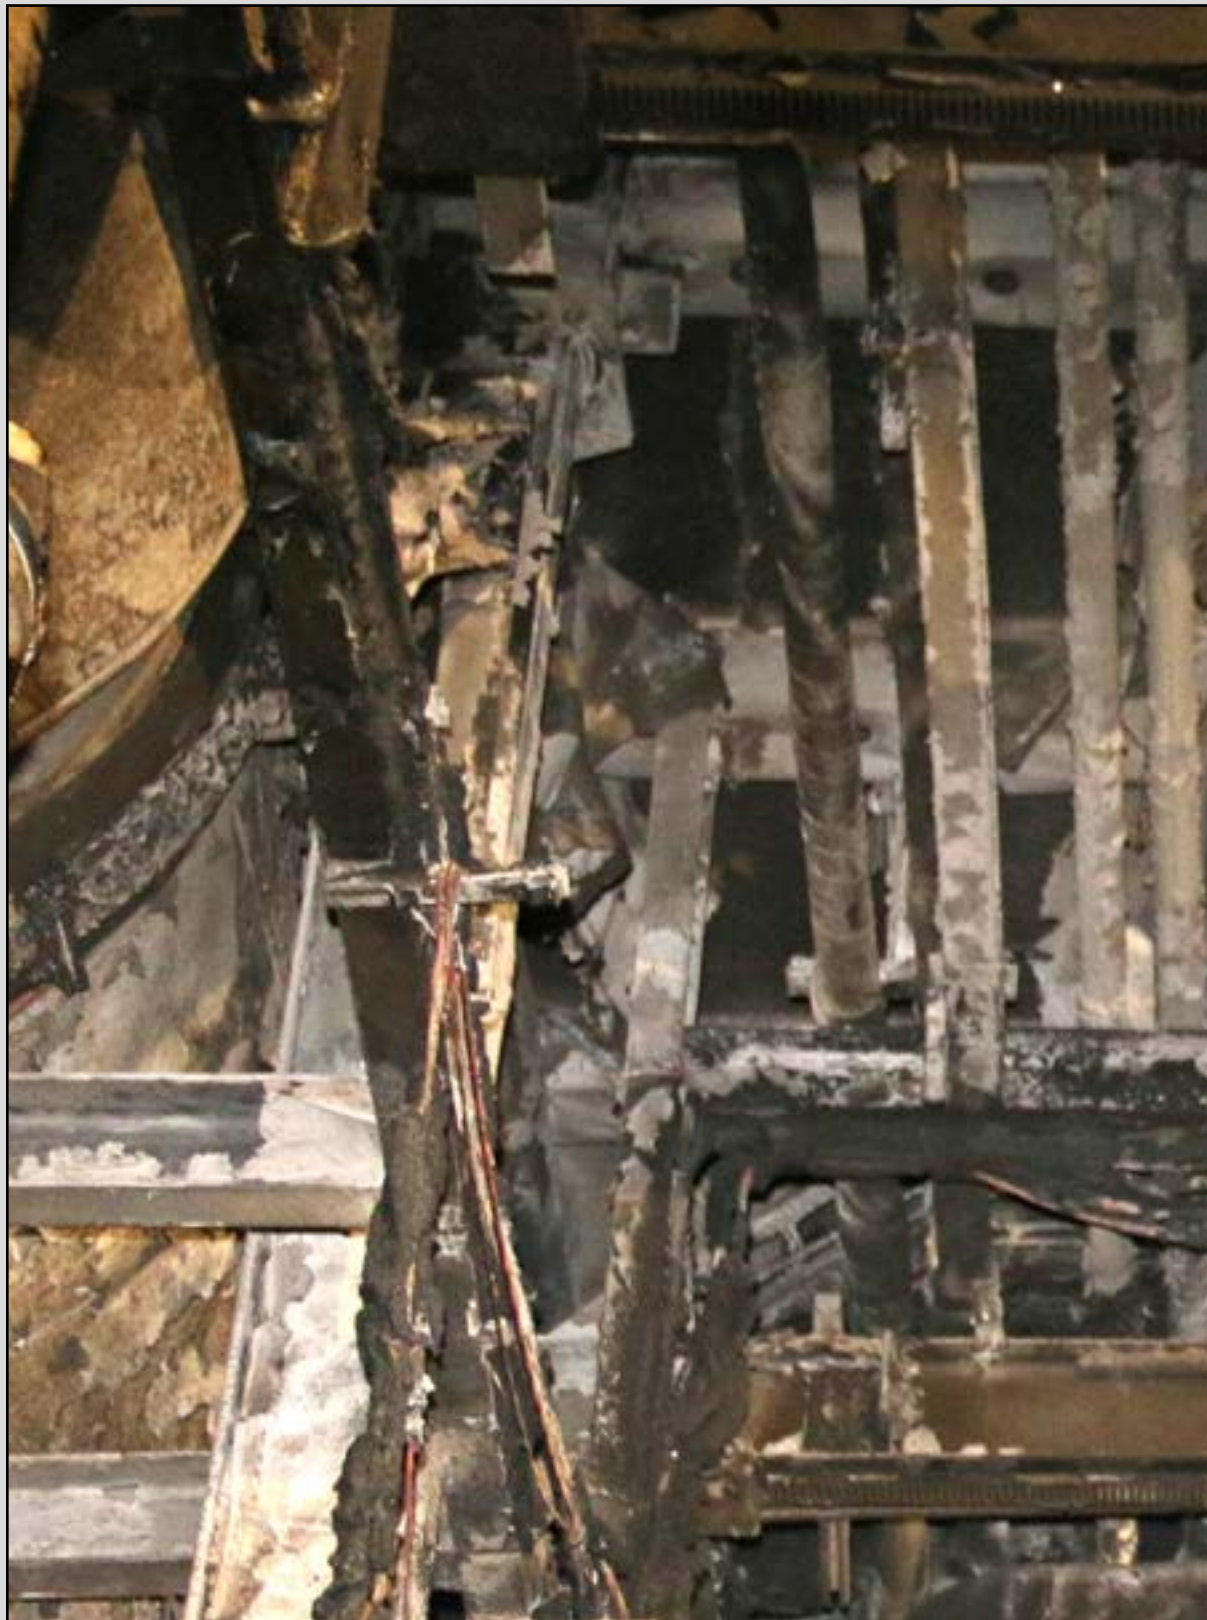
#### H4 Heat affected cable, core exposed / fully failed sheath

Fully failed outer sheath, with exposed inner core due to external heat sources (for example cable near leaking exhaust). At this stage, an HV or instrumentation cable should be considered beyond repair. LV cables may be considered for repair. Various repair options are available depending upon site conditions and operational constraints.

- H4 Heat affected cable, core exposed / fully failed sheath.
