Certified Sustainable Cable Maintenance

Cable Maintenance Guide for implementation in a life extension program

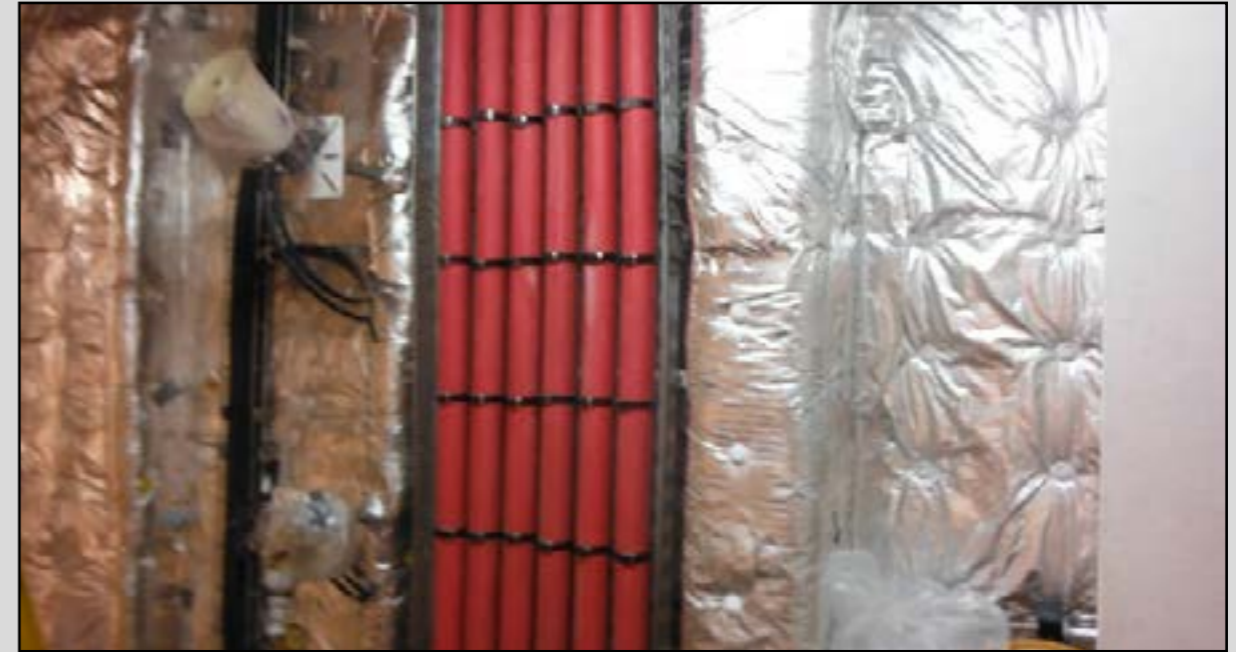
A1 New / good condition cable unbleached, dust covered for internal areas

Cables in this condition do not require any maintenance. Fire protection properties and lifetime extension would be increased by application of FS coating systems at this stage.

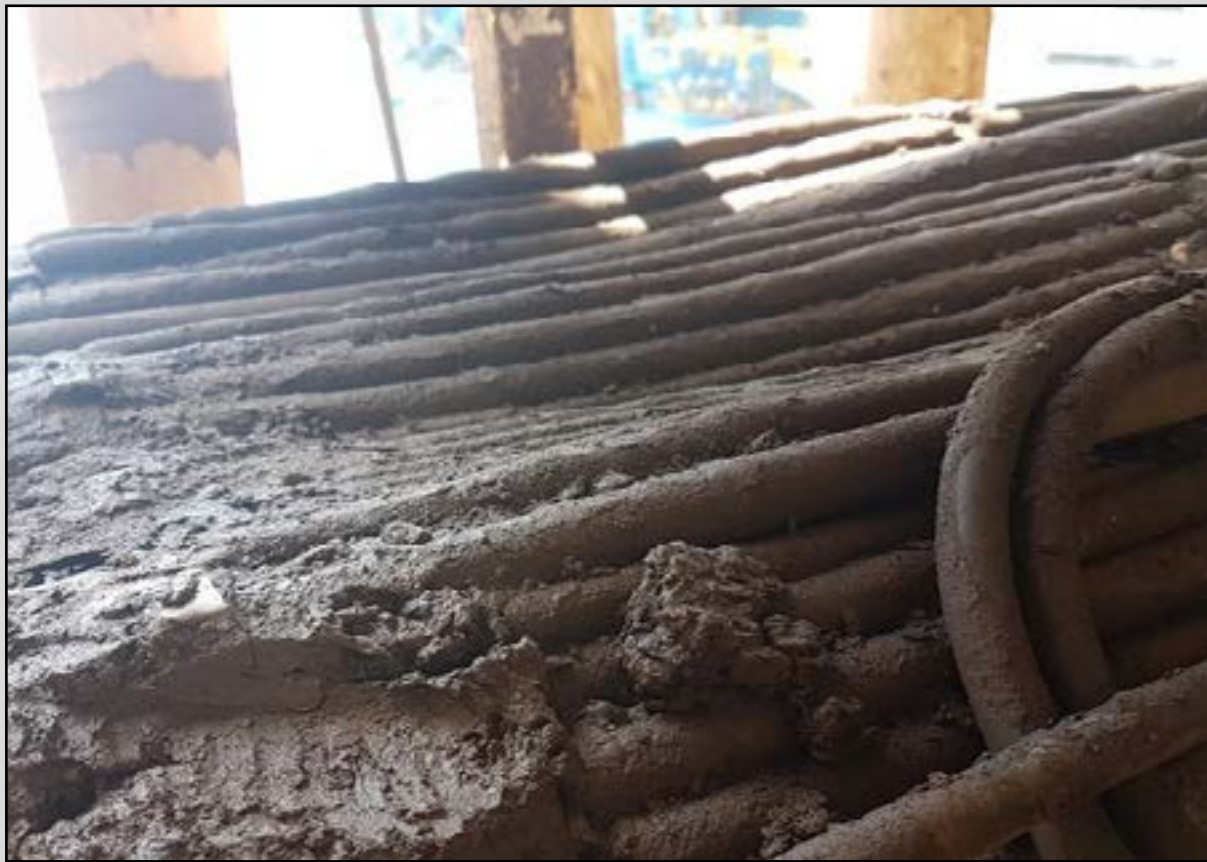
C1 Good appearance but with surface contaminates that may degrade the sheath: Acids, Oil based drilling Mud's, Hydraulic fluid, Gas Turbine / Compressor oil, grease & oil based paints

Many hydrocarbon-based chemicals could react with the cable to soften the outer sheath hydraulic fluid & compressor oil being of particular concern. It is advised to clean the cables using HP water and a degreaser like rig wash.

Attempt to pinch the sheath, if you can move it from the core, then chemical softening has already started. Washing and degreasing the cable may halt this process but the cable has already lost a high percentage of its protective capabilities: I.e. Low Smoke emission, insulation value, dielectric strength.

It is advised to coat the cable with FS5 at this stage to restore / enhance the lost properties of the sheath and to protect the sheath from further chemical degradation.

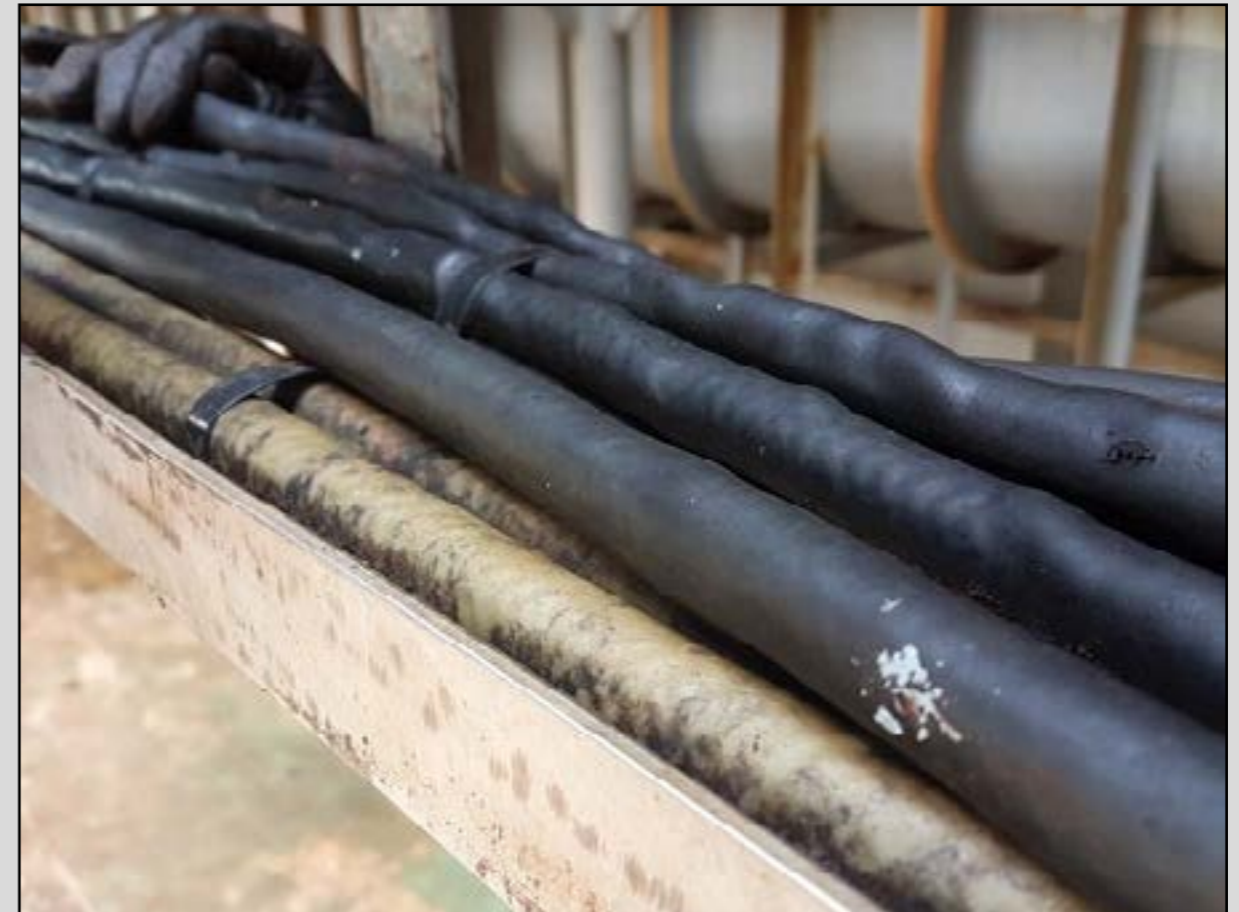
C2 Damaged sheath softened or even wrinkled sheath due to contaminates

Washing and then coating the cable with FS5 may be considered if wrinkled is still minor however, we would advise that FS carry out a survey and advise the correct course of action at this stage. The sheath can be fully stripped off and a new one installed utilizing our FS17 repair tape and FS5 coating system.

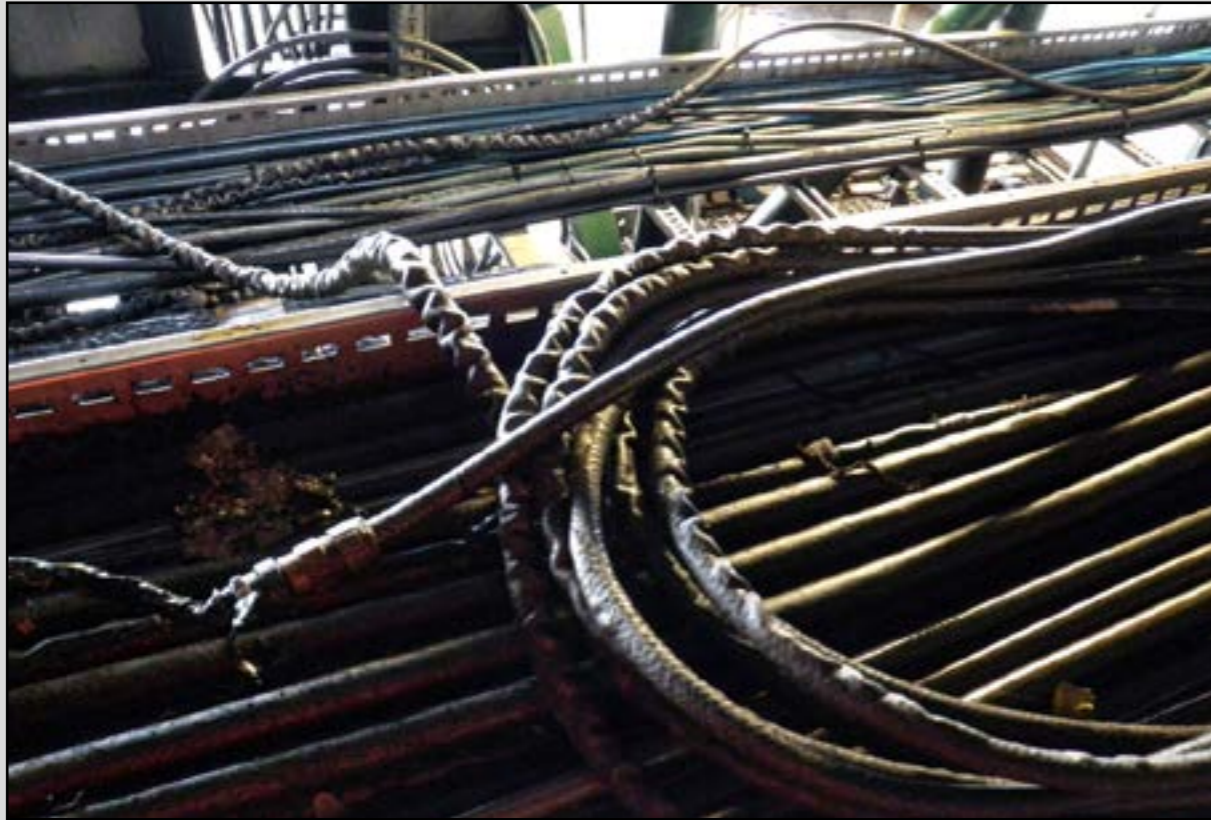
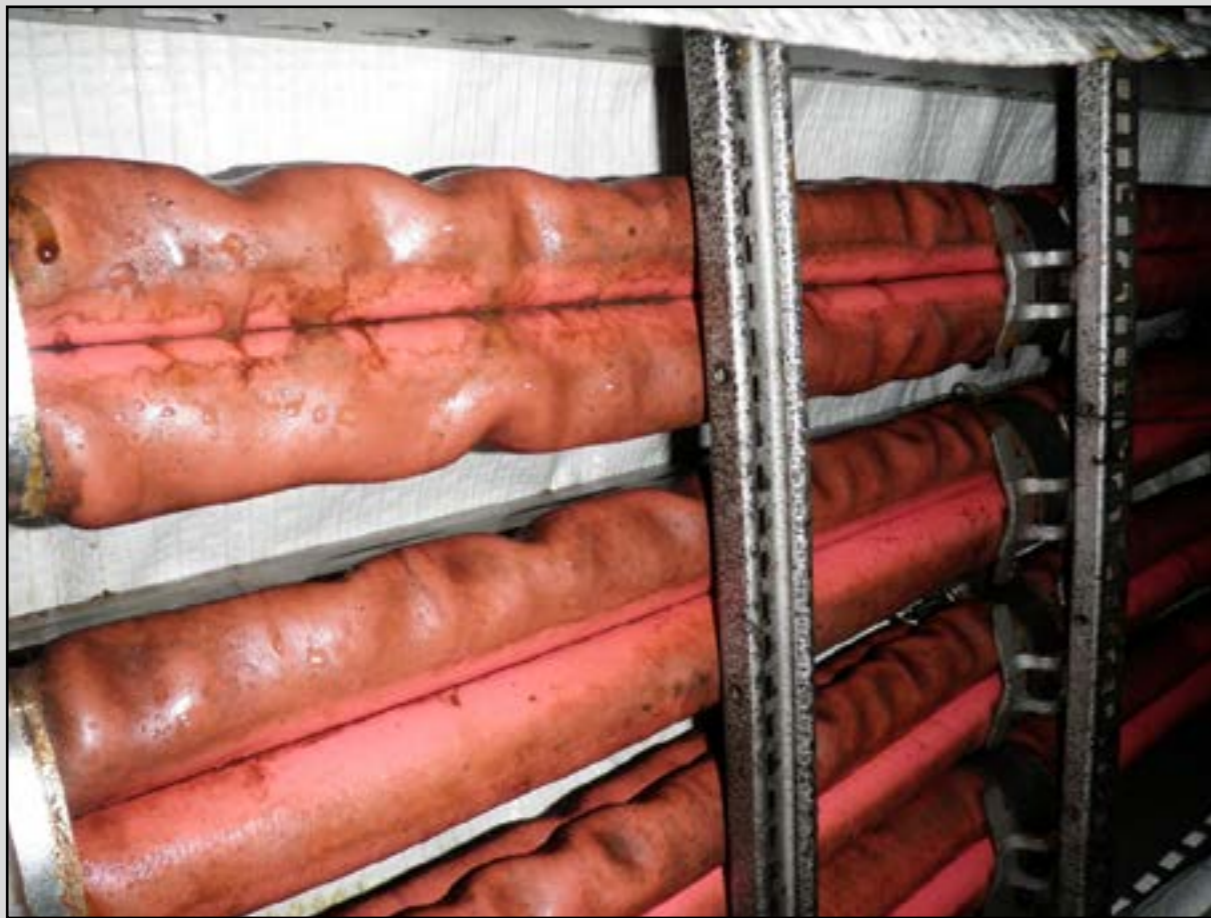
C2 Damaged sheath softened or even wrinkled sheath due to contaminates

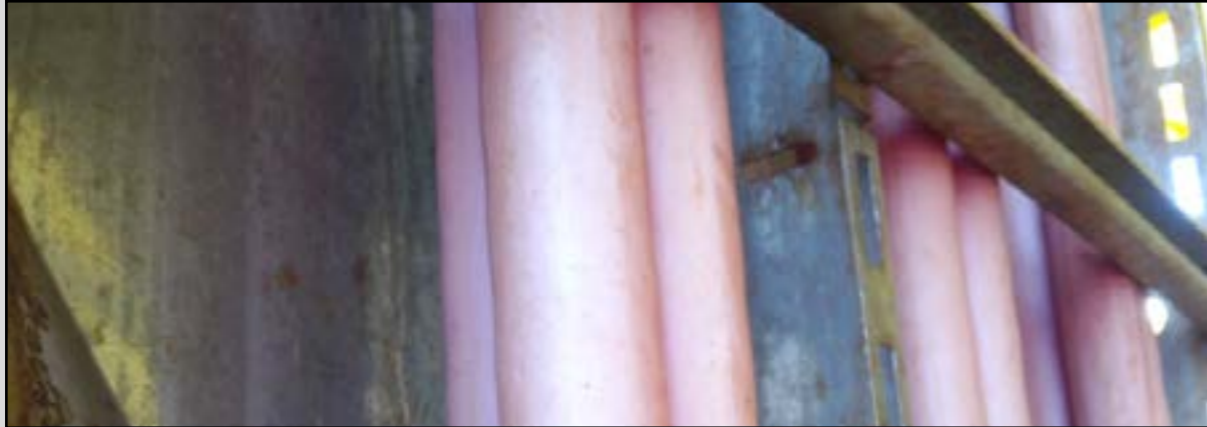
UV1 Colour faded (bleached) but not chalking

Red, yellow and blue cables tend to be affected by UV exposure worse than black or grey coloured cables. The first sign of UV degradation is loss of colour. This could indicate that the sheath material is at the first stage of UV affected breakdown.

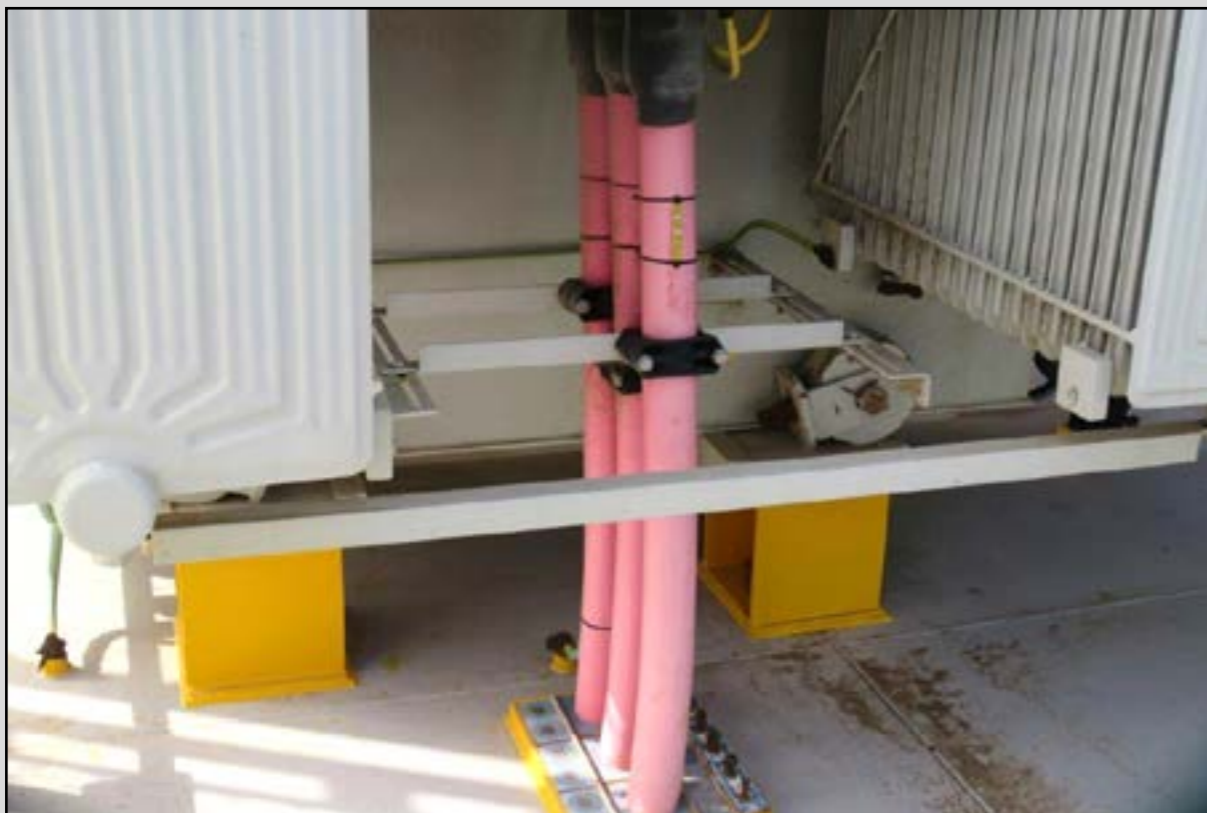
UV2 Colour faded & chalking

Rub your gloved finger over the cable, if it comes away with a chalk like residue and the area that you have just rubbed is slightly shiny then chalking has started. This is a sure sign that the sheath material is beginning to break down. Life expectancy of the sheath at this stage is dependent upon thickness and quality of the remaining sheath. Erecting shade to cover cable runs may be considered or covering cable tray runs with covers. Application of FS5 at this stage will totally halt the UV aging of the cable.

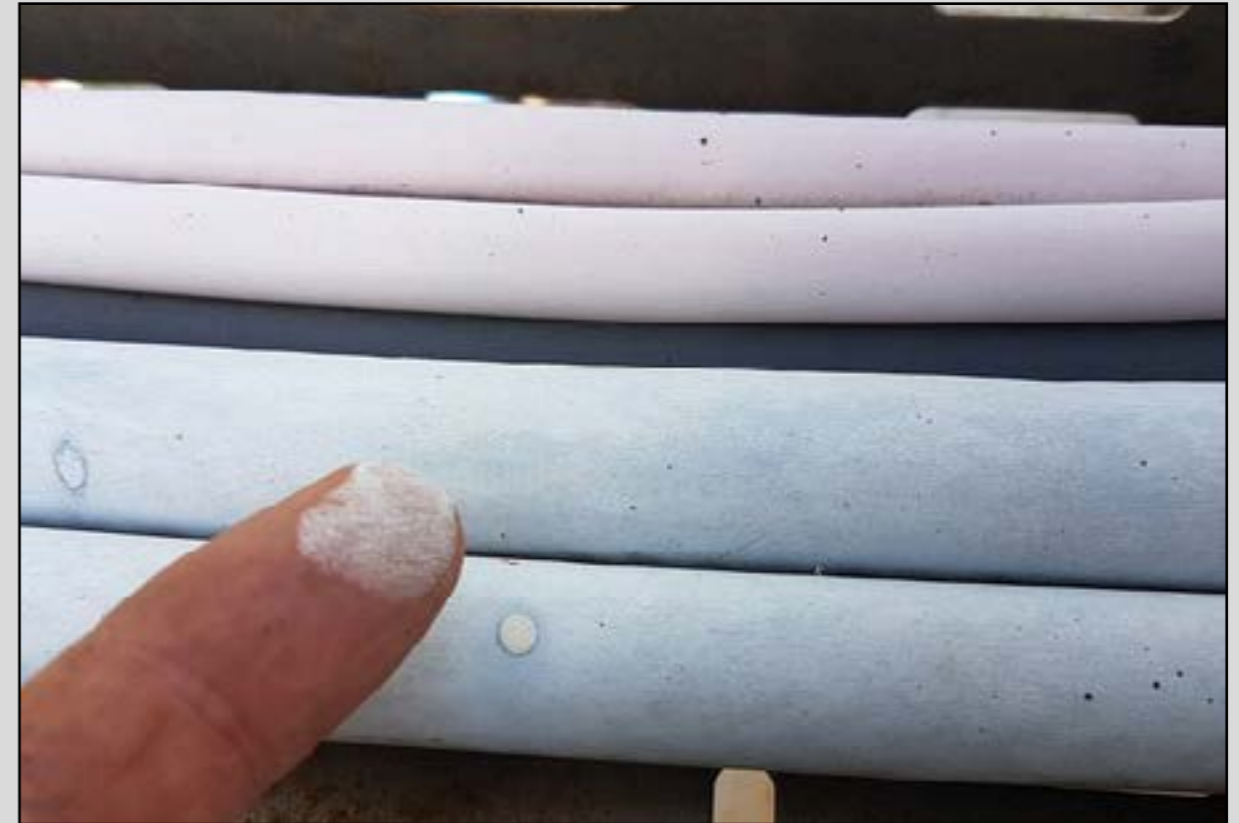
UV2 Colour faded & chalking

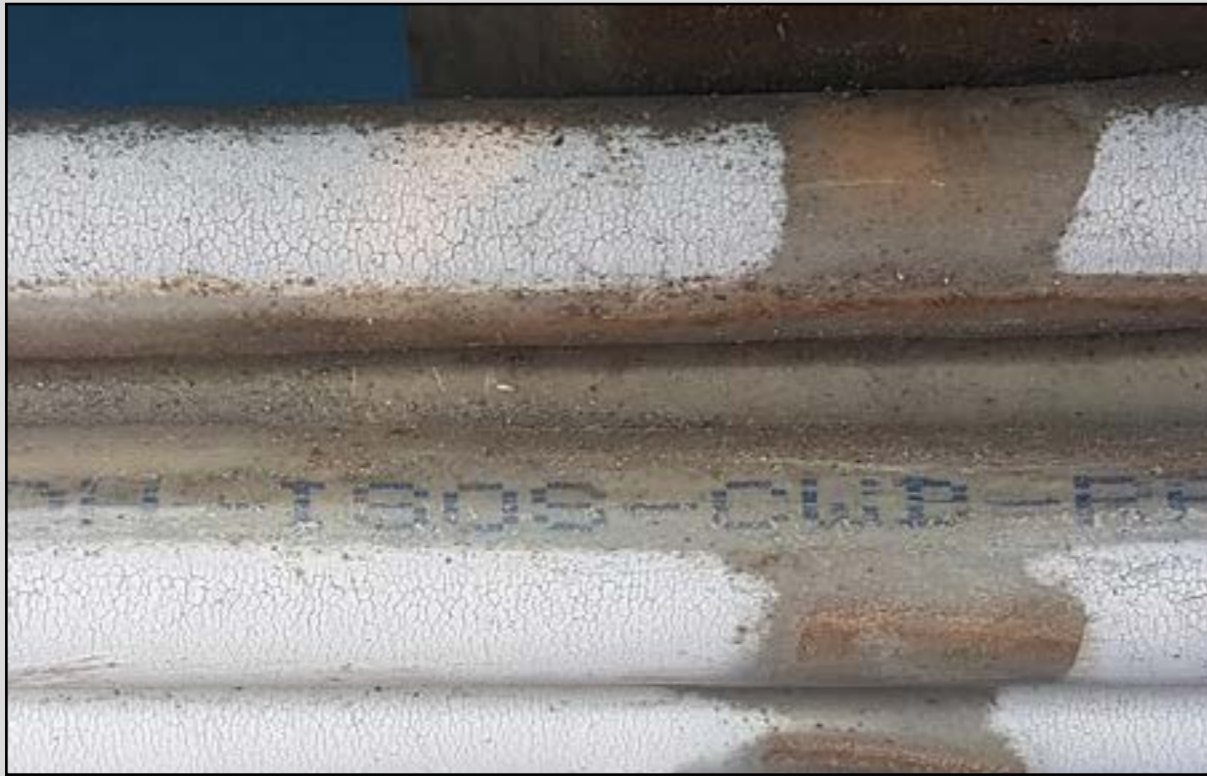
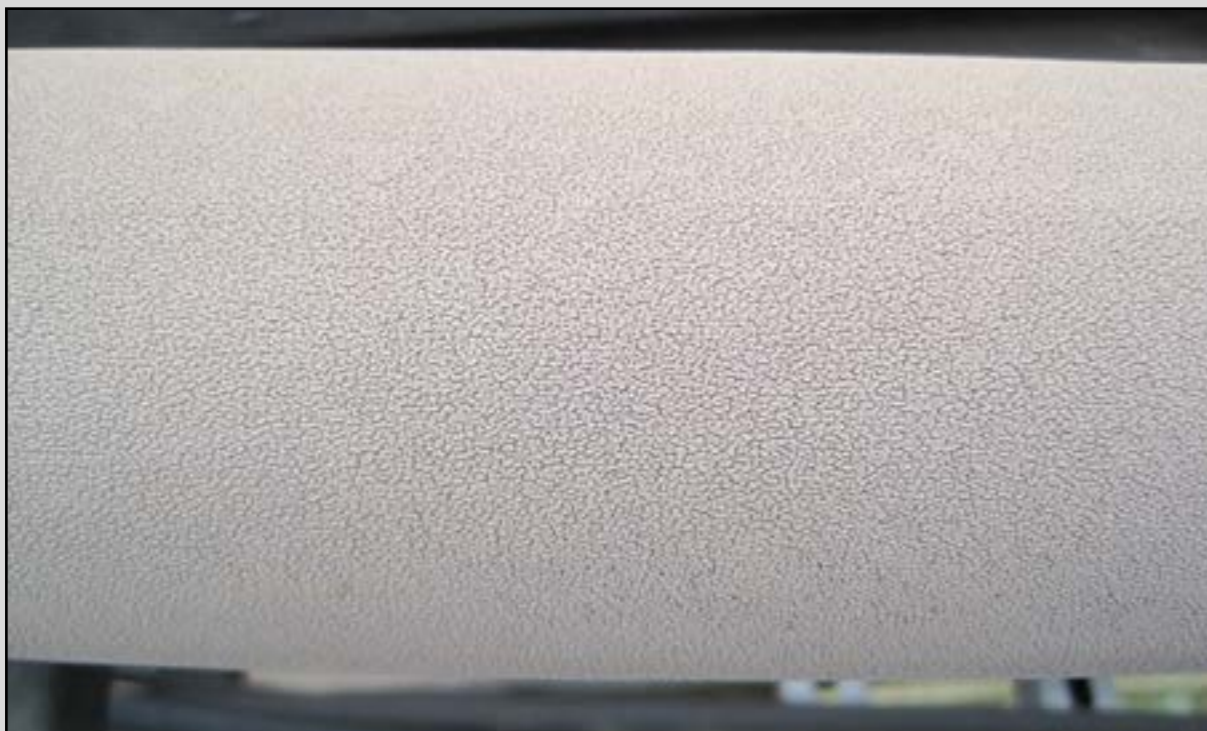
UV3 Perishing started

Perishing or micro cracking of the cable sheath can occur at anytime after chalking has been noted. This may not be visible to the naked eye; a digital photo of the sheath can be taken, and by zooming in, micro cracking, if present, will be noted. Life expectancy of the cable at this stage could be anywhere between 18-36 months before the sheath fully cracks. At this stage many of the cable sheaths properties; dielectric strength and insulation values, have lowered considerably. Application of FS5 at this stage will totally halt aging of the cable and restore its lost properties.

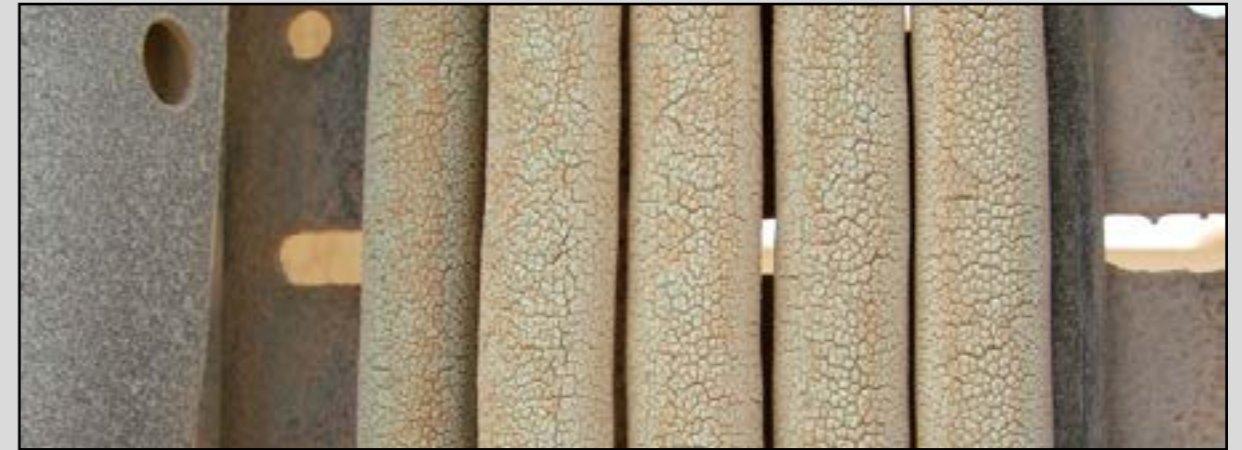
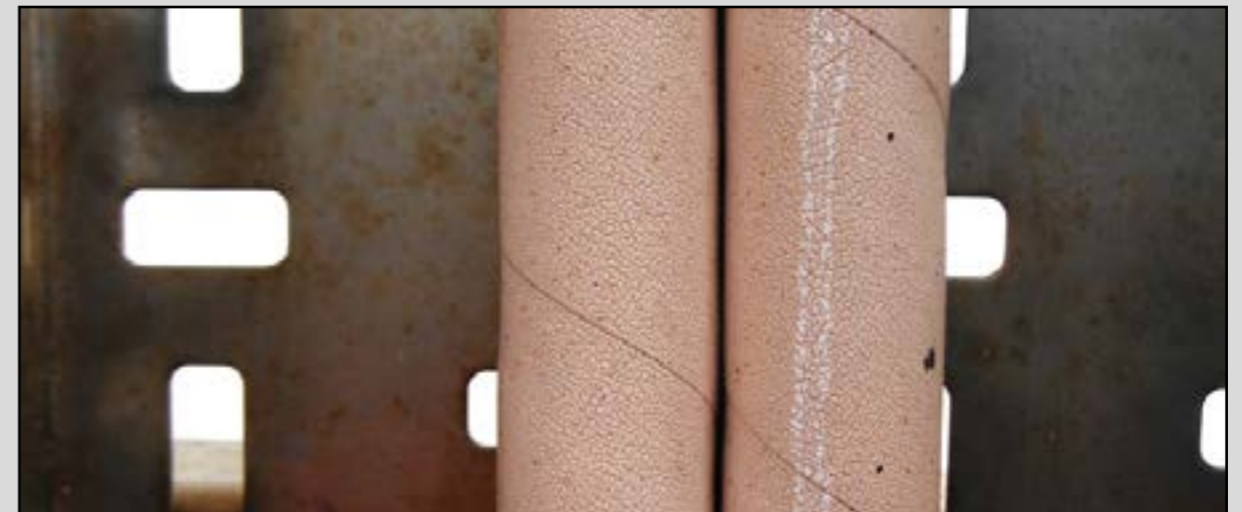
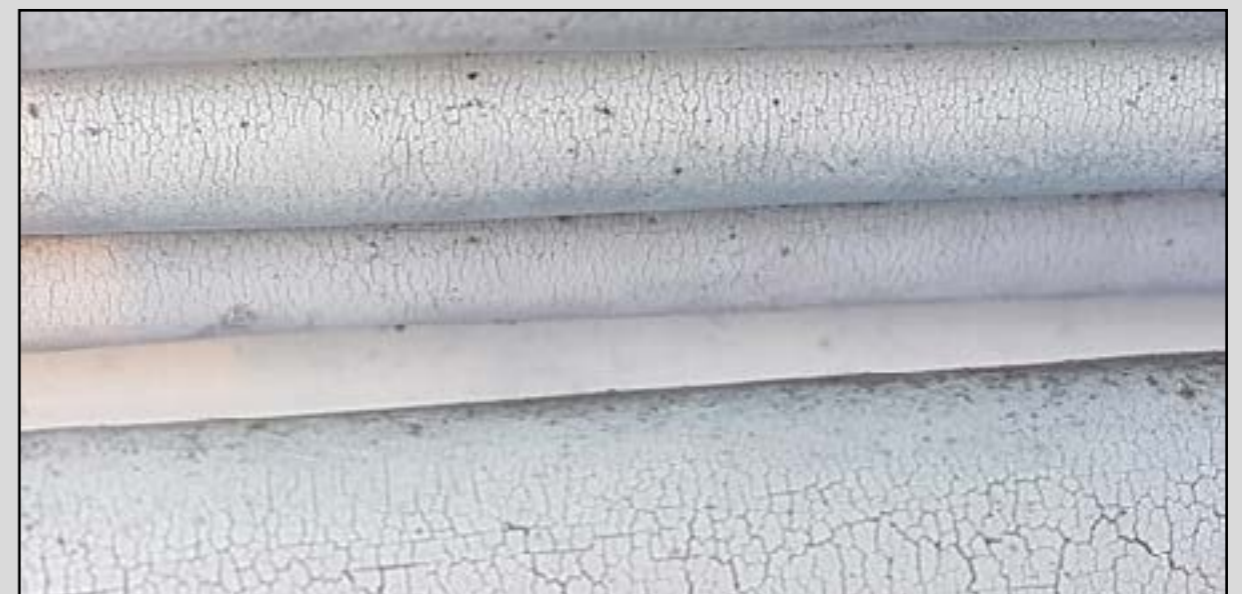
UV4 Heavily Perished

Cracks in the cable sheath will be fully visible to the naked eye but have not yet reached the armour or inner core. The sheath material may be very brittle and most of the cables dielectric strength and insulation value may have been lost. FS5 coating may need to be combined with an underlay of FS17 repair tape in places to restore the properties of the cables, depending upon how brittle the sheath material is.

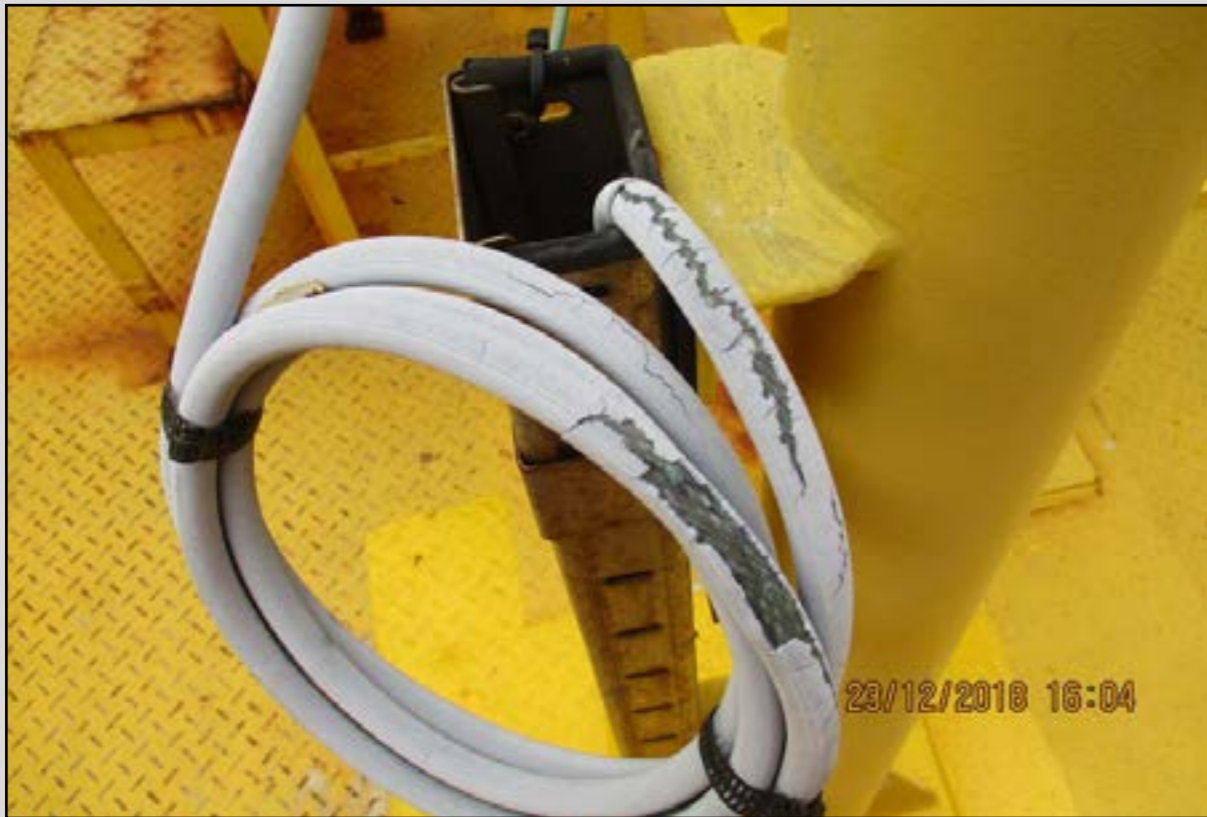
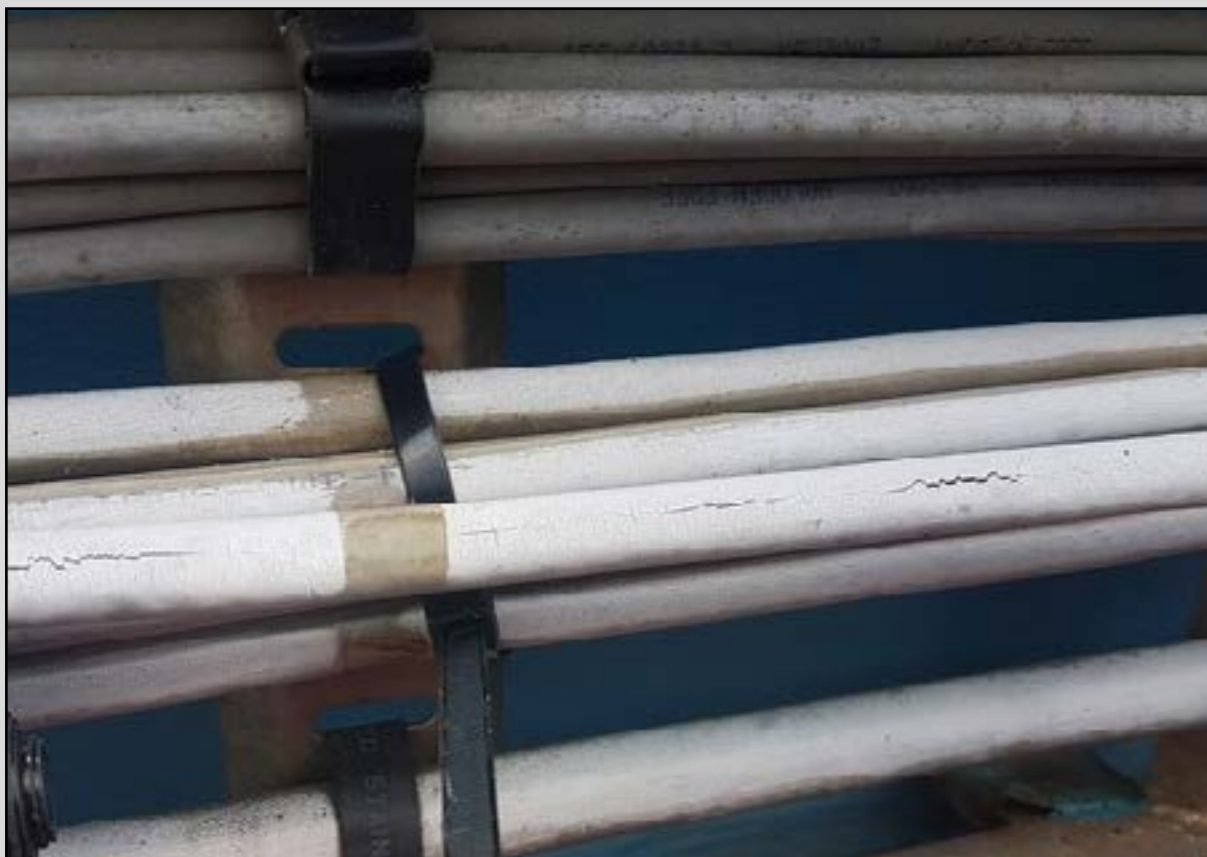
UV5 Cracked sheath

Inner armour or inner sheath (if present) is now exposed, and the cable is now a major safety concern for hazardous (gas) areas. Fire Security offers various repair options at this stage, depending upon site conditions and operational constraints.

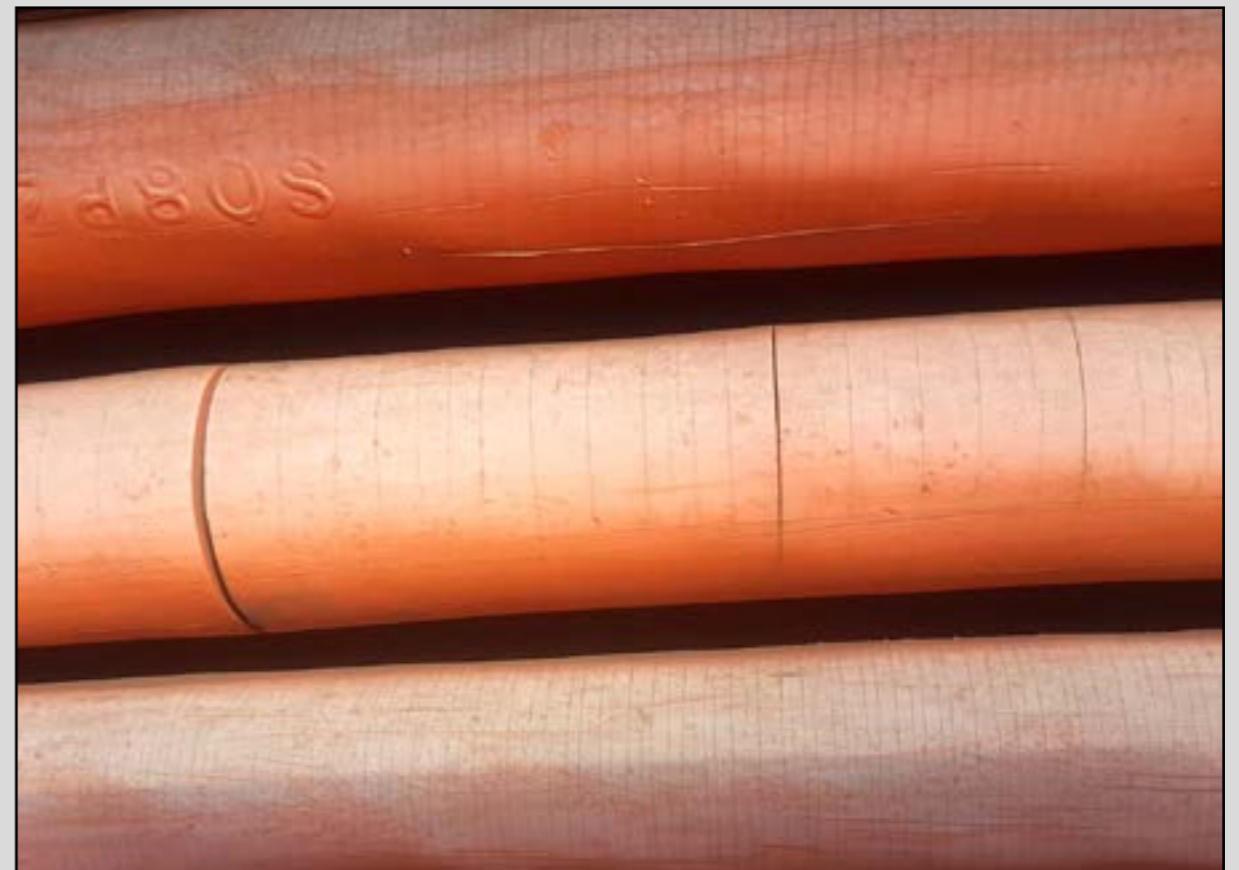
UV5 Cracked sheath

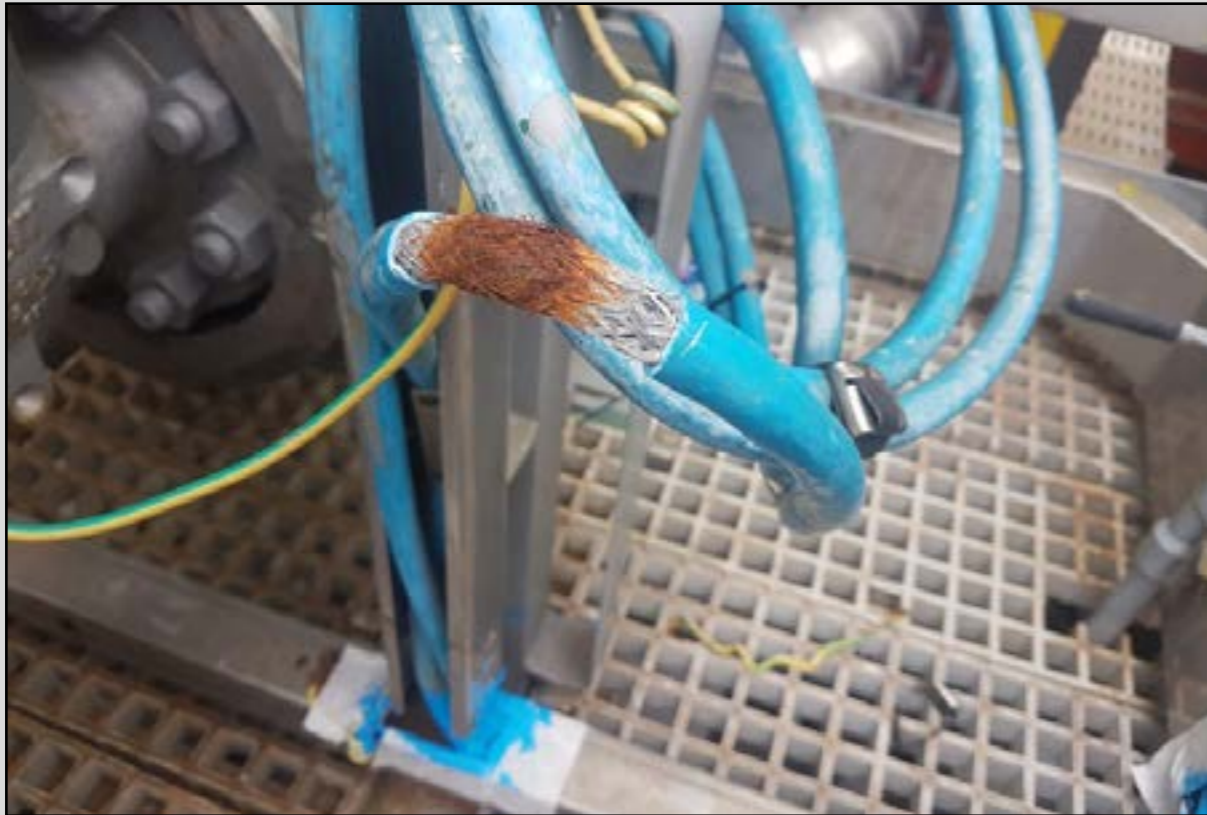
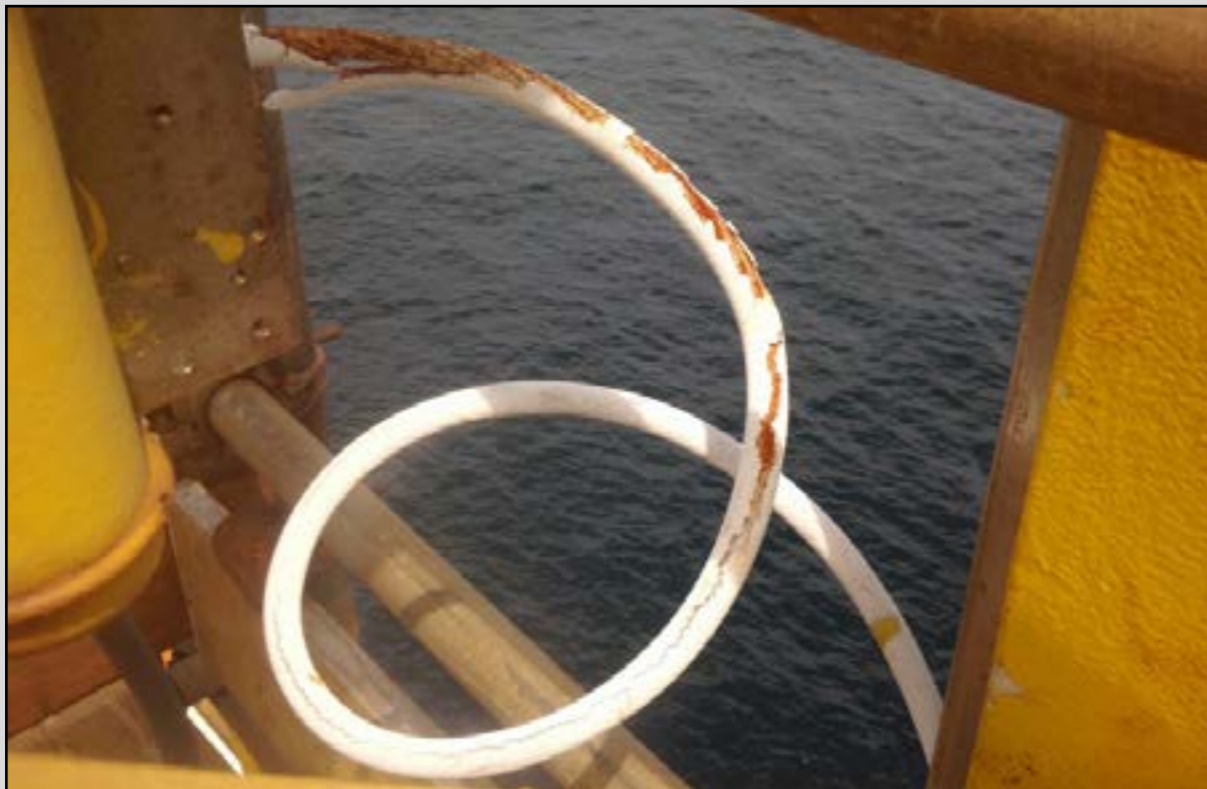
UV6 Cracked sheath, rusting armour

Inner armour or inner sheath (if present) is now exposed and the cable is now a major safety concern for hazardous (gas) areas. Rust streaking may be noted on the cable sheath and possible bulging of the sheath near cracks due to the rust expanding. Fire Security offers various repair options at this stage depending upon site conditions and operational constraints.

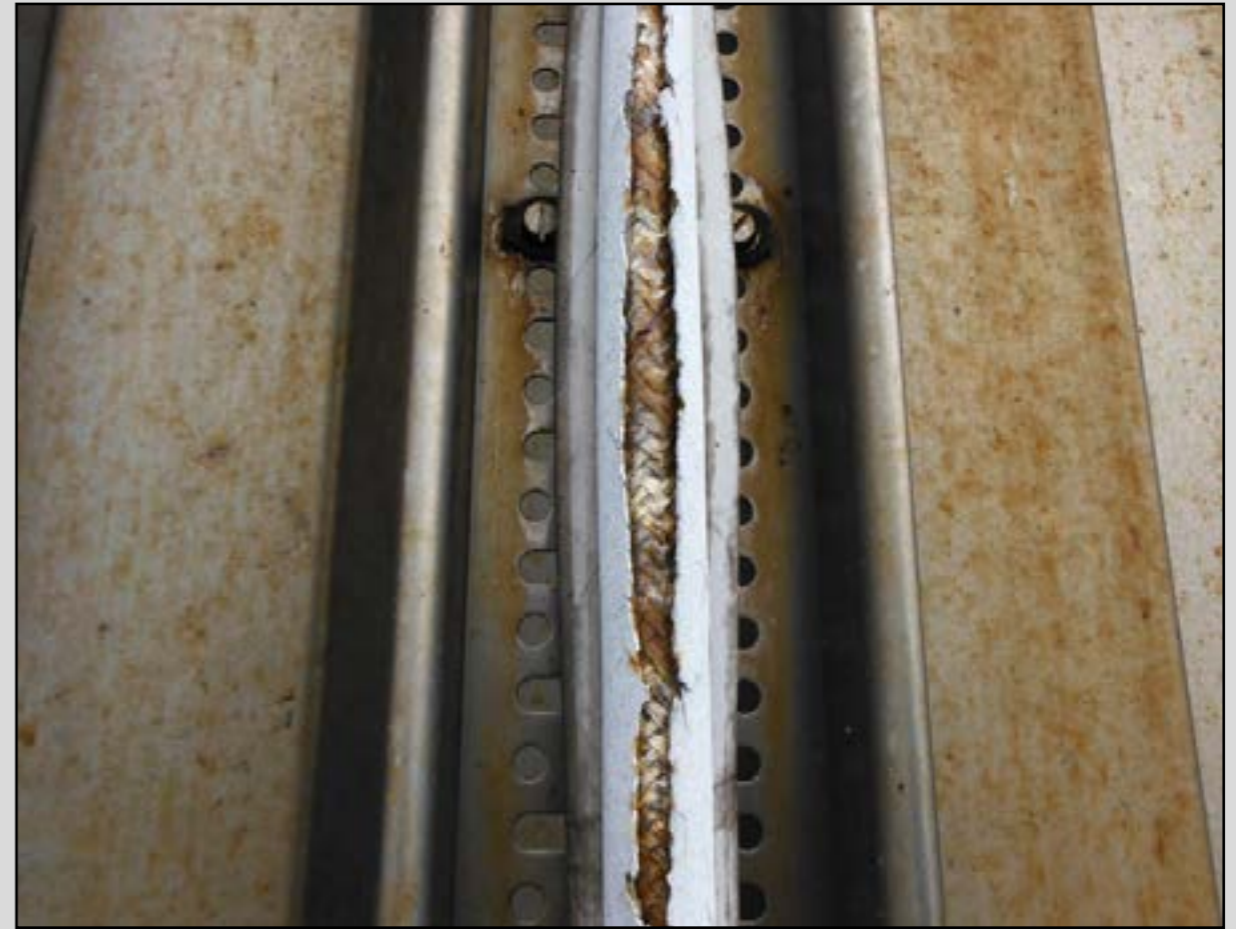
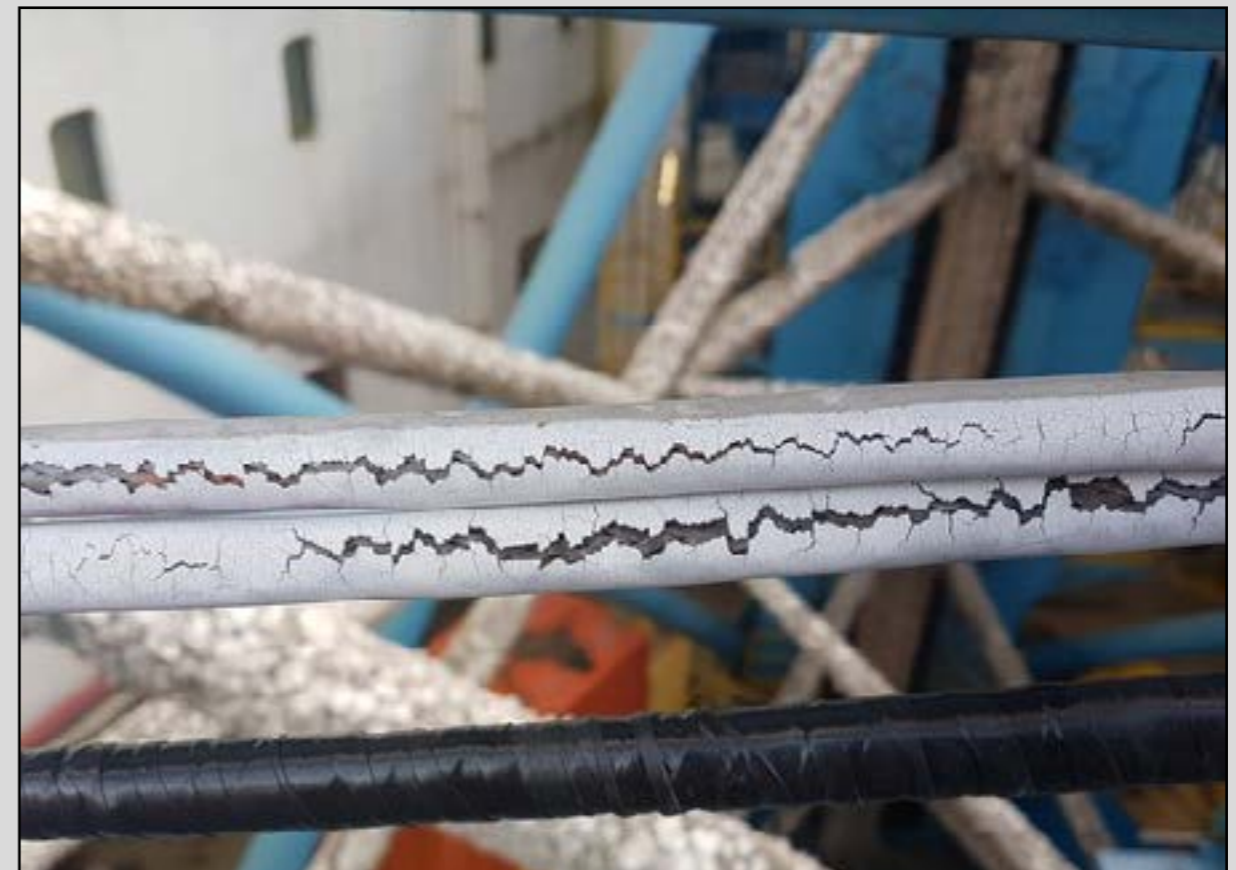
UV6 Cracked sheath, rusting armour

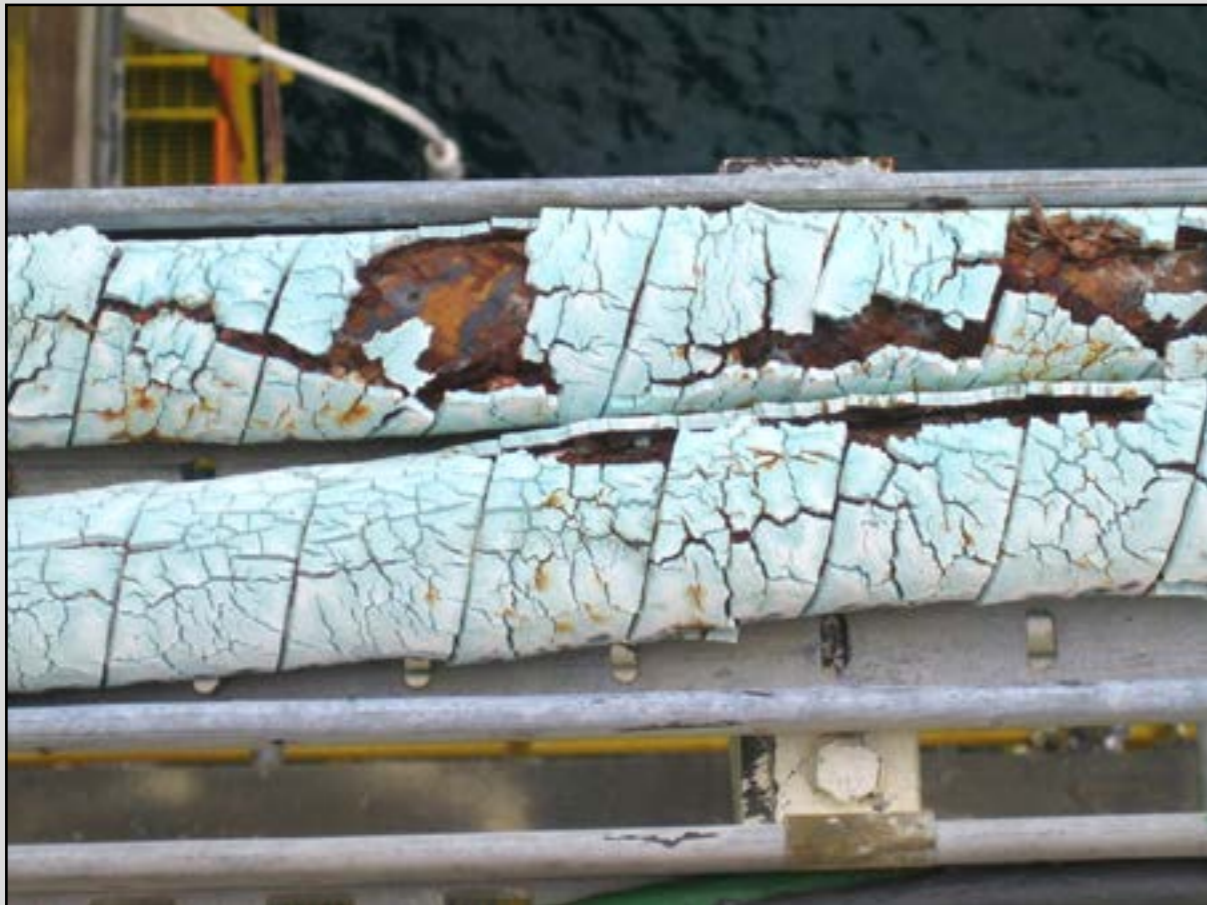
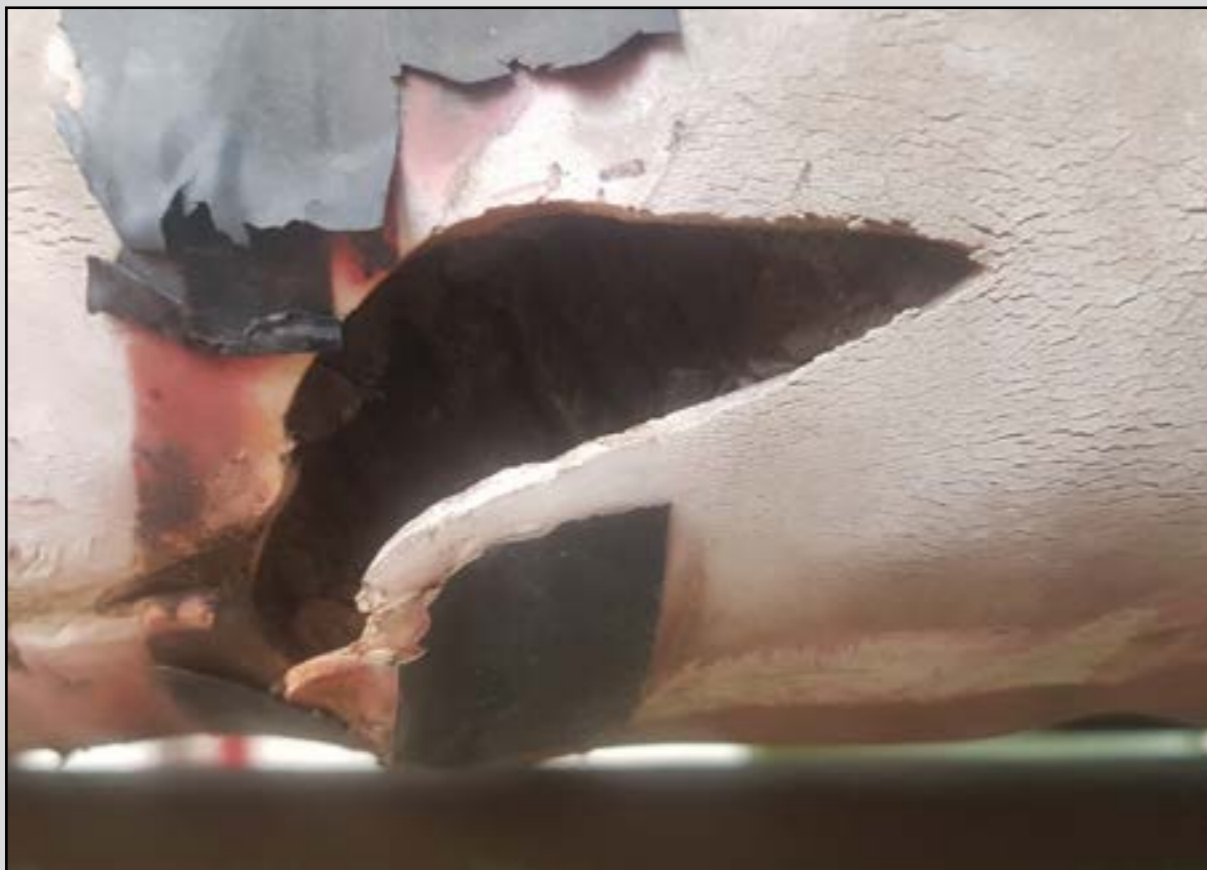
UV6 Cracked sheath, rusting armour
