Certified Sustainable Cable Maintenance

Cable Maintenance Guide for implementation in a life extension program

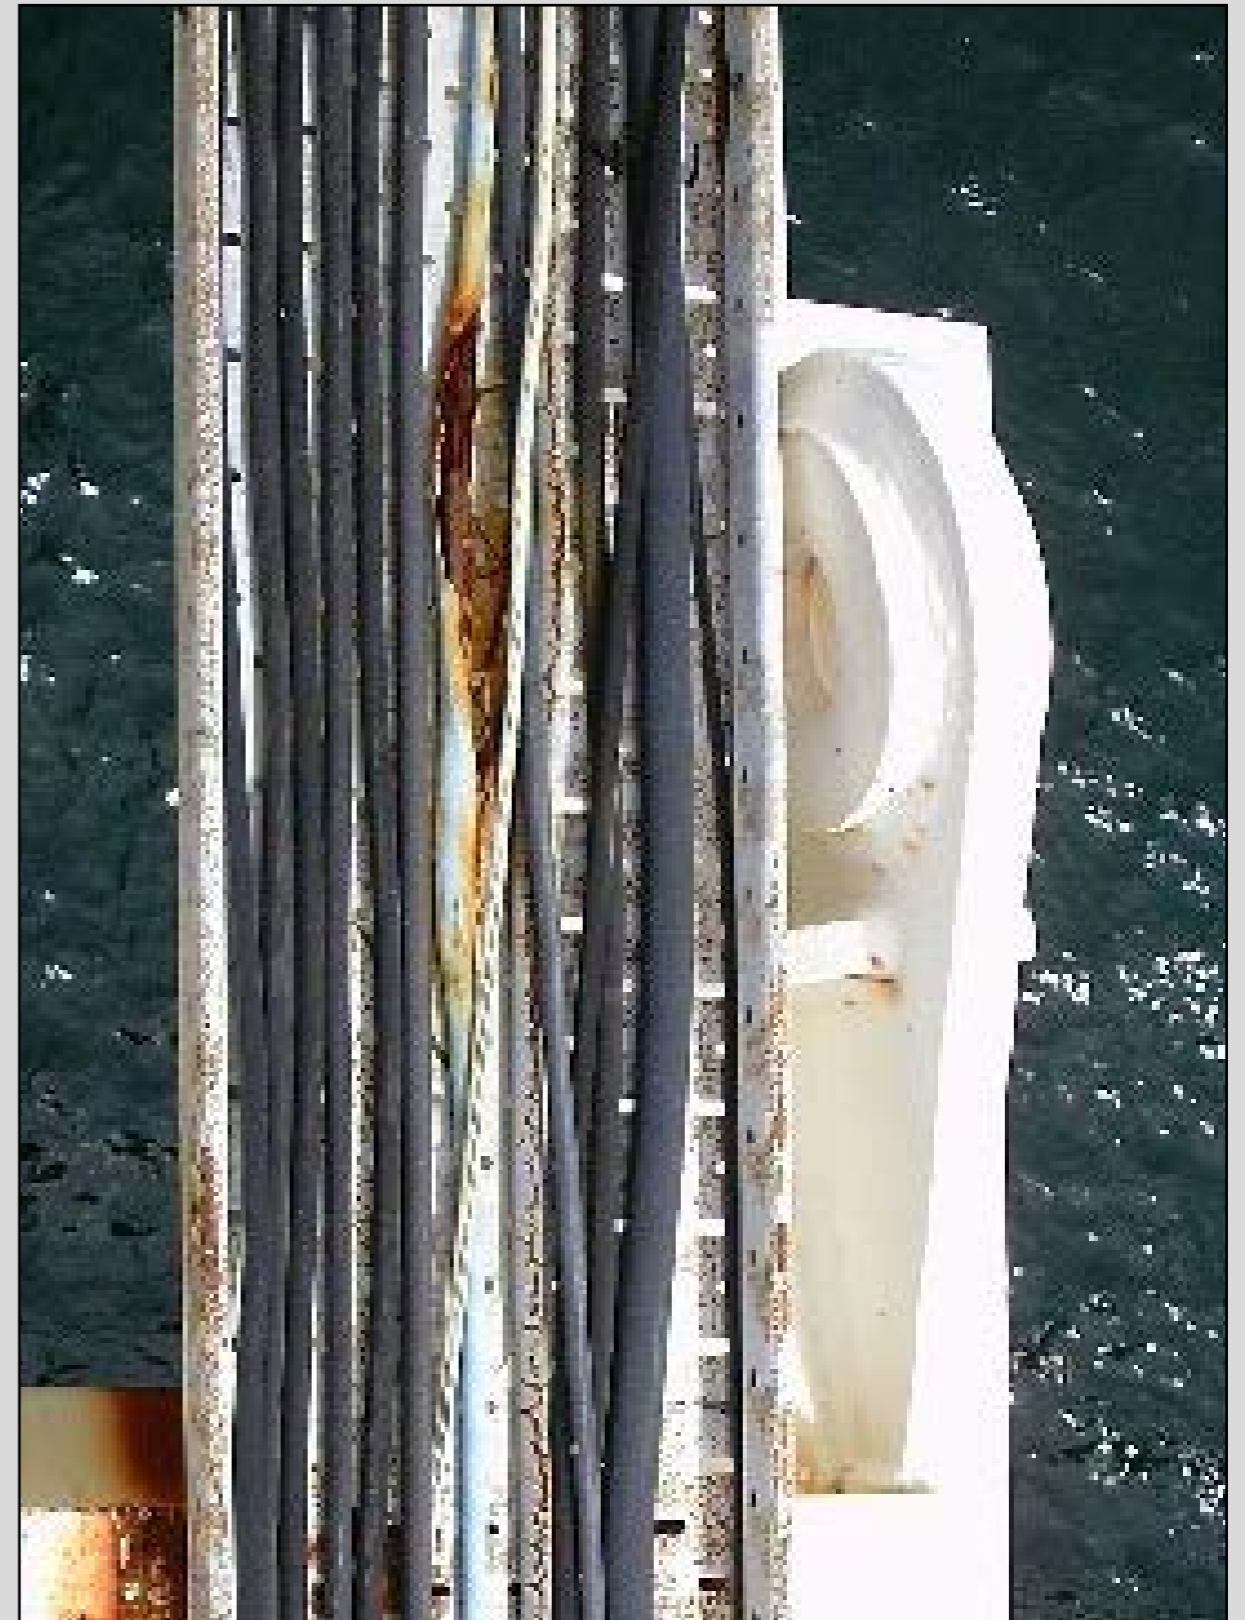
UV7 About to expose inner core

Fully failed outer sheath, stained with rust (if armour is present), and exposed inner core. At this stage, an HV cable should be considered beyond repair. If the client carries out megger testing and is happy with the results, then LV or Instrumentation/ control cables could be repaired (Not recommended for plant shut down or other critical operational cables).

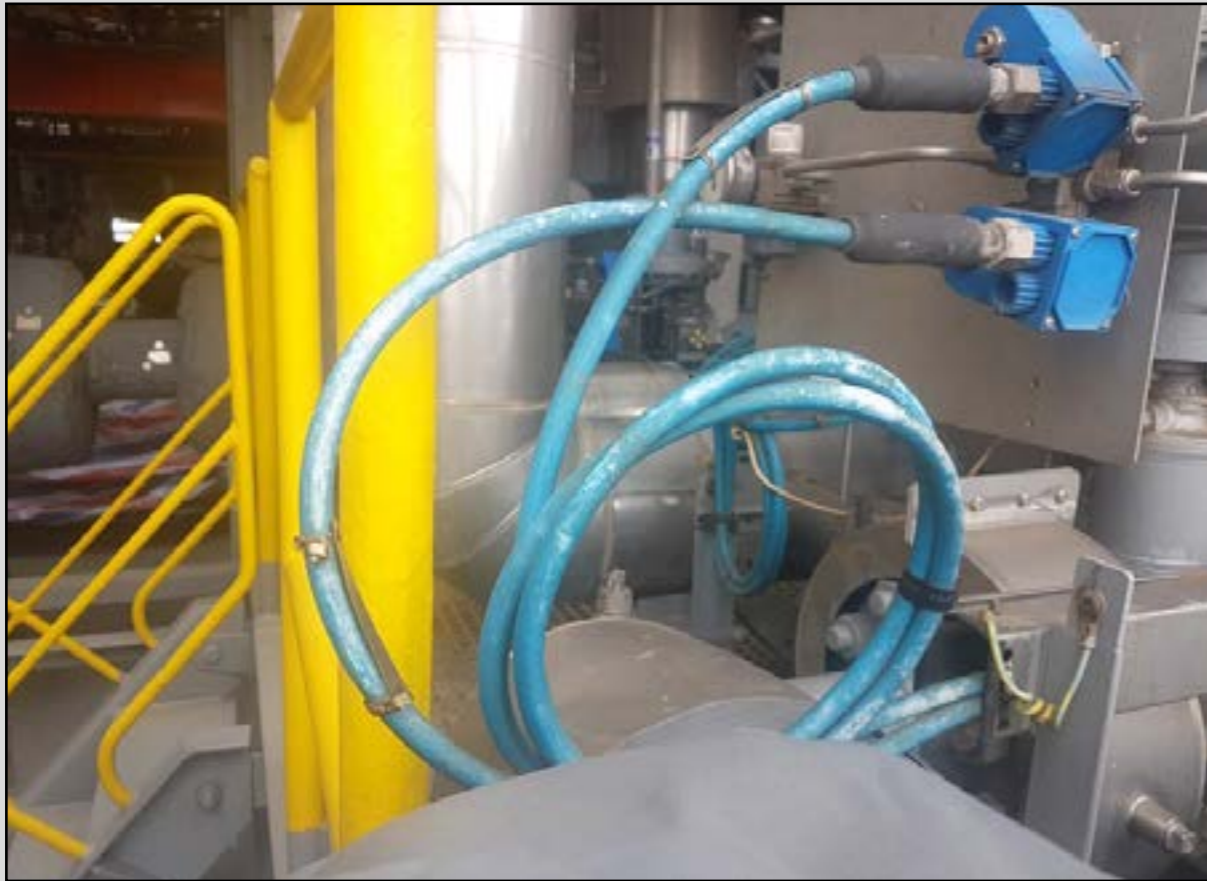
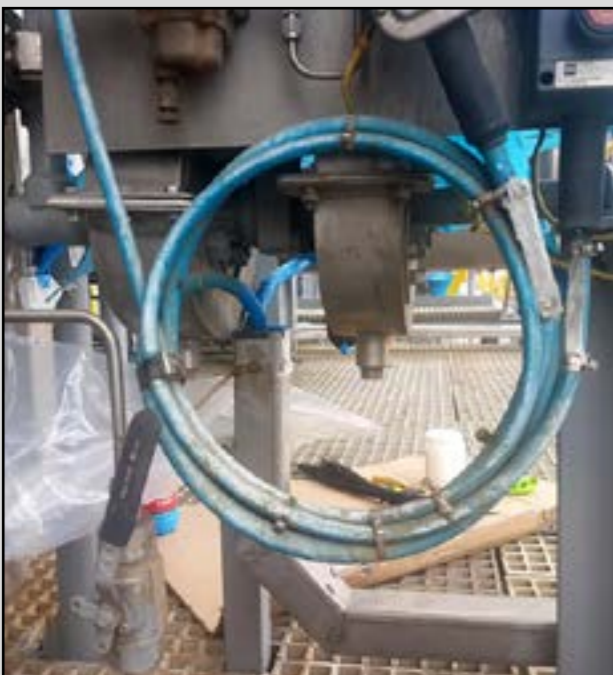
QC1 Early ageing cable due to manufacture mishap, UV Exposed, may be graded on UV 1-7 scale

Fire Security offers various repair options for this, depending upon the extent of aging, site conditions and operational constraints.

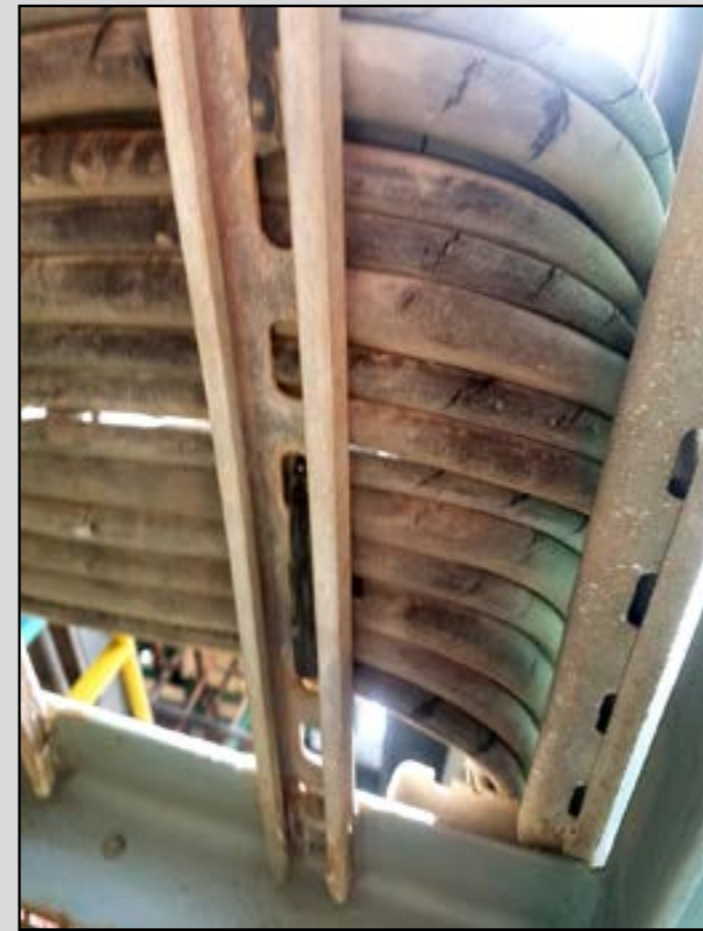
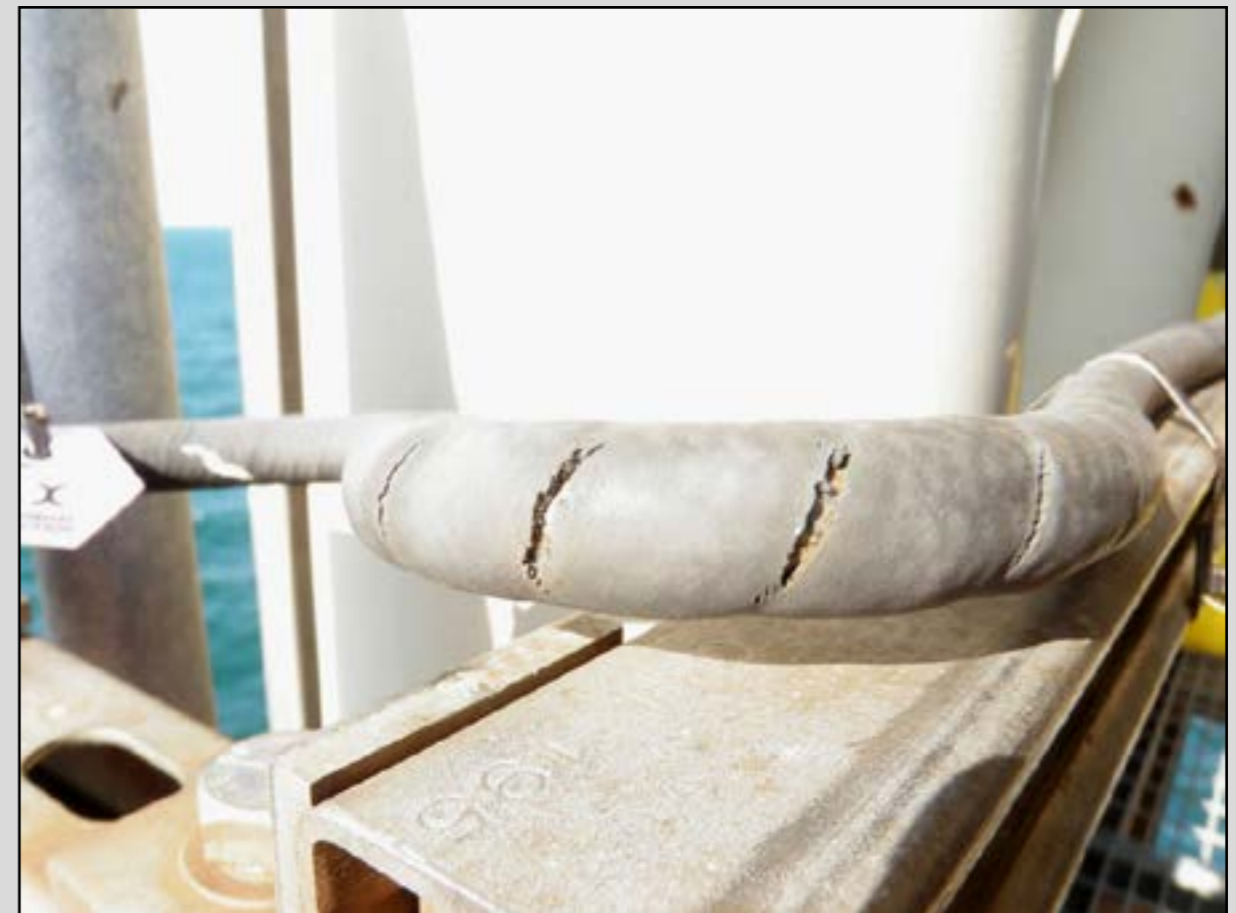
QC2 Stress cracking, mostly on tight bends (Usually Transverse)

Transverse cracking normally found on the outside of cables on tight bends.

For small diameter cables; Cover with FS17 Tape, coat with FS5.

For large diameter cables, Fill with FS21, repair with FS17 Tape, coat with FS5.

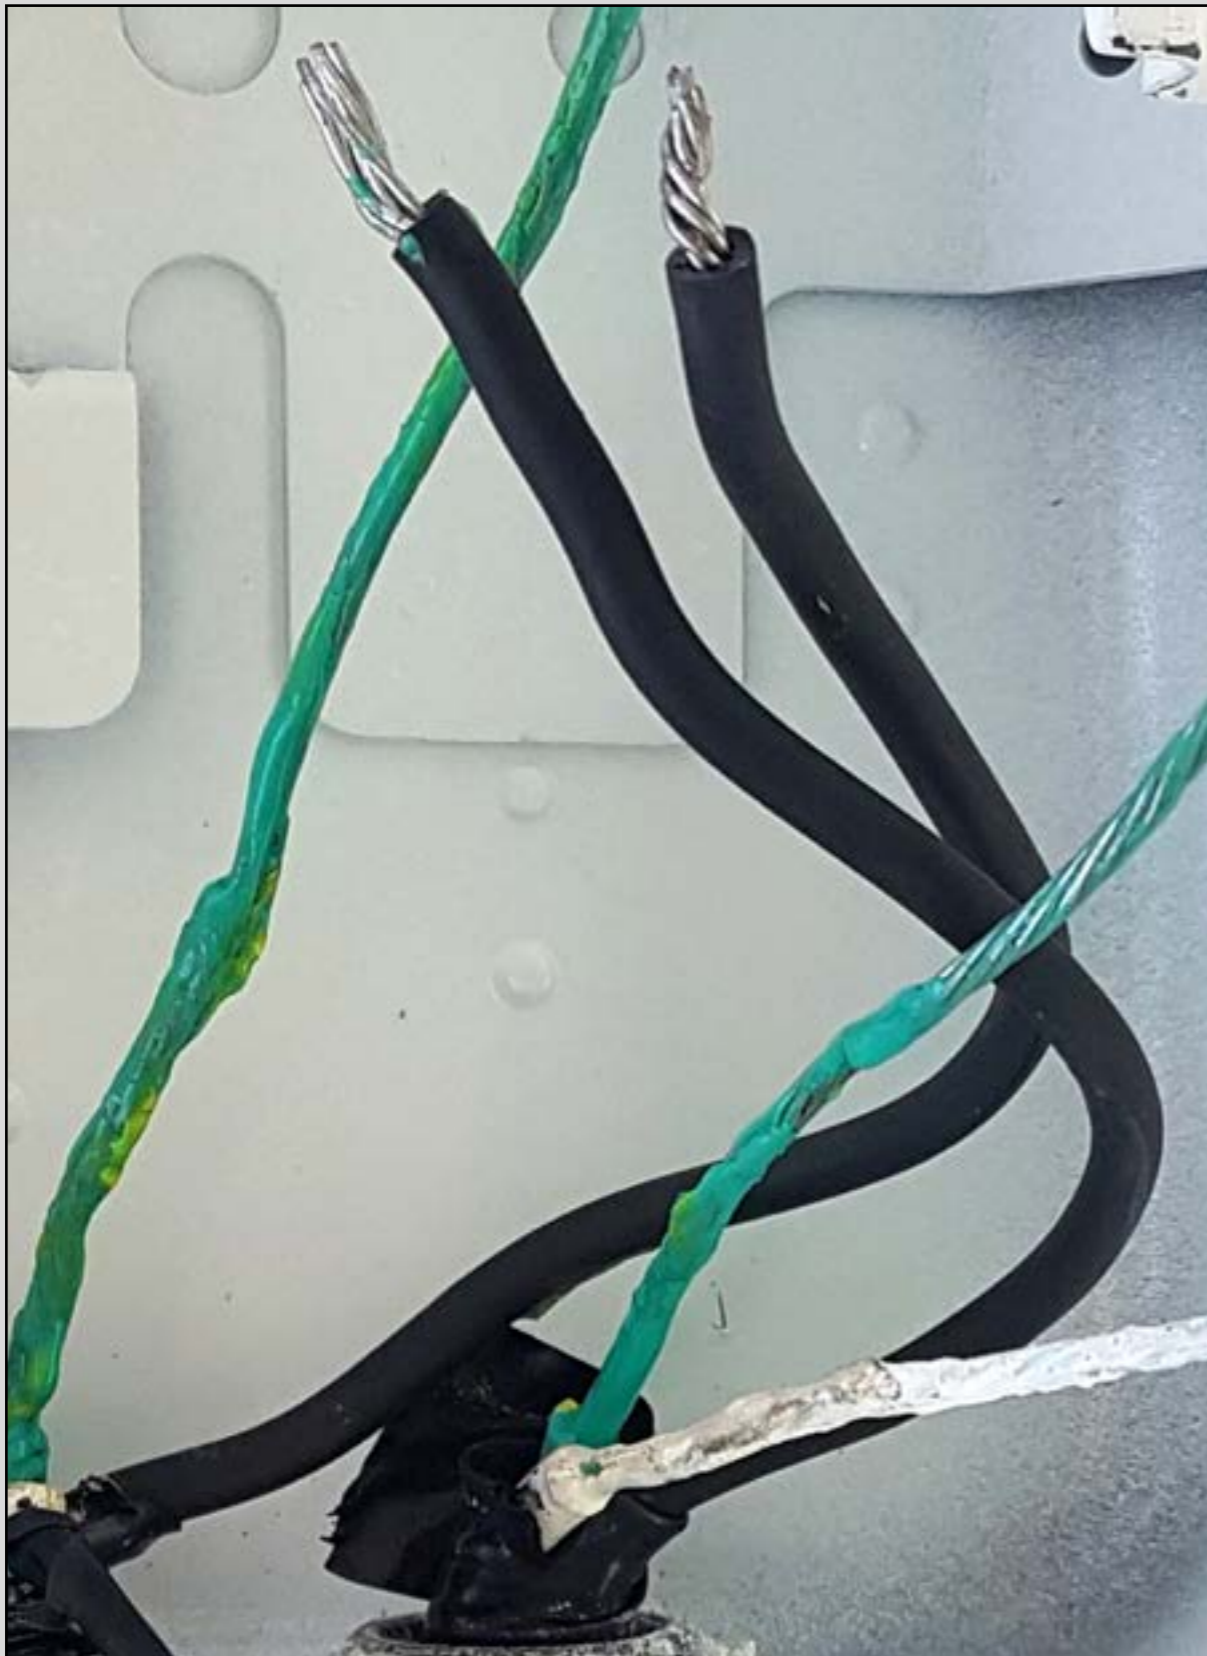
QC3 Sheath material turning to a soft 'gum' like consistency

Similar to chemically affected cable sheath, the material can be 'pinched' and even 'picked' off the sheath, and sticks like chewing gum to the fingers. FS has so far only come across this type of breakdown on exposed inner core wire sheaths at termination points. Options include coating the area with FS5 or slipping a pre-prepared colour coded sheath over the affected section.

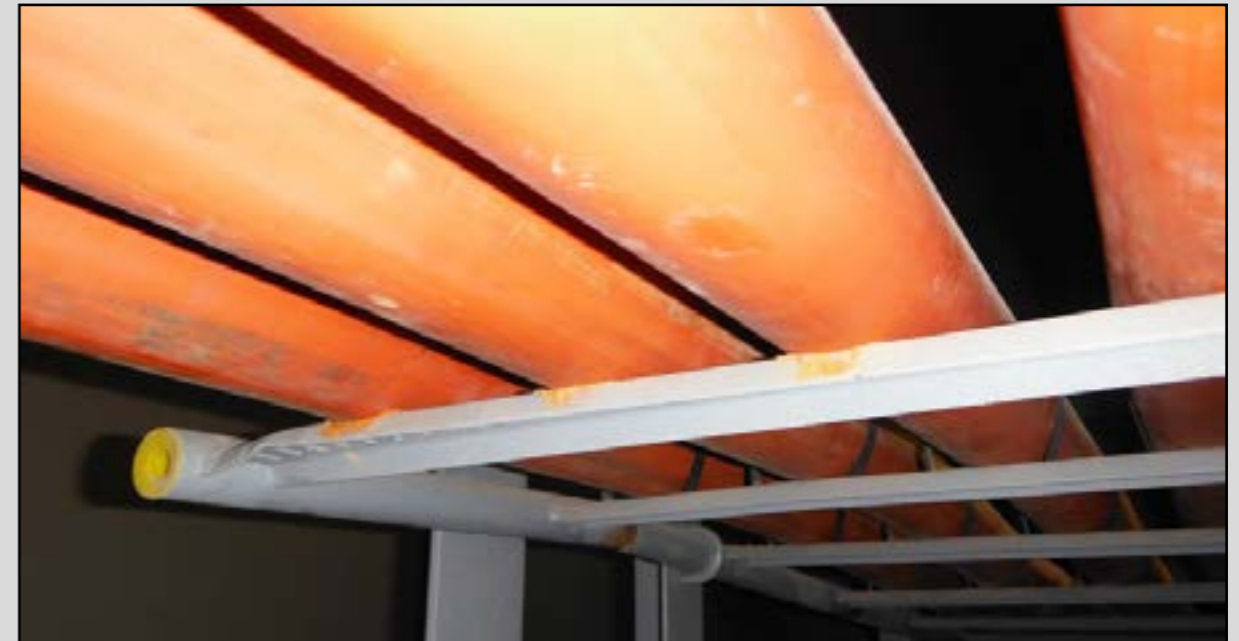
M1 Impact / Chaffing (mechanical damage) damaged outer sheath

Cable sheath is either split by impact or worn down by repeated rubbing (chaffing) of the cable against a hard surface. FS17 Tape repair of area and coating with FS5. Friction protection in the form of rubber mats or Teflon sheeting to be installed to prevent further chaffing.

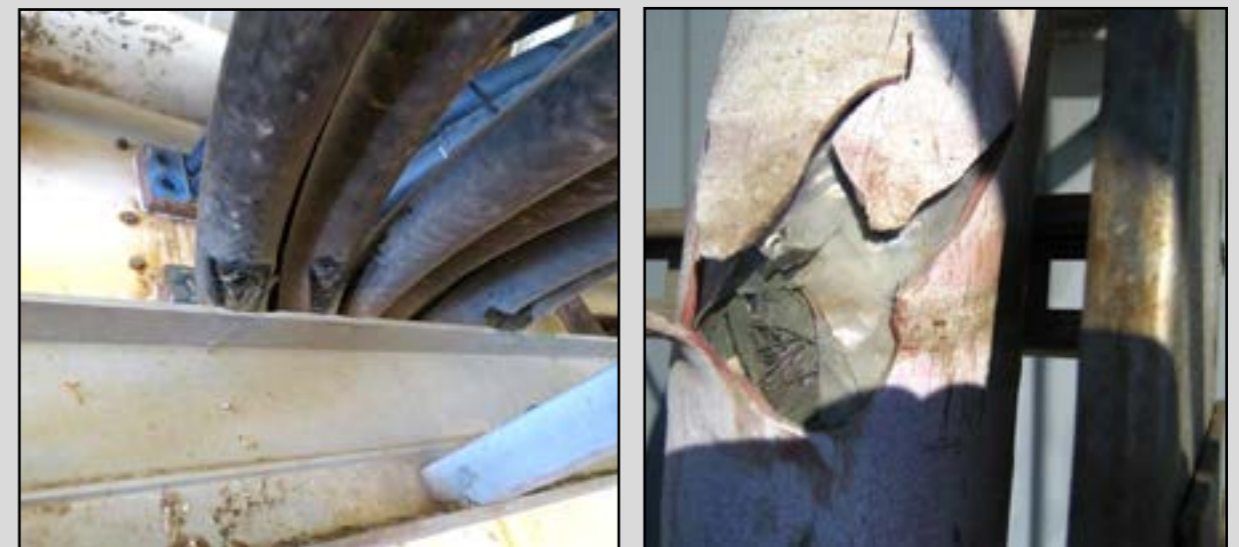
M2 Impact / Chaffing (mechanical damage) fully thru the sheath into armour

Cable sheath is either split by impact or worn down by repeated rubbing (chaffing) of the cable against a hard surface, the damage has extended to the armour, but the inner core is still intact. FS18 Shielding tape repair of armour, FS17 tape repair above this, and coating with FS5. Friction protection in the form of rubber mats or Teflon sheeting to be installed to prevent further chaffing.

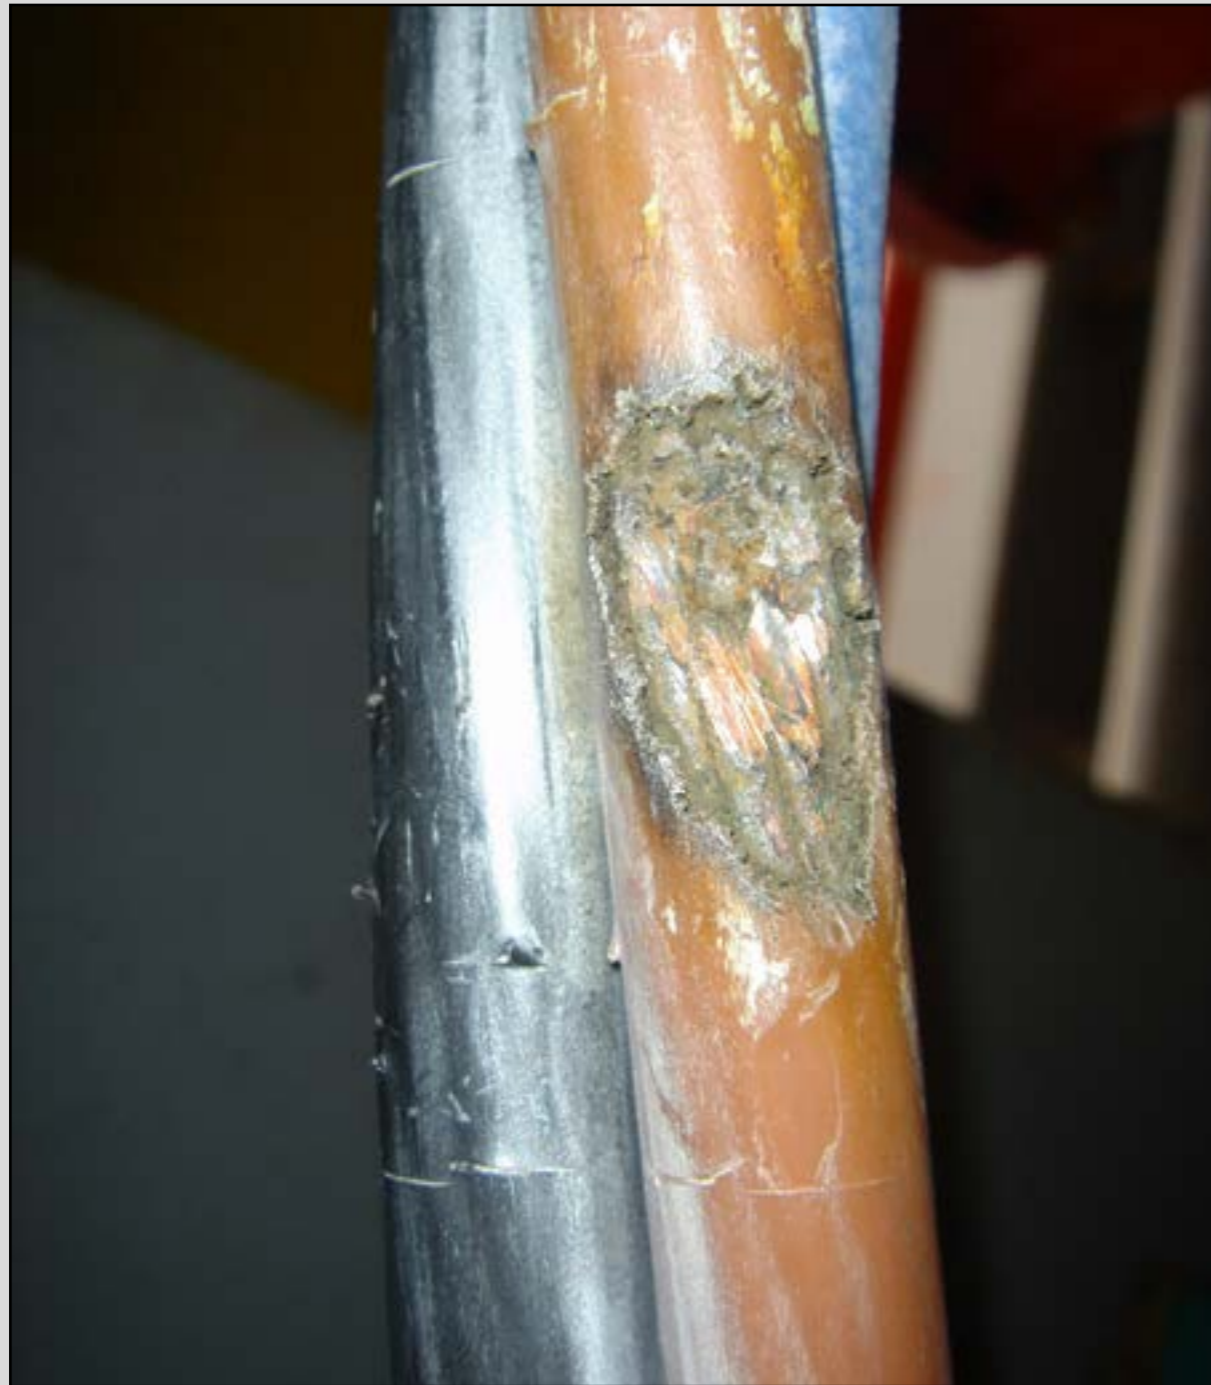
M3 Impact / Chaffing (mechanical damage) into inner core

Cable sheath is either split by impact or worn down by repeated rubbing (chaffing) of the cable against a hard surface, and damage has extended past the armour and into the inner core.

If the client carries out megger testing of the cable and is happy with the results, then the repair of LV & instrumentation cables may be carried out as for M2 condition cables. This is not recommended for HV or Plant shut down / operationally critical cables.

FS18 Shielding tape repair of armour, FS17 tape repair above this, and coating with FS5. Friction protection in the form of rubber mats or Teflon sheeting to be installed to prevent further chaffing.

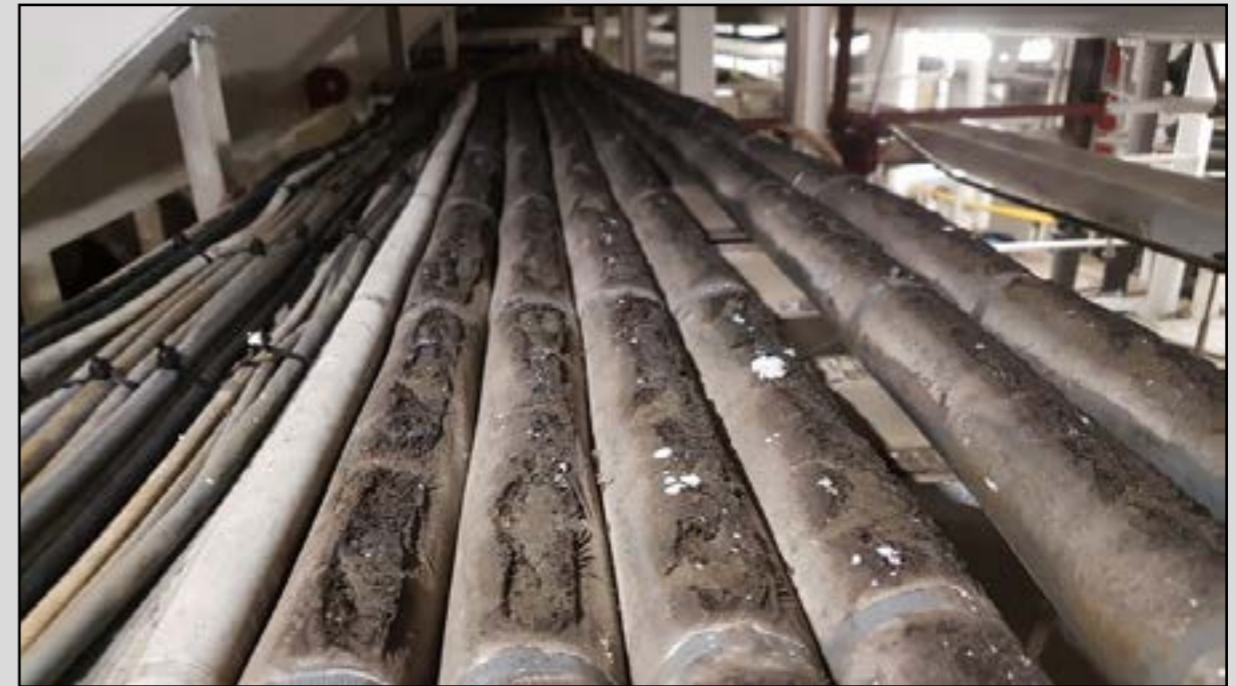
H1 Heat affected cable, sheath is misshapen and / or brittle

Sheath material has partially melted and then re-hardened. If the client is convinced that the inner core is not affected, then repairs to the outer sheath can be carried out. FS17 tape repair and coating with FS5

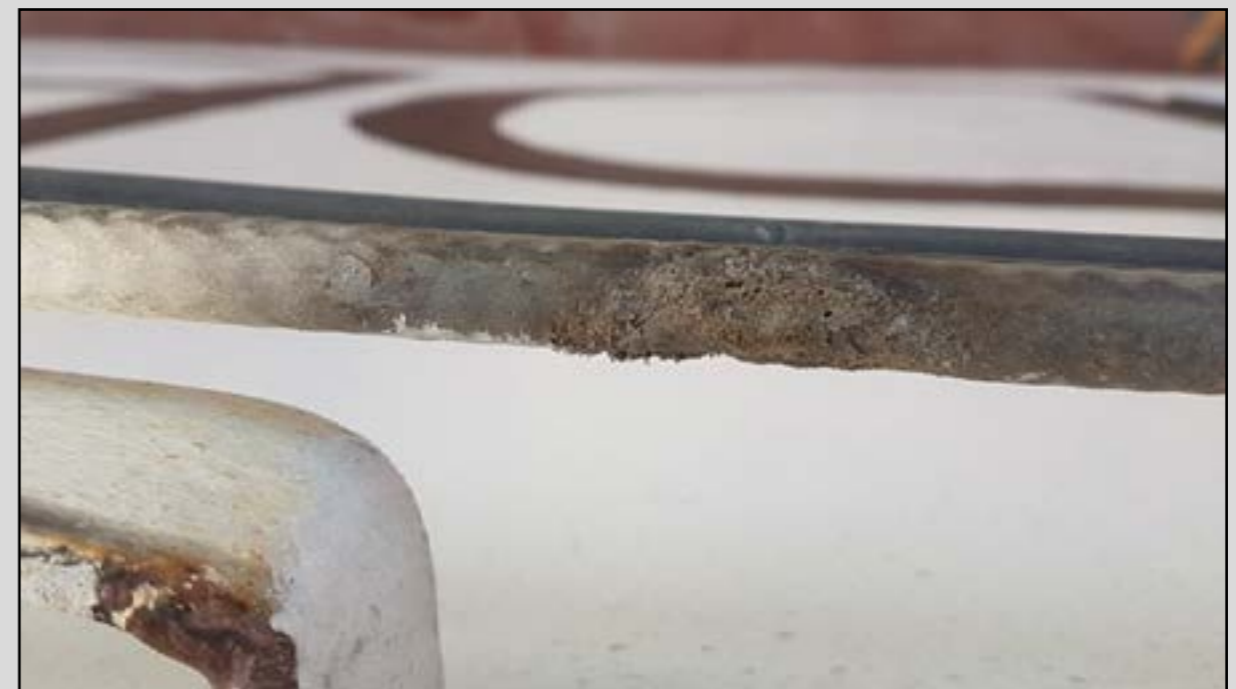
H2 Heat affected cable, the sheath is charred, possibly with burn thru spots to armour

Cables that have been affected by fire but are still capable of operation. FS17 tape repair and coating with FS5.

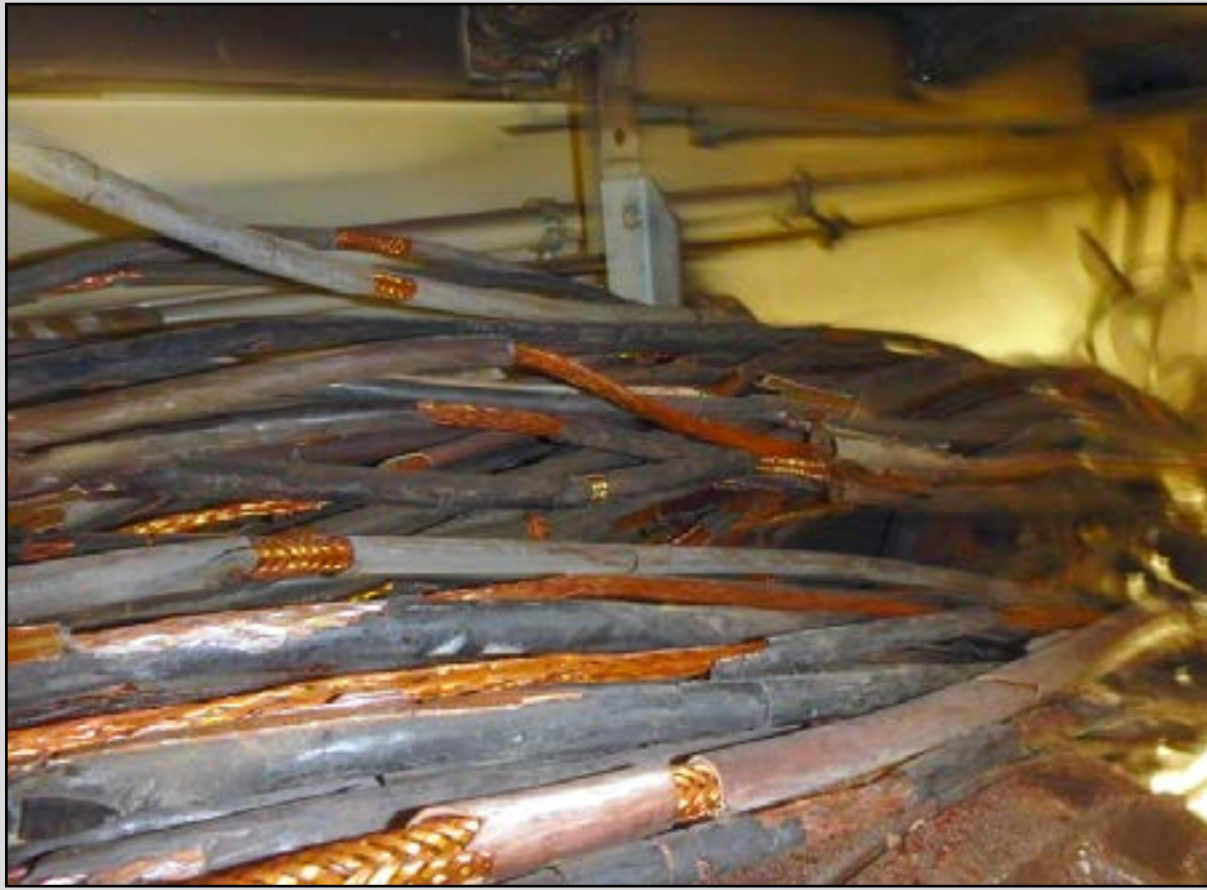
H3 Heat affected cable, the sheath is fully compromised, armour may be discoloured but is still intact, core unaffected

Cables that have been affected by fire but are still capable of operation. FS17 tape repair and coating with FS5.

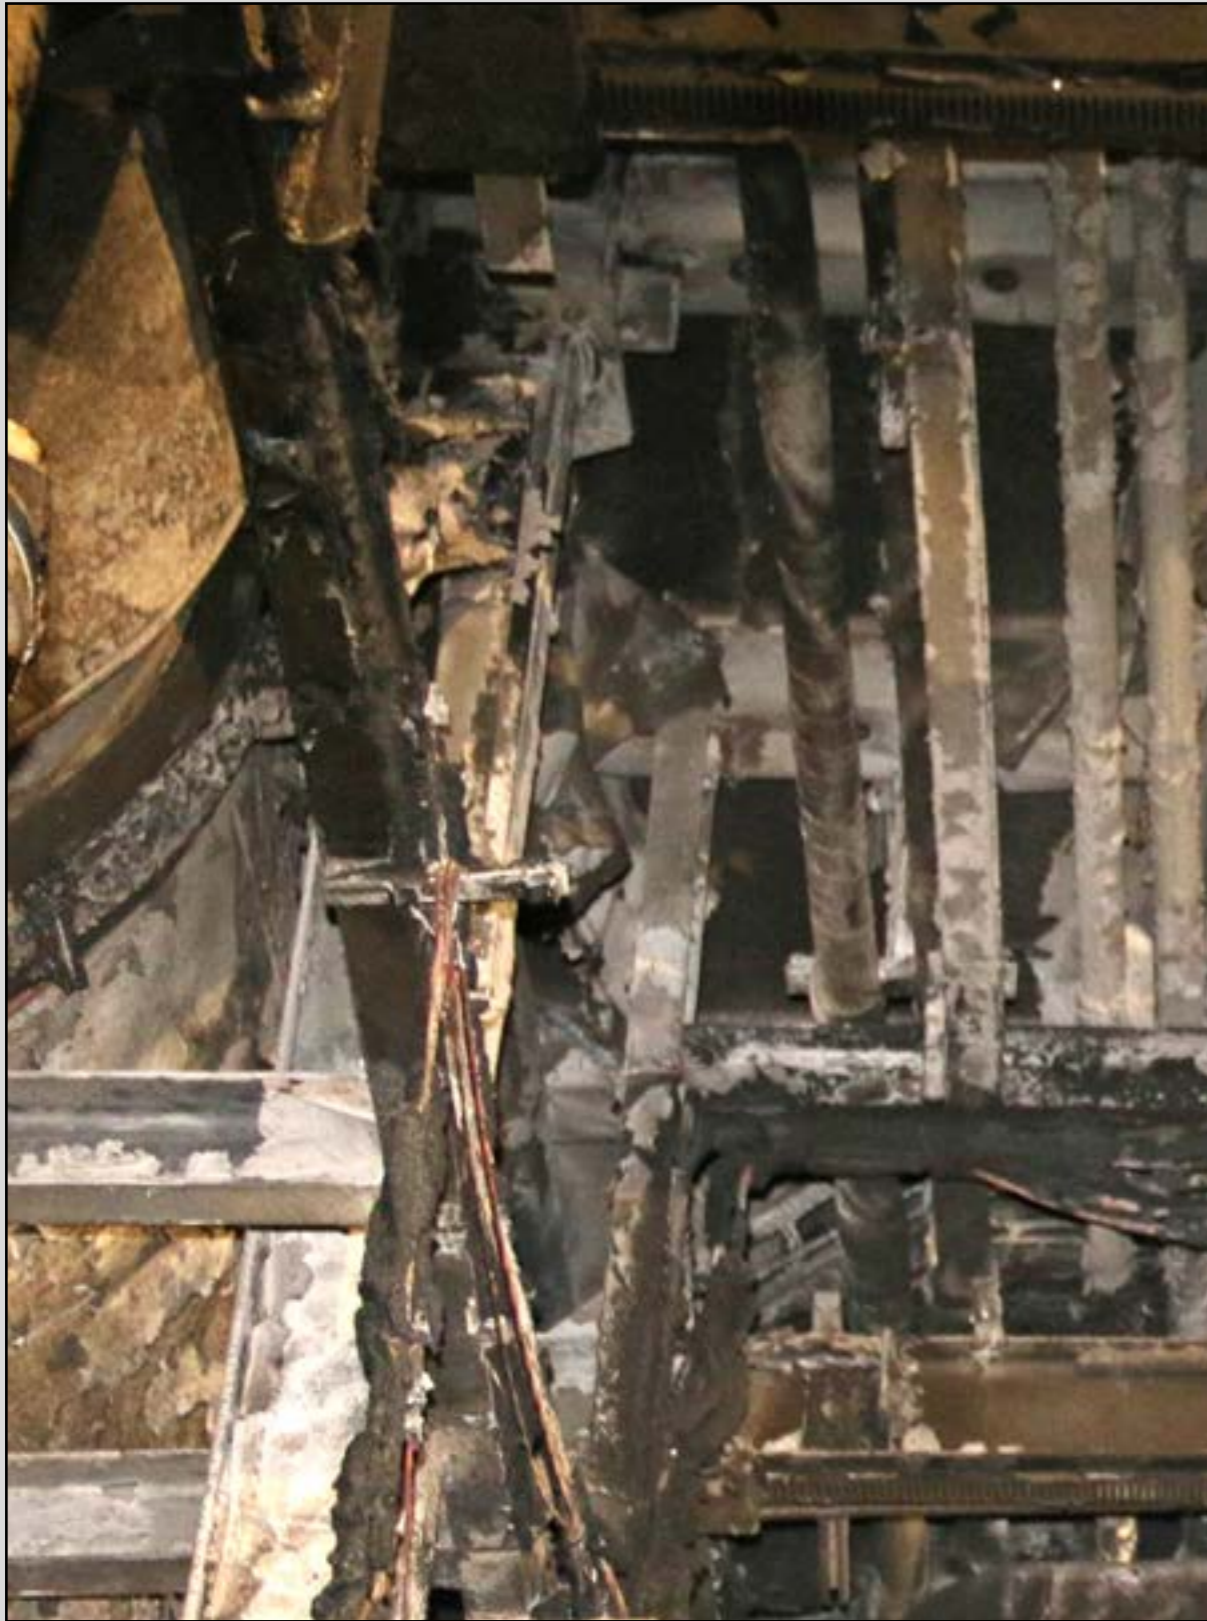
H4 Heat affected cable, core exposed / fully failed sheath

Fully failed outer sheath, with exposed inner core due to external heat sources (for example cable near leaking exhaust). At this stage, an HV or instrumentation cable should be considered beyond repair. LV cables may be considered for repair. Various repair options are available depending upon site conditions and operational constraints.

- H4 Heat affected cable, core exposed / fully failed sheath.
