Cable Maintenance Guide for implementation in a life extension program

Grades of cable condition and suggested maintenance/lifetime extension

FIRE SECURITY

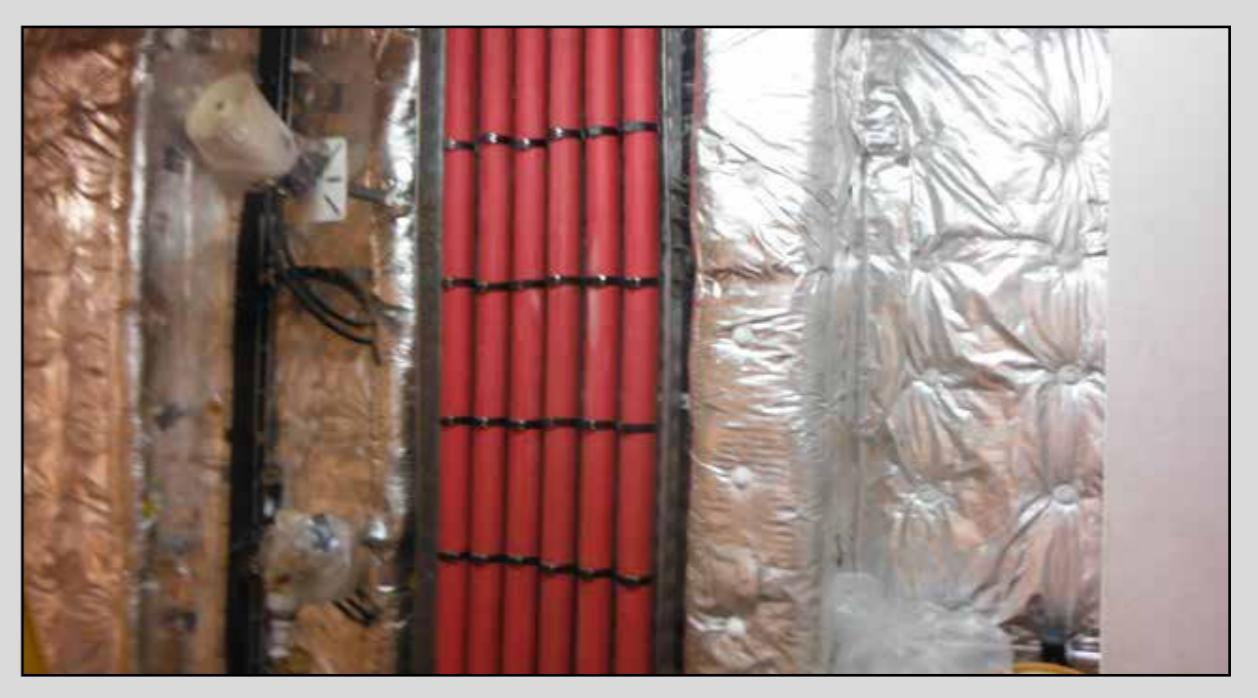
A1 internal areas

Cables in this condition do not require any maintenance. Fire protection properties and lifetime extension would be increased by application of FS coating systems at this stage.

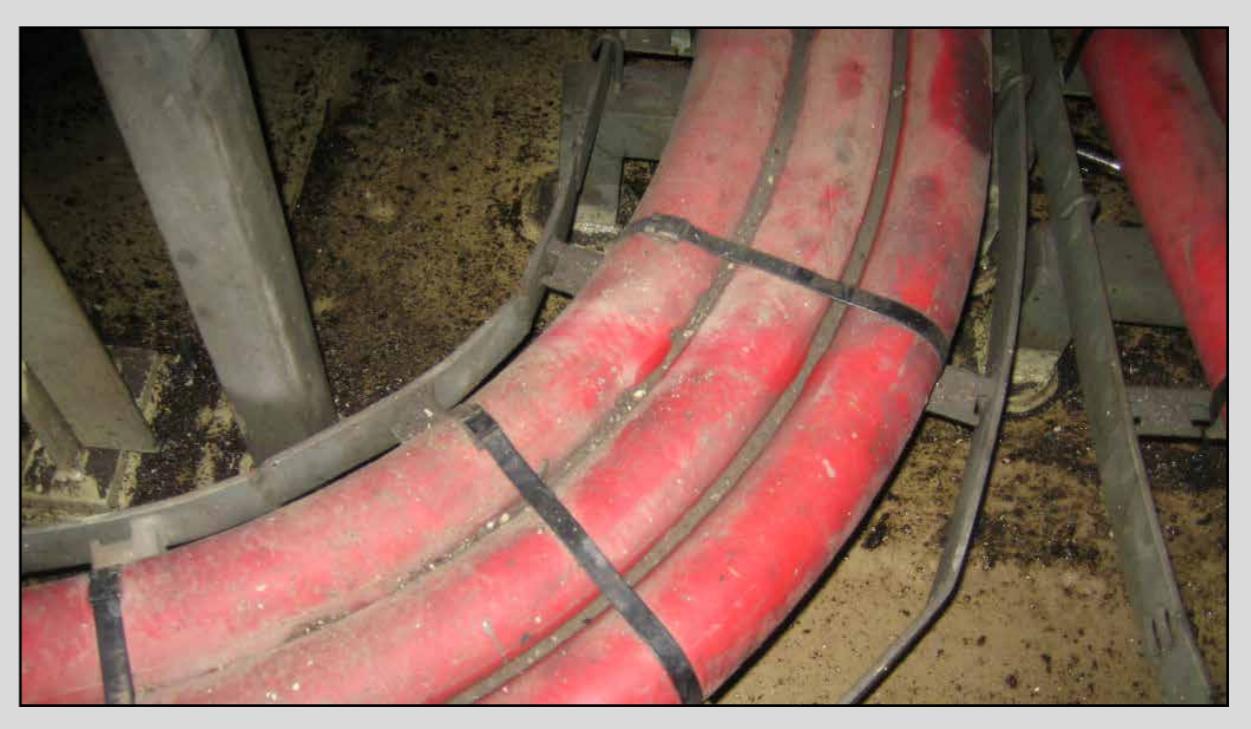
B1 cement water-based drilling mud

Cables in this condition do not need to have any maintenance, however HP water blasting could be considered if contaminates build up in thickness possibly affecting the cooling properties of the sheath. Some cables could be bleached by Guano.

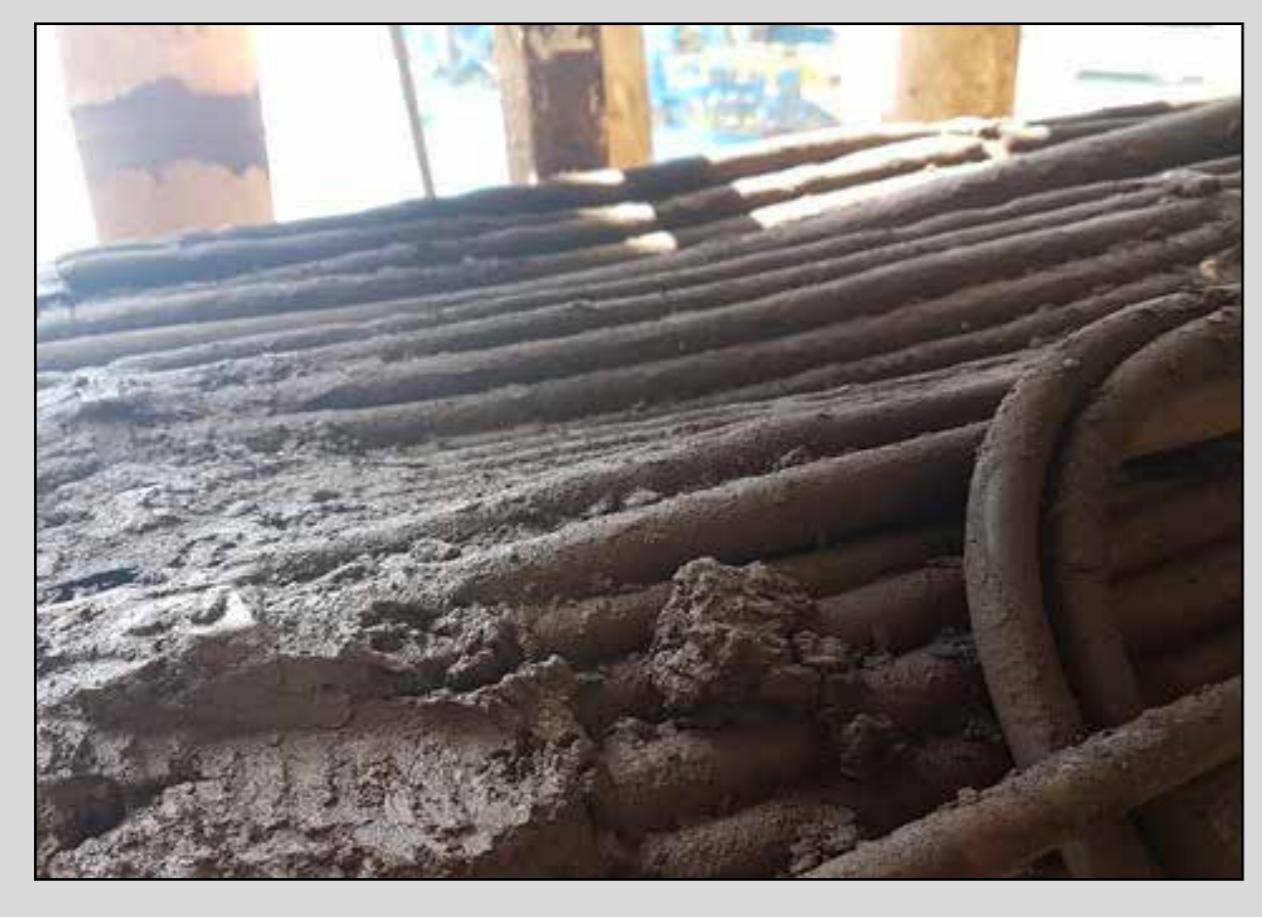
Good appearance but with surface contaminates that may **C1** degrade the sheath: Acids, Oil based drilling Mud's, Hydraulic fluid, Gas Turbine / Compressor oil, grease & oil based paints

Many hydrocarbon-based chemicals could react with the cable to soften the outer sheath hydraulic fluid & compressor oil being of particular concern. It is advised to clean the cables using HP water and a degreaser like rig wash.

Attempt to pinch the sheath, if you can move it from the core, then chemical softening has already started. Washing and degreasing the cable may halt this process but the cable has already lost a high percentage of its protective capabilities: I.e. Low Smoke emission, insulation value, dielectric strength.

It is advised to coat the cable with FS5 at this stage to restore / enhance the lost properties of the sheath and to protect the sheath from further chemical degradation.

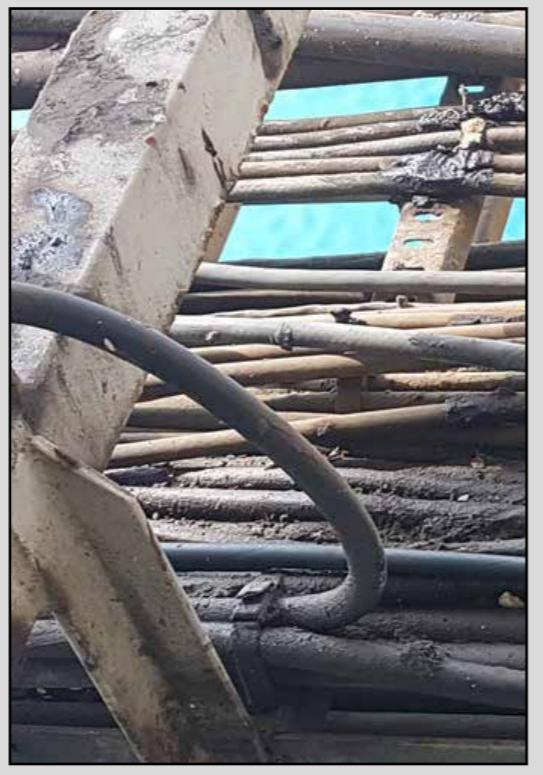
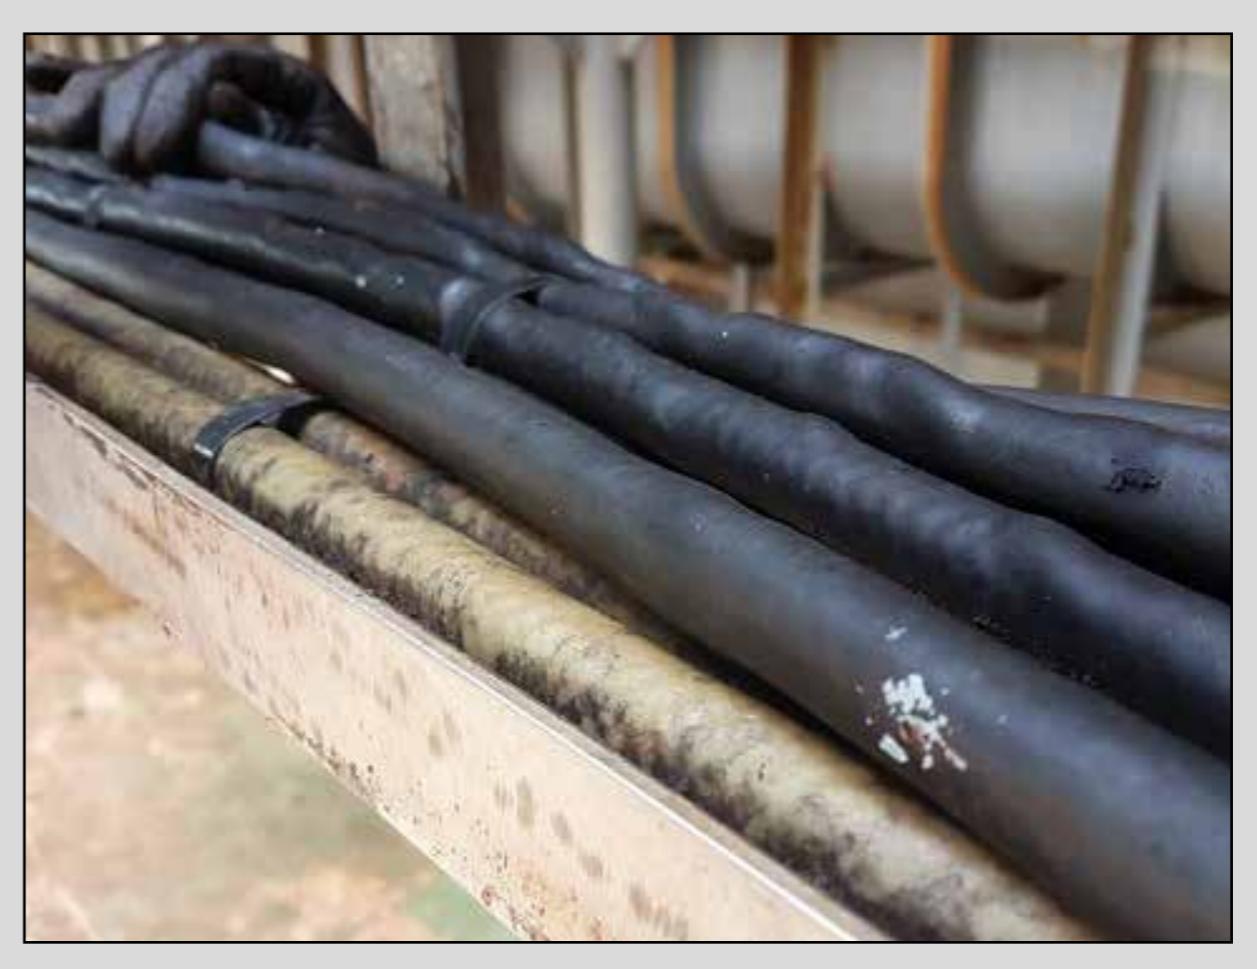
C2 contaminates

Washing and then coating the cable with FS5 may be considered if concertinaing is still minor however, we would advise that FS carry out a survey and advise the correct course of action at this stage. The sheath can be fully stripped off and a new one installed utilizing our FS17 repair tape and FS5 coating system.

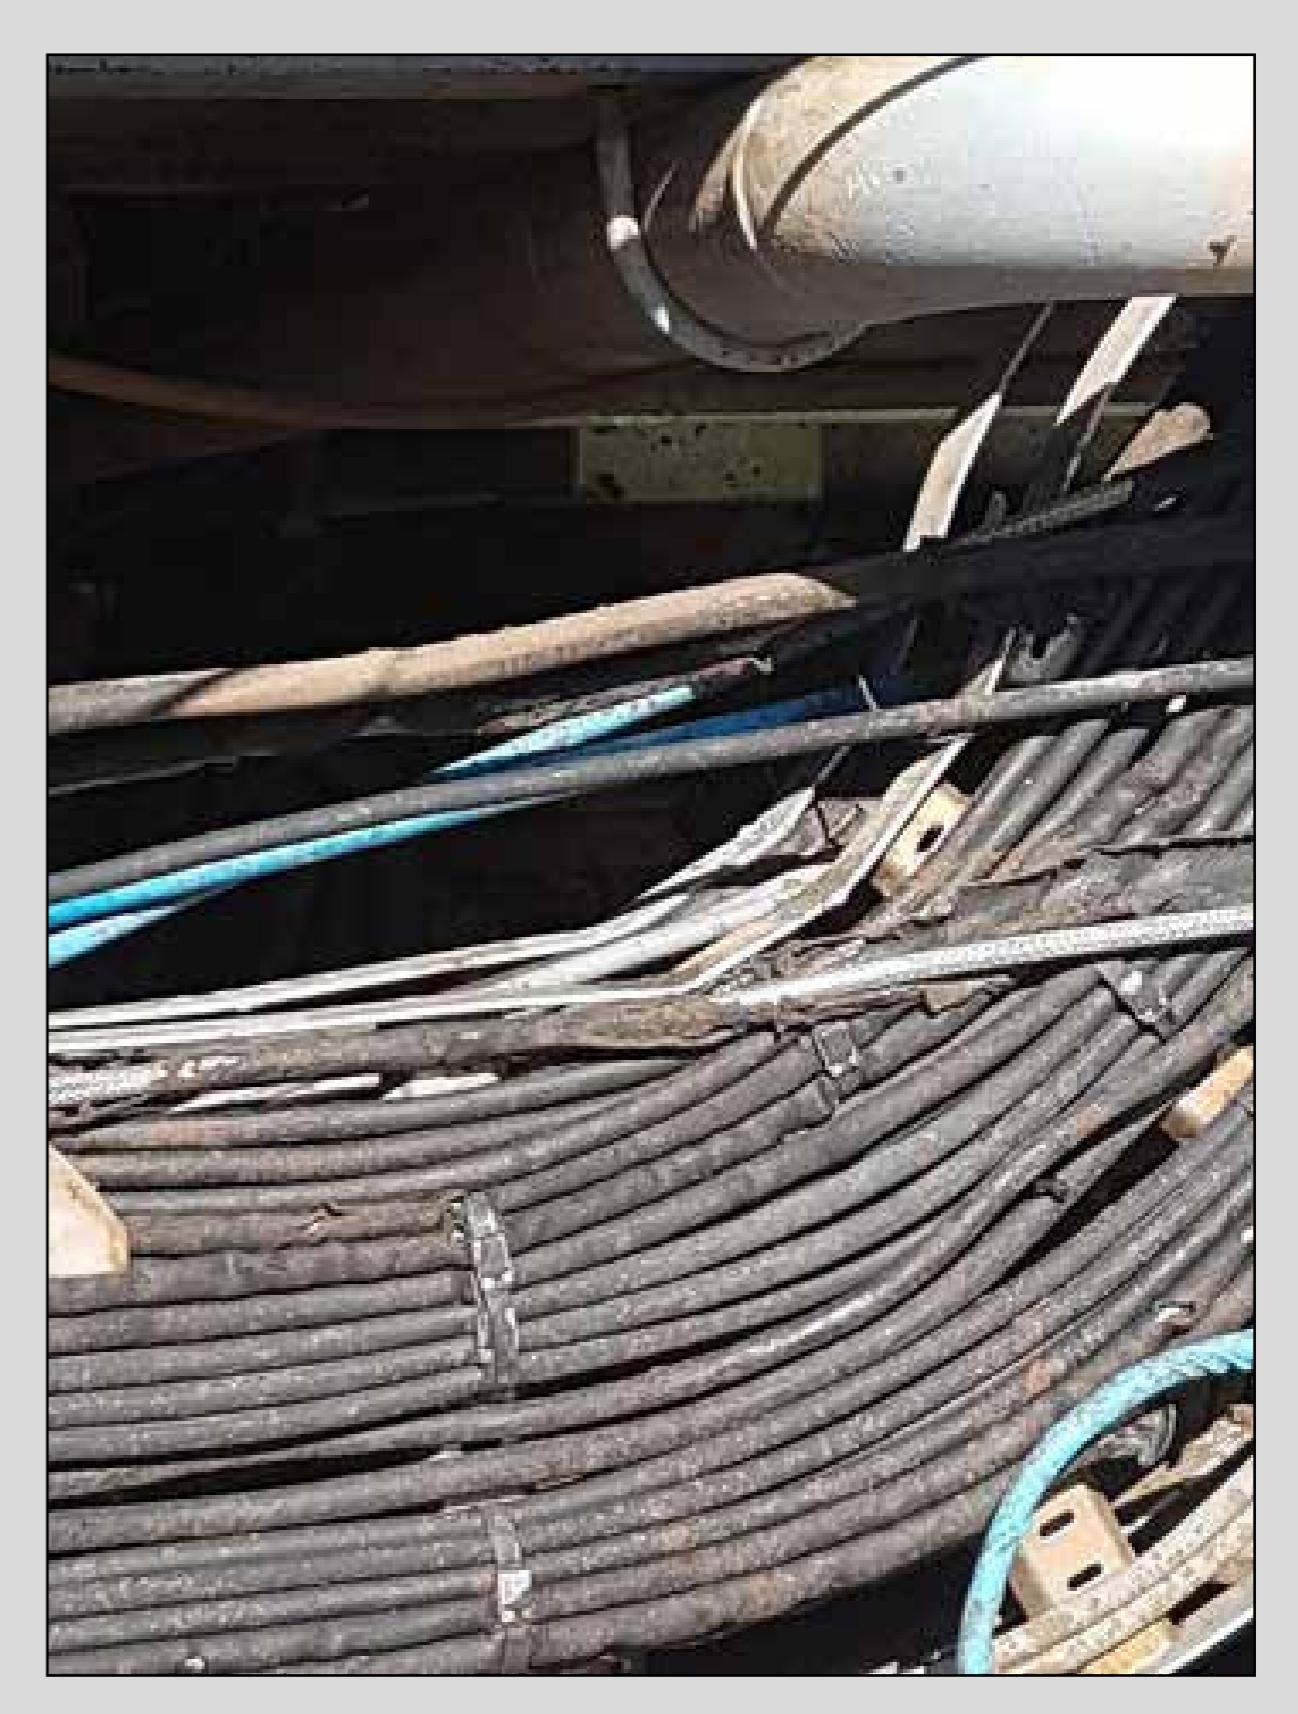
C3 Failed sheath due to contaminates

Cables with fully failed outer sheaths can have the sheaths replaced by using FS17 repair tape and FS5 coating, armour (if present) may need to be replaced, this we can do with FS18 shielding tape. The condition of the inner sheath(s) to be assessed first.

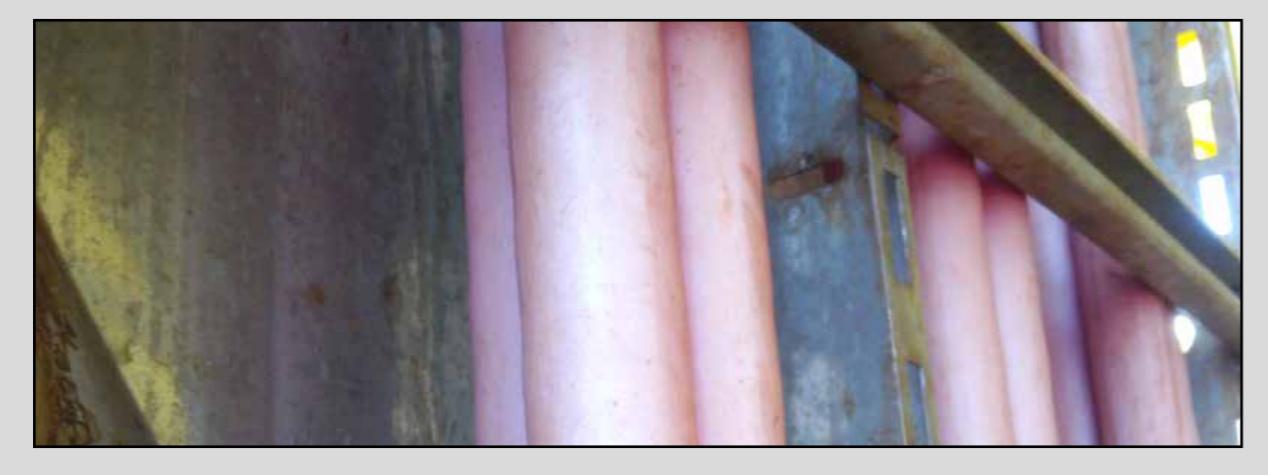
Colour faded (bleached) but not chalking UV1

Red, yellow and blue cables tend to be affected by UV exposure worse than black or grey coloured cables. The first sign of UV degradation is loss of colour. This could indicate that the sheath material is at the first stage of UV affected breakdown.

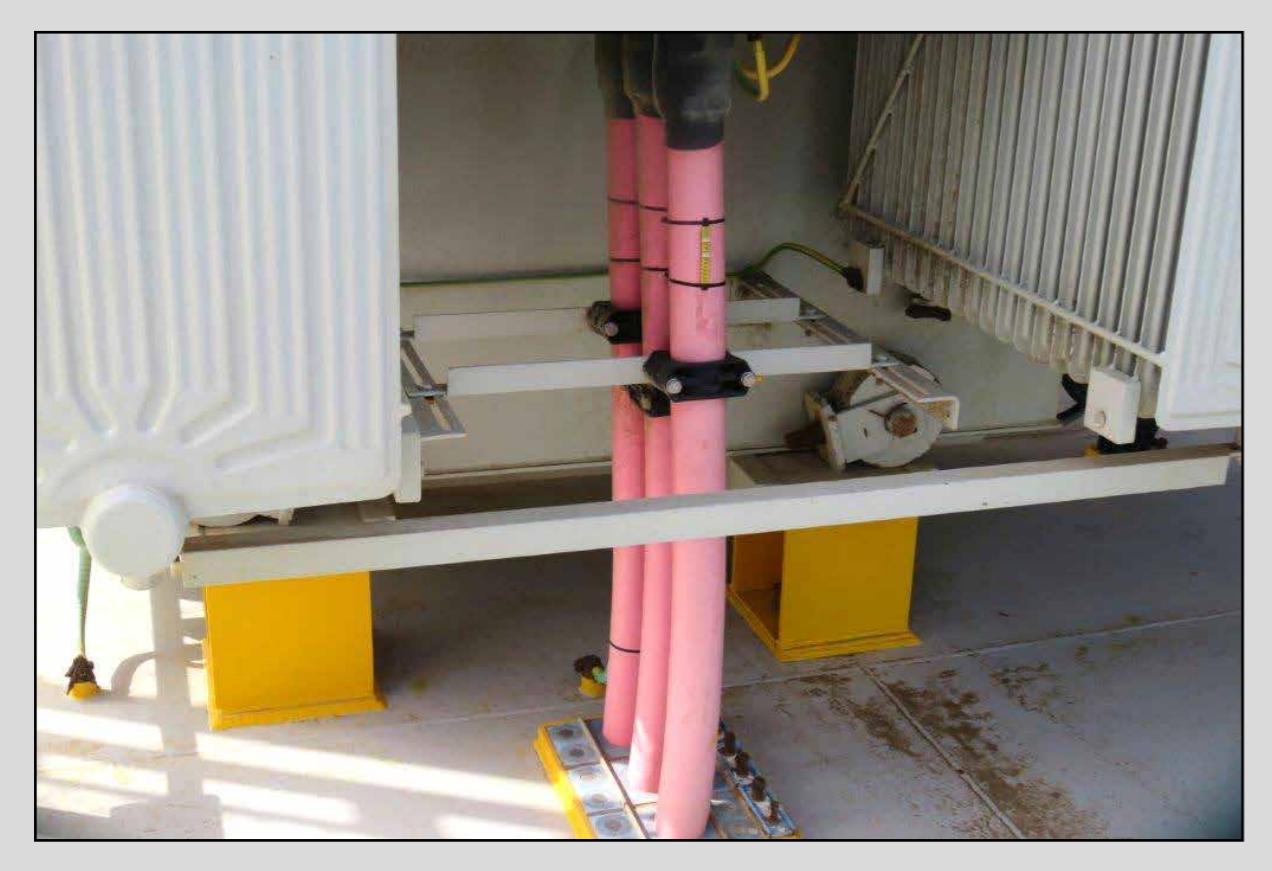
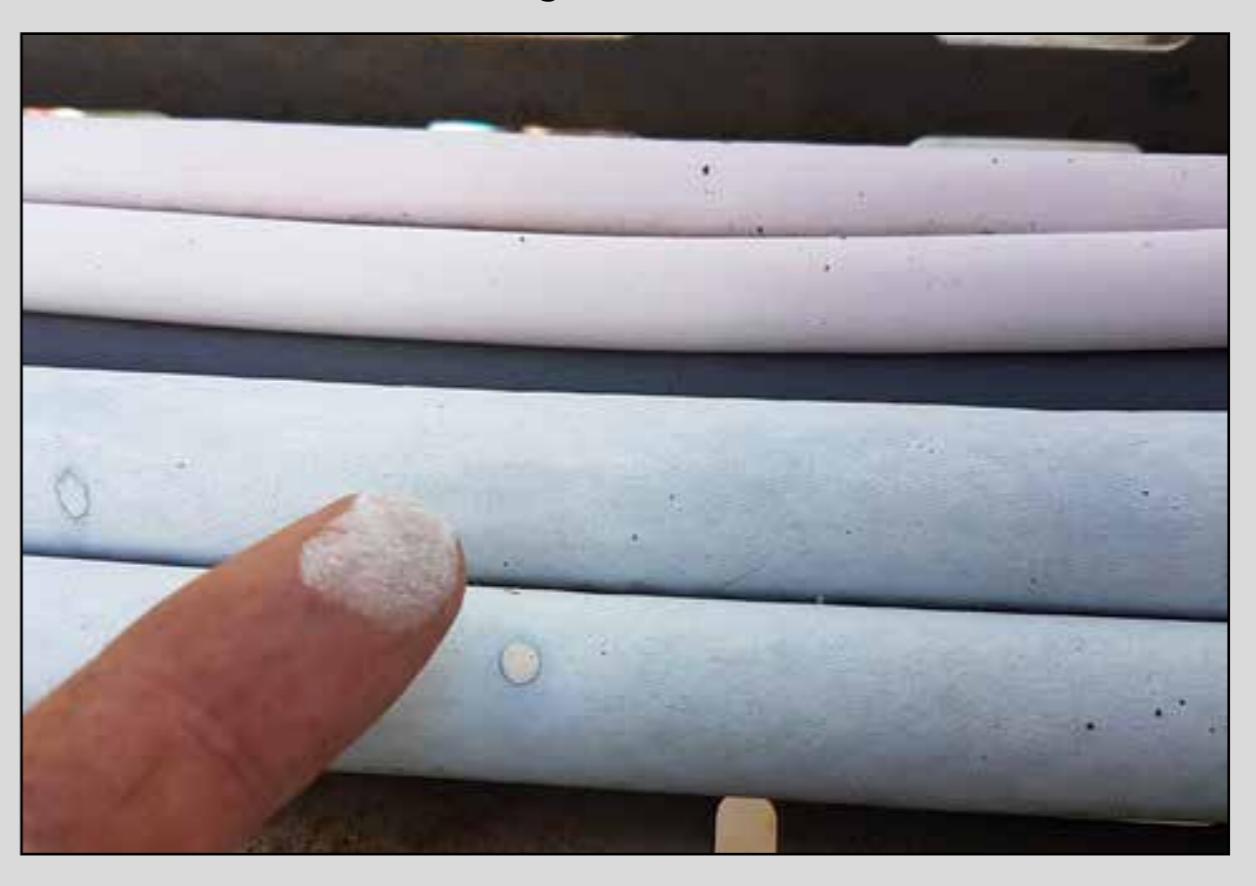
UV2 Colour faded & chalking

Rub your gloved finger over the cable, if it comes away with a chalk like residue and the area that you have just rubbed is slightly shiny then chalking has started. This is a sure sign that the sheath material is beginning to break down. Life expectancy of the sheath at this stage is dependent upon thickness and quality of the remaining sheath. Erecting shade to cover cable runs may be considered or covering cable tray runs with covers. Application of FS5 at this stage will totally halt the UV aging of the cable.

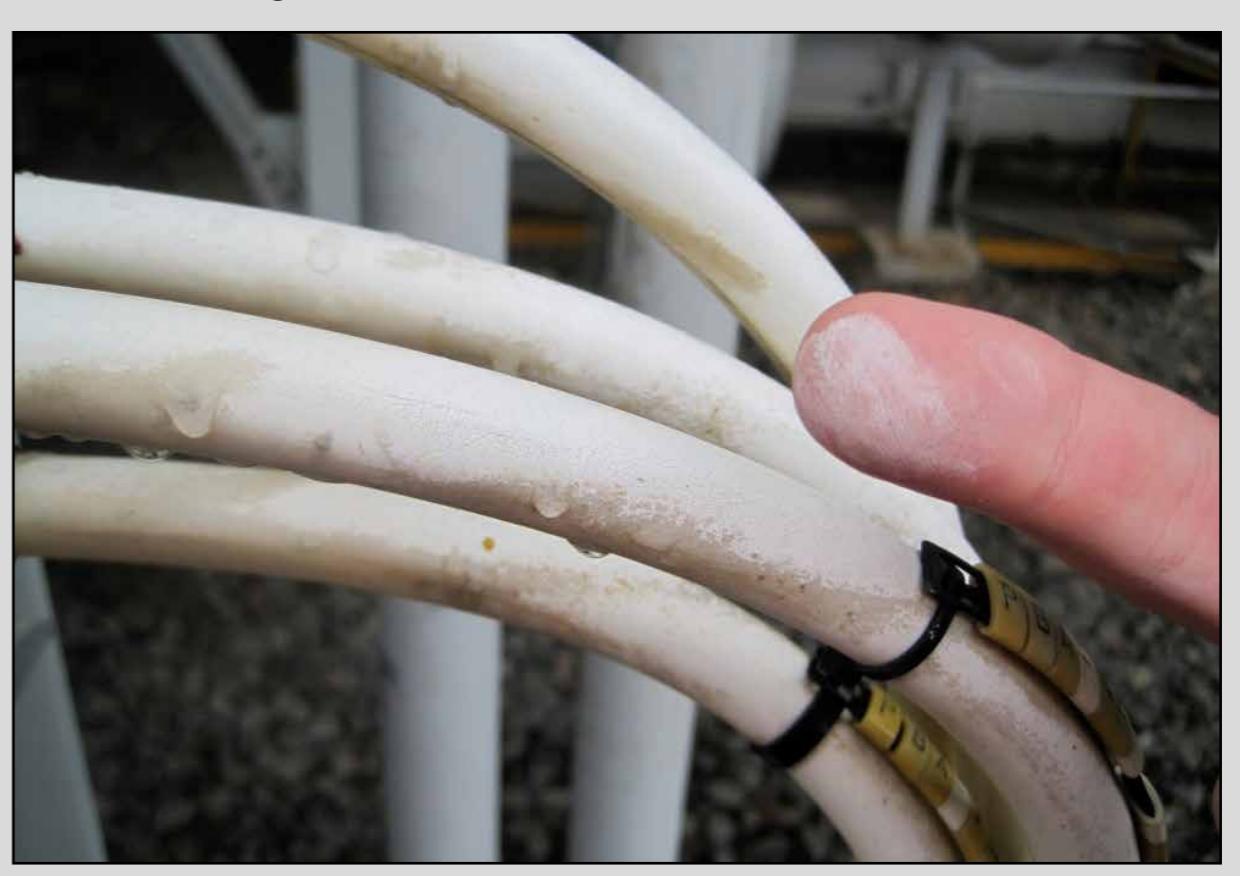
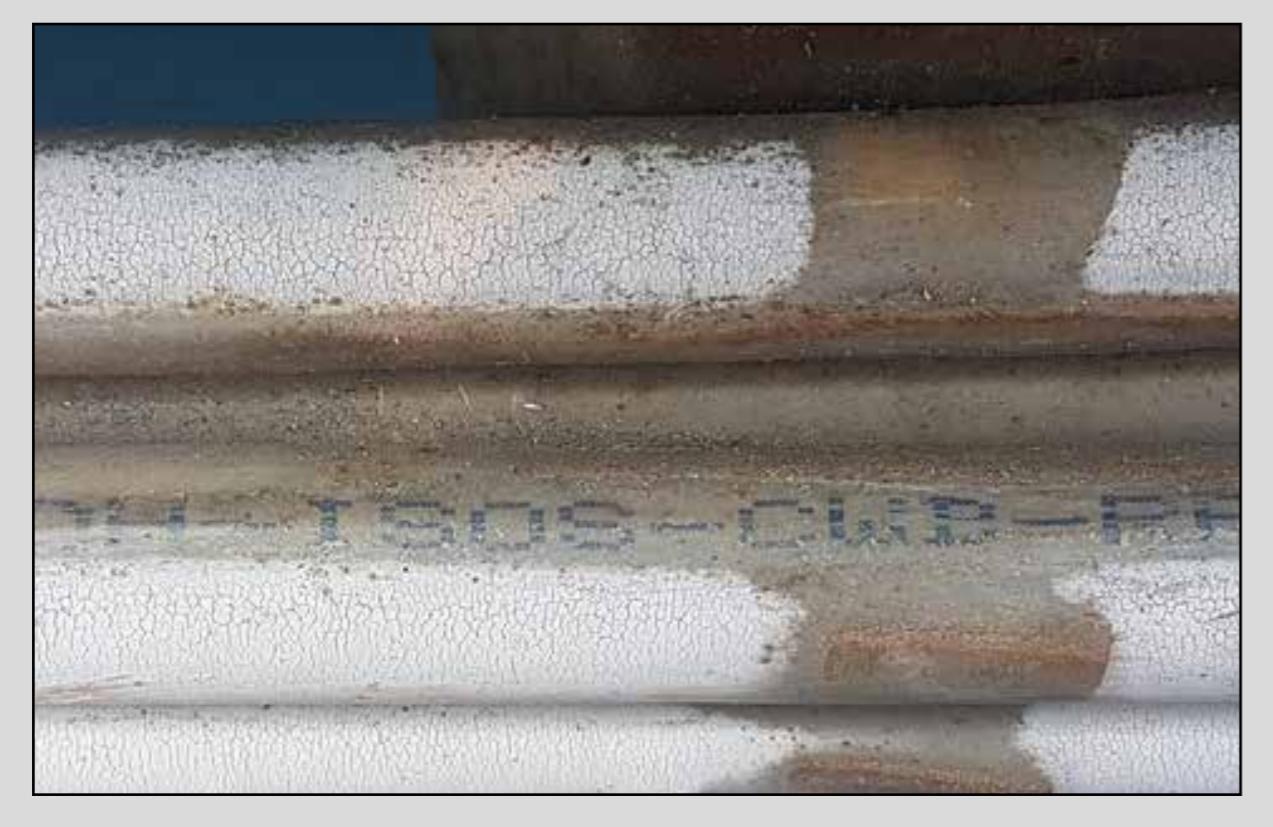
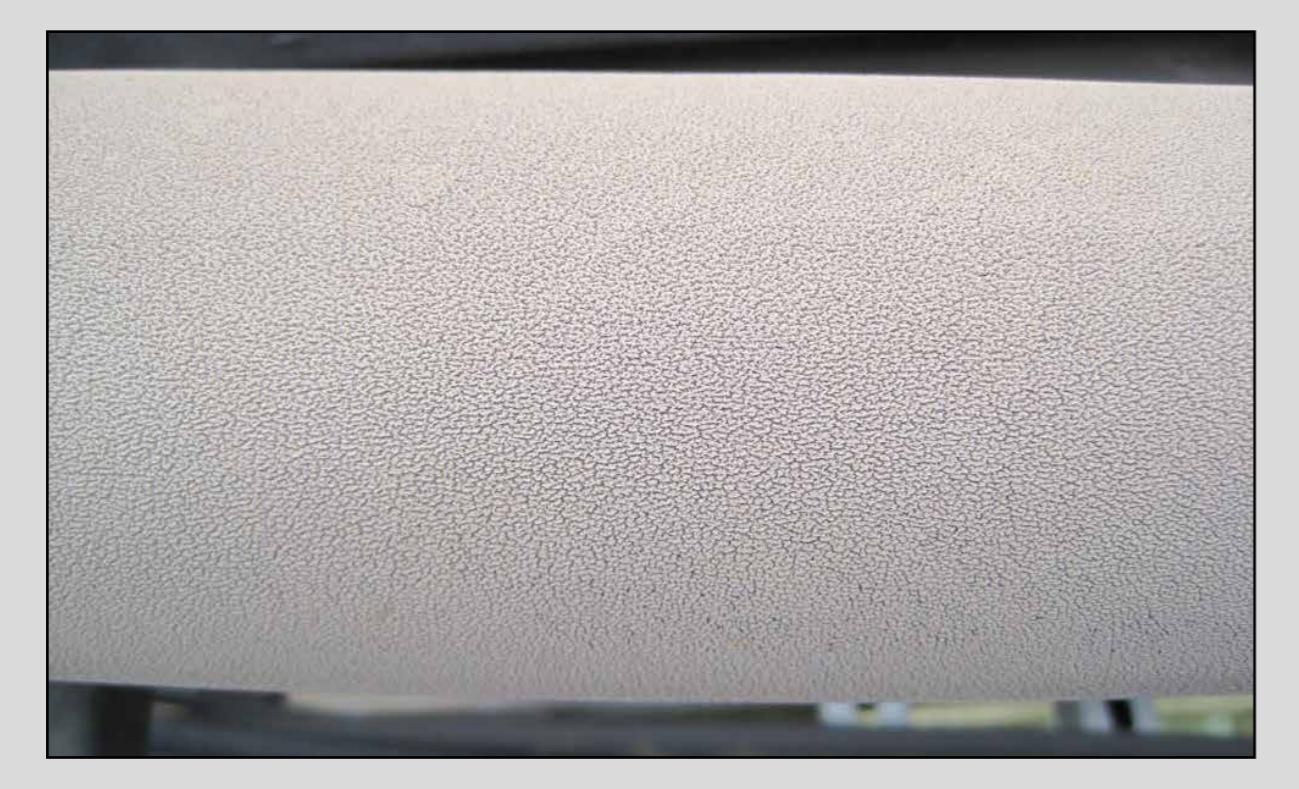
UV3 Perishing started

Perishing or micro cracking of the cable sheath can occur at anytime after chalking has been noted. This may not be visible to the naked eye; a digital photo of the sheath can be taken, and by zooming in, micro cracking, if present, will be noted. Life expectancy of the cable at this stage could be anywhere between 18-36 months before the sheath fully cracks. At this stage many of the cable sheaths properties; dielectric strength and insulation values, have lowered considerably. Application of FS5 at this stage will totally halt aging of the cable and restore its lost properties.

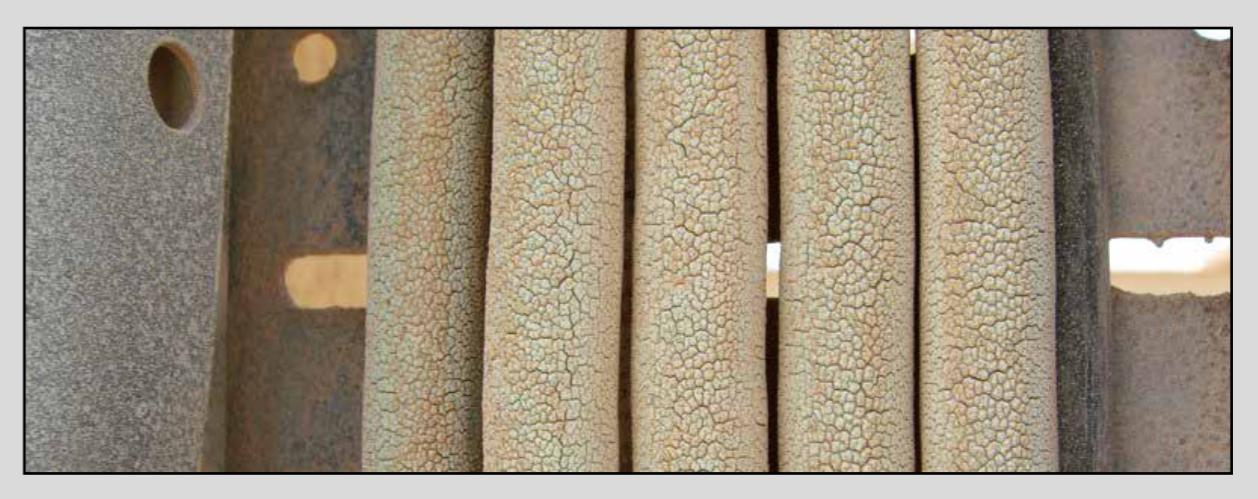
Heavily Perished UV4

Cracks in the cable sheath will be fully visible to the naked eye but have not yet reached the armour or inner core. The sheath material may be very brittle and most of the cables dielectric strength and insulation value may have been lost. FS5 coating may need to be combined with an underlay of FS17 repair tape in places to restore the properties of the cables, depending upon how brittle the sheath material is.

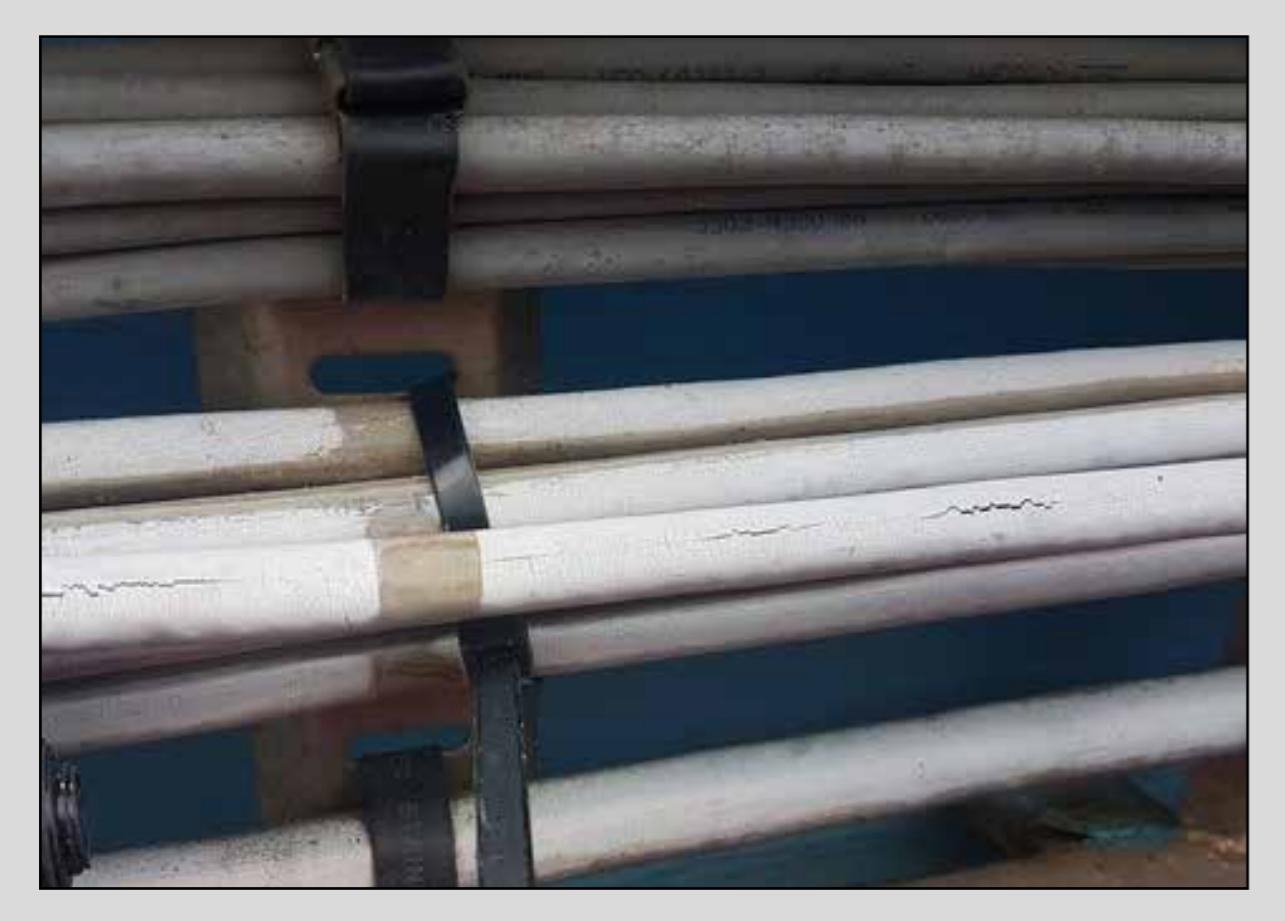
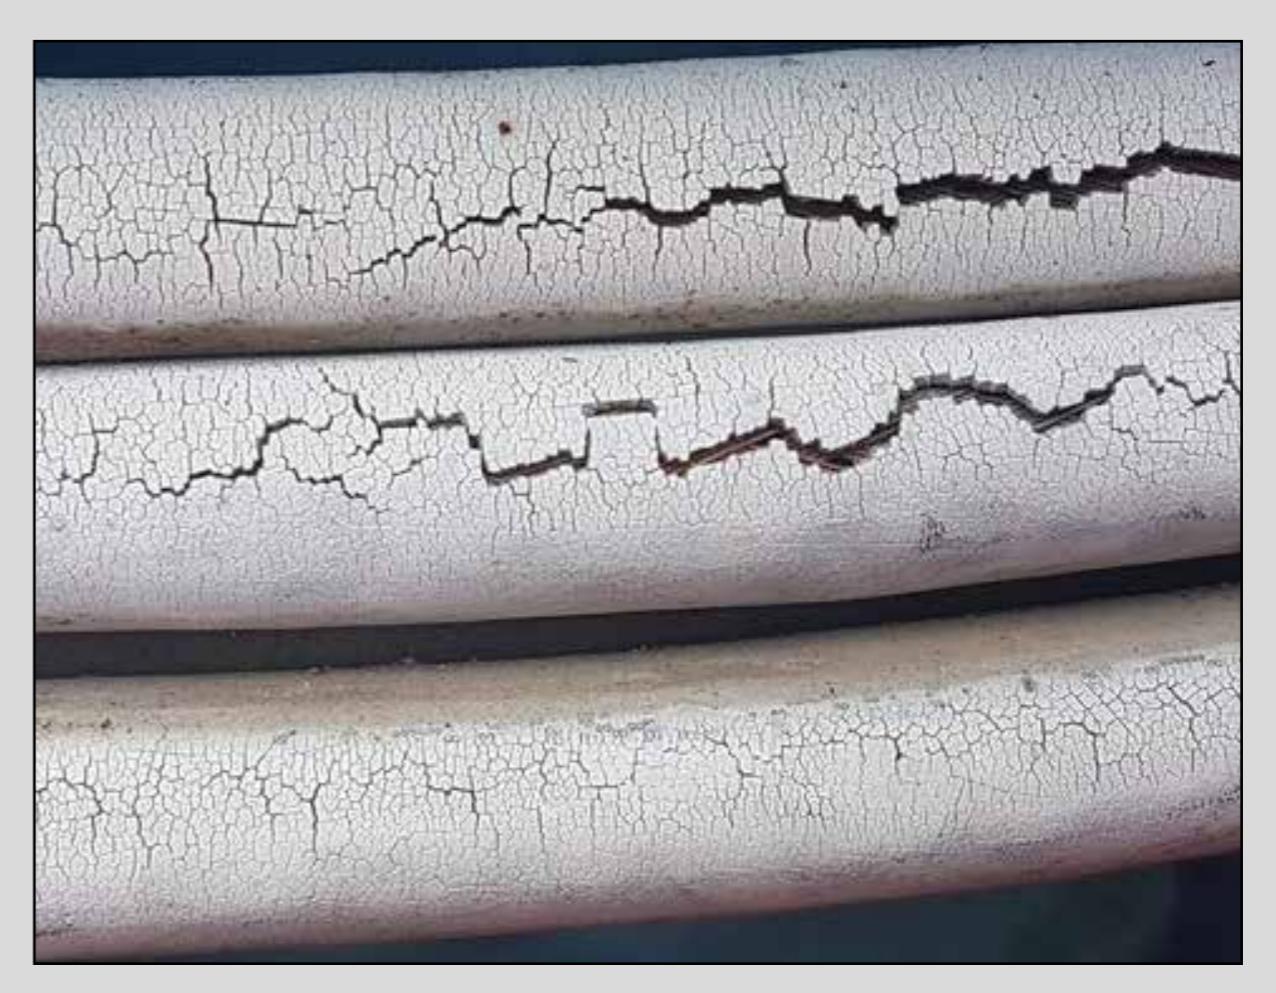
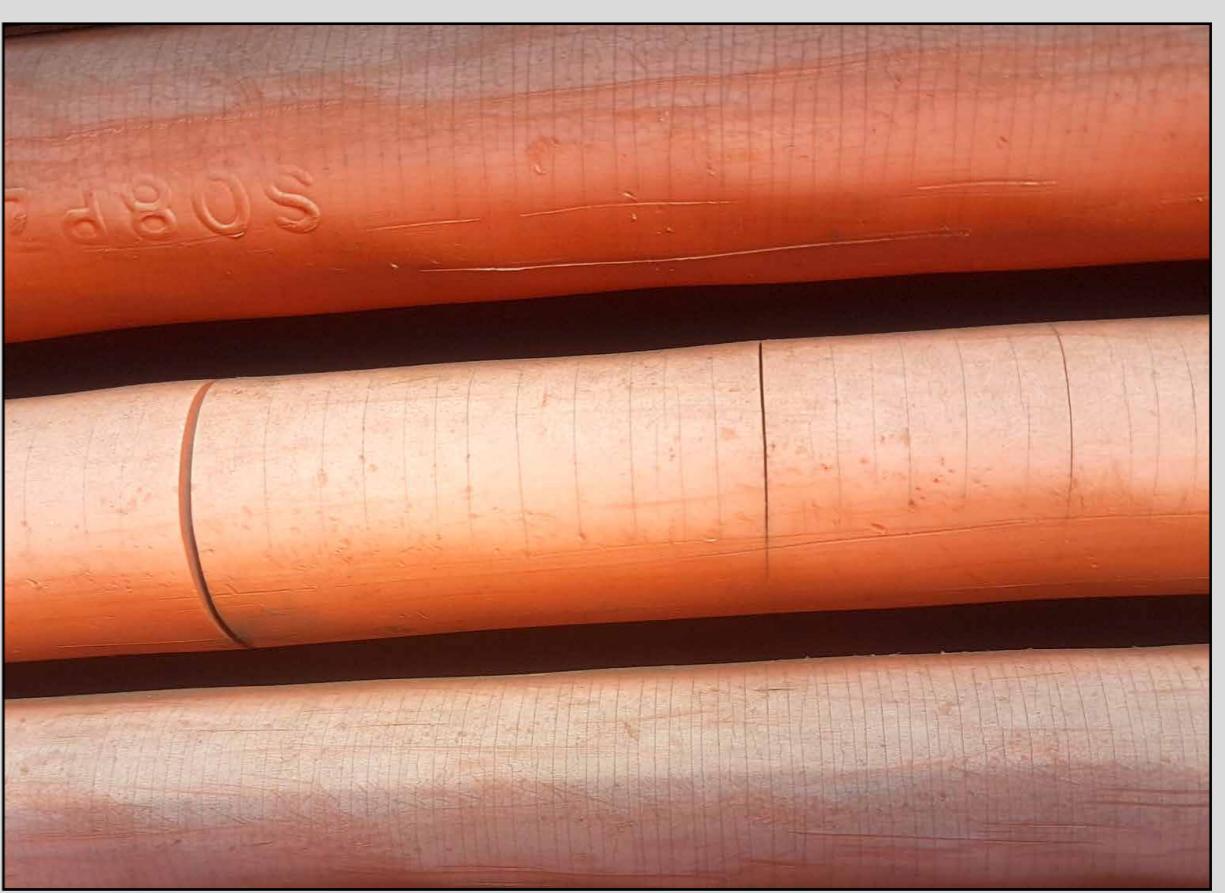
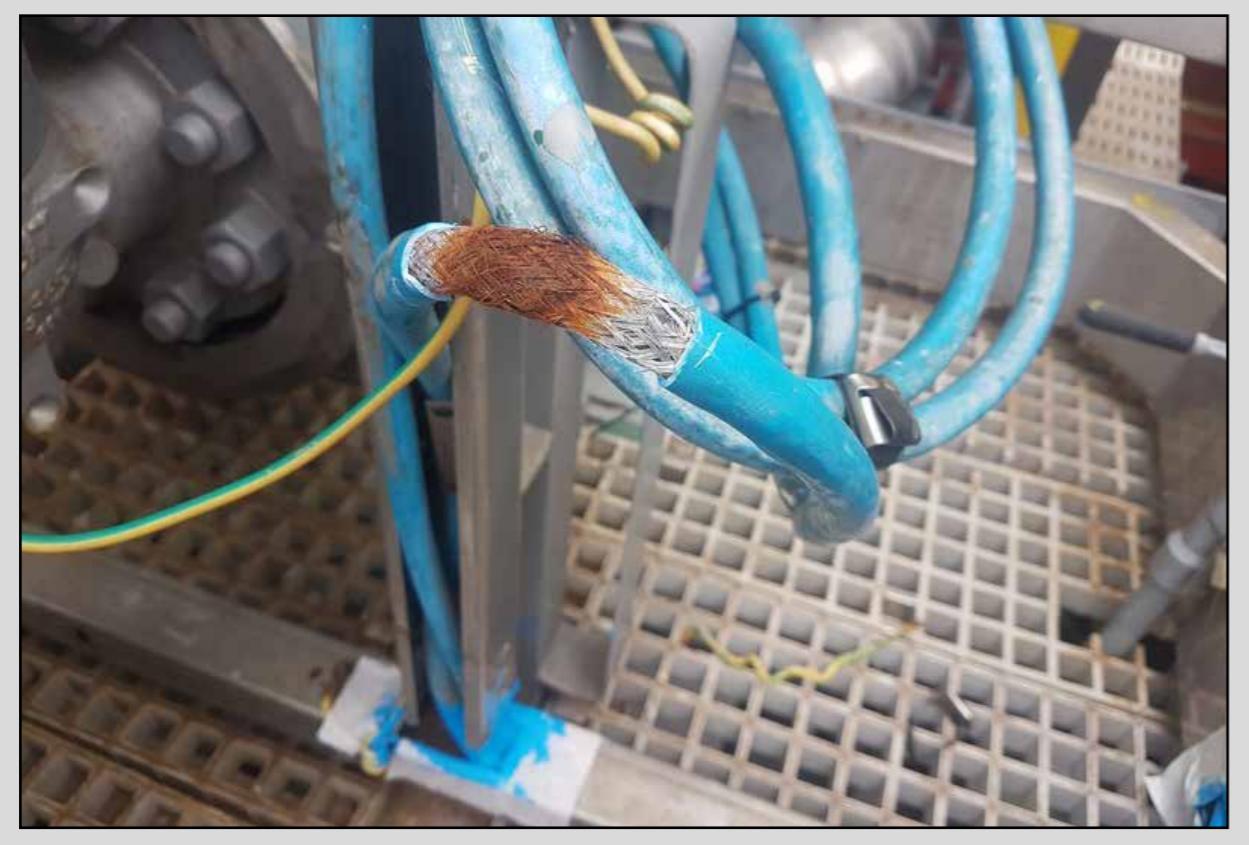
UV5 Cracked sheath

Inner armour or inner sheath (if present) is now exposed, and the cable is now a major safety concern for hazardous (gas) areas. Fire Security offers various repair options at this stage, depending upon site conditions and operational constraints.

Inner armour or inner sheath (if present) is now exposed and the cable is now a major safety concern for hazardous (gas) areas. Rust streaking may be noted on the cable sheath and possible bulging of the sheath near cracks due to the rust expanding. Fire Security offers various repair options at this stage depending upon site conditions and operational constraints.
