Cable Maintenance Guide for implementation in a life extension program

Grades of cable condition and suggested maintenance/lifetime extension

FIRE SECURITY

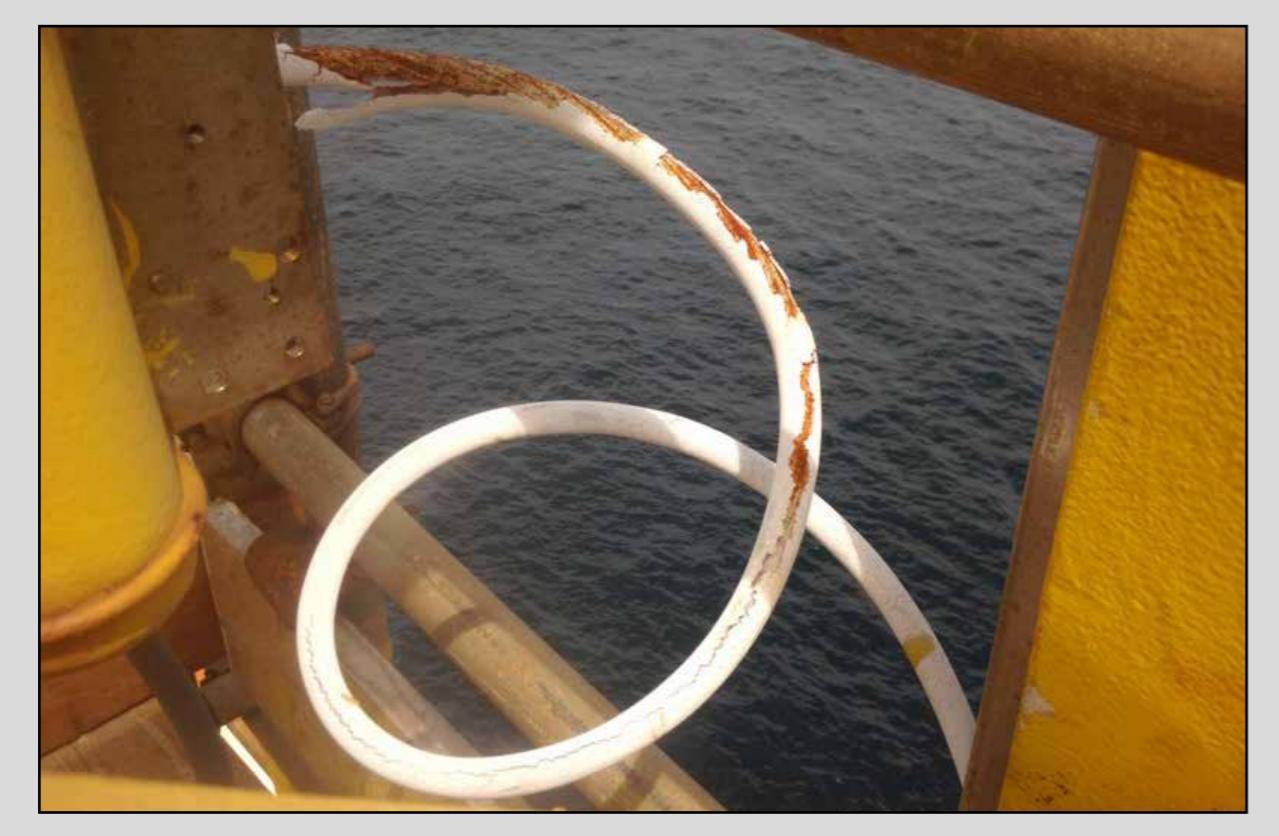
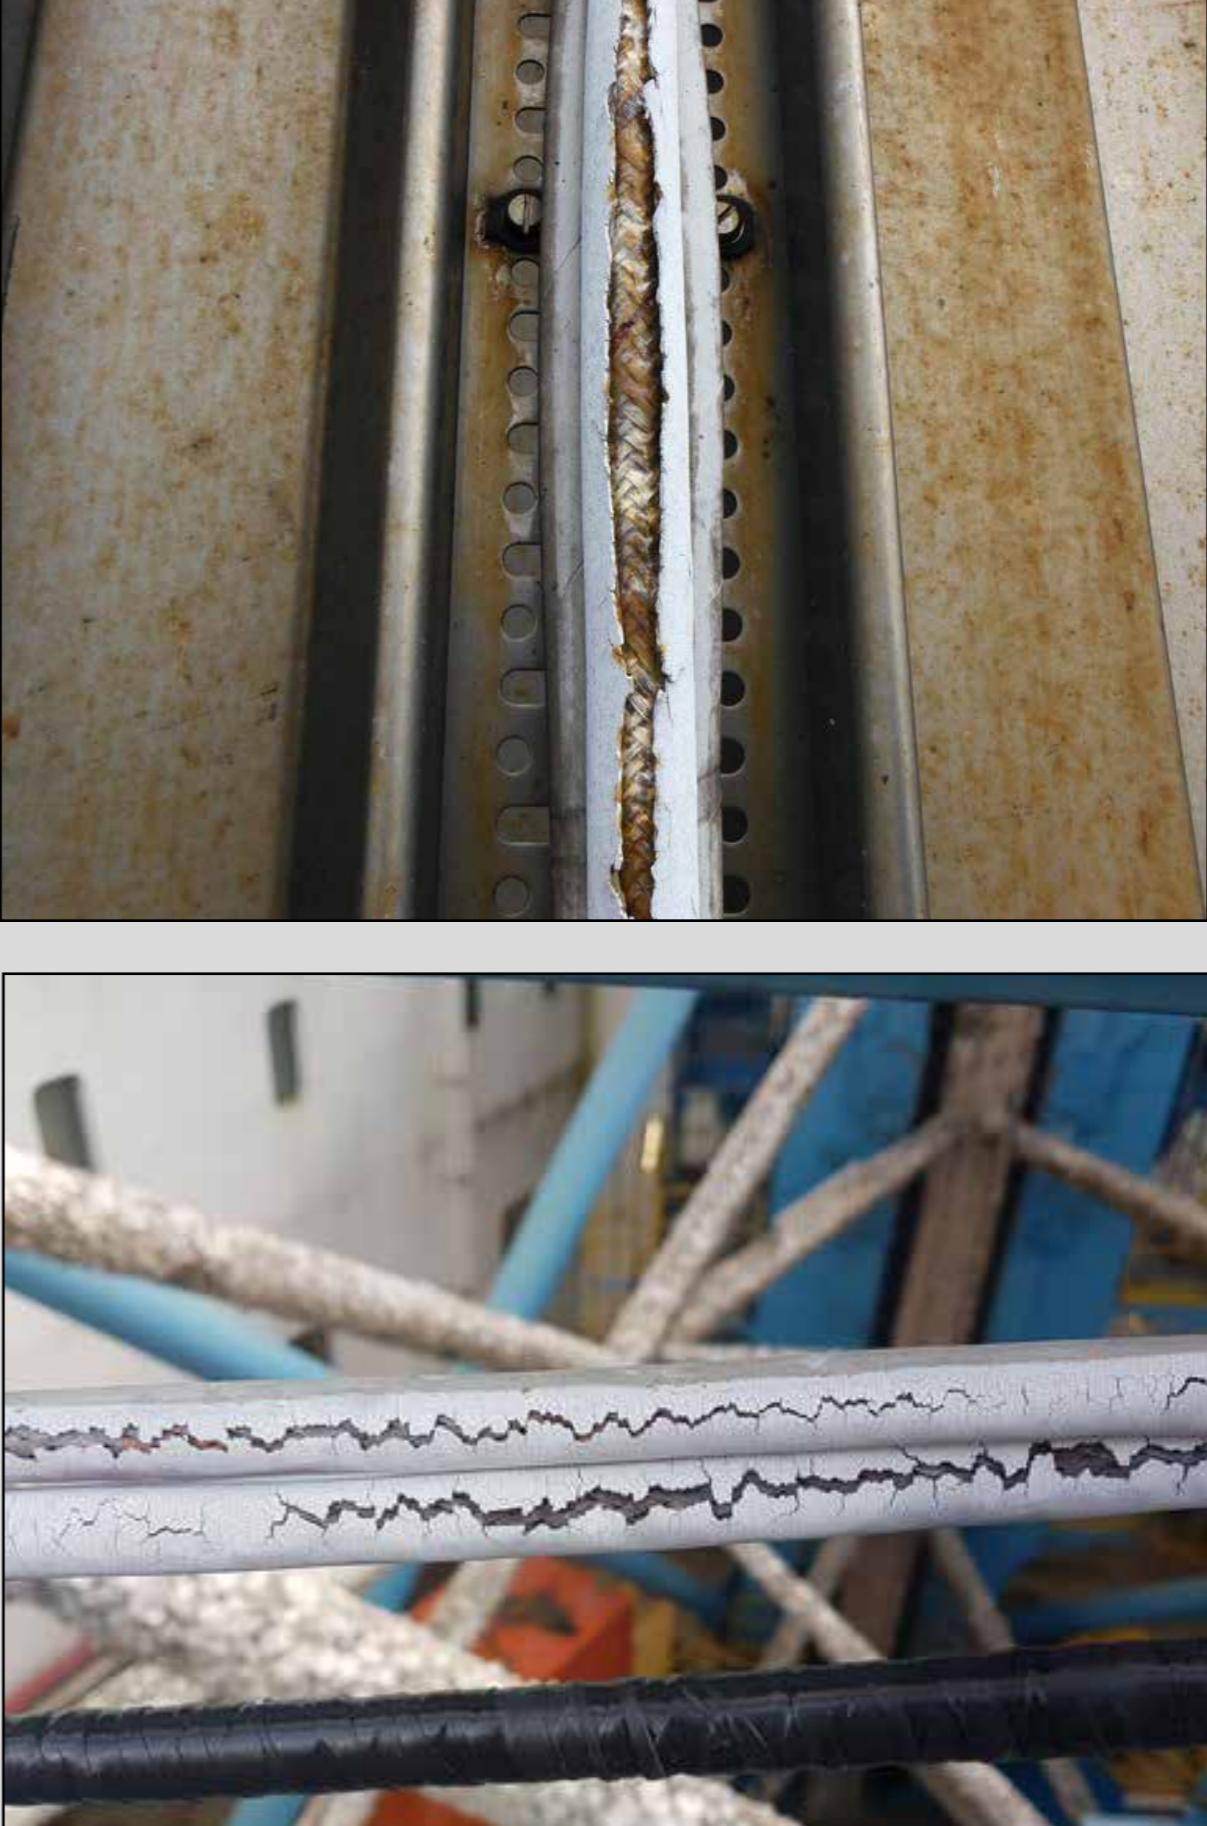
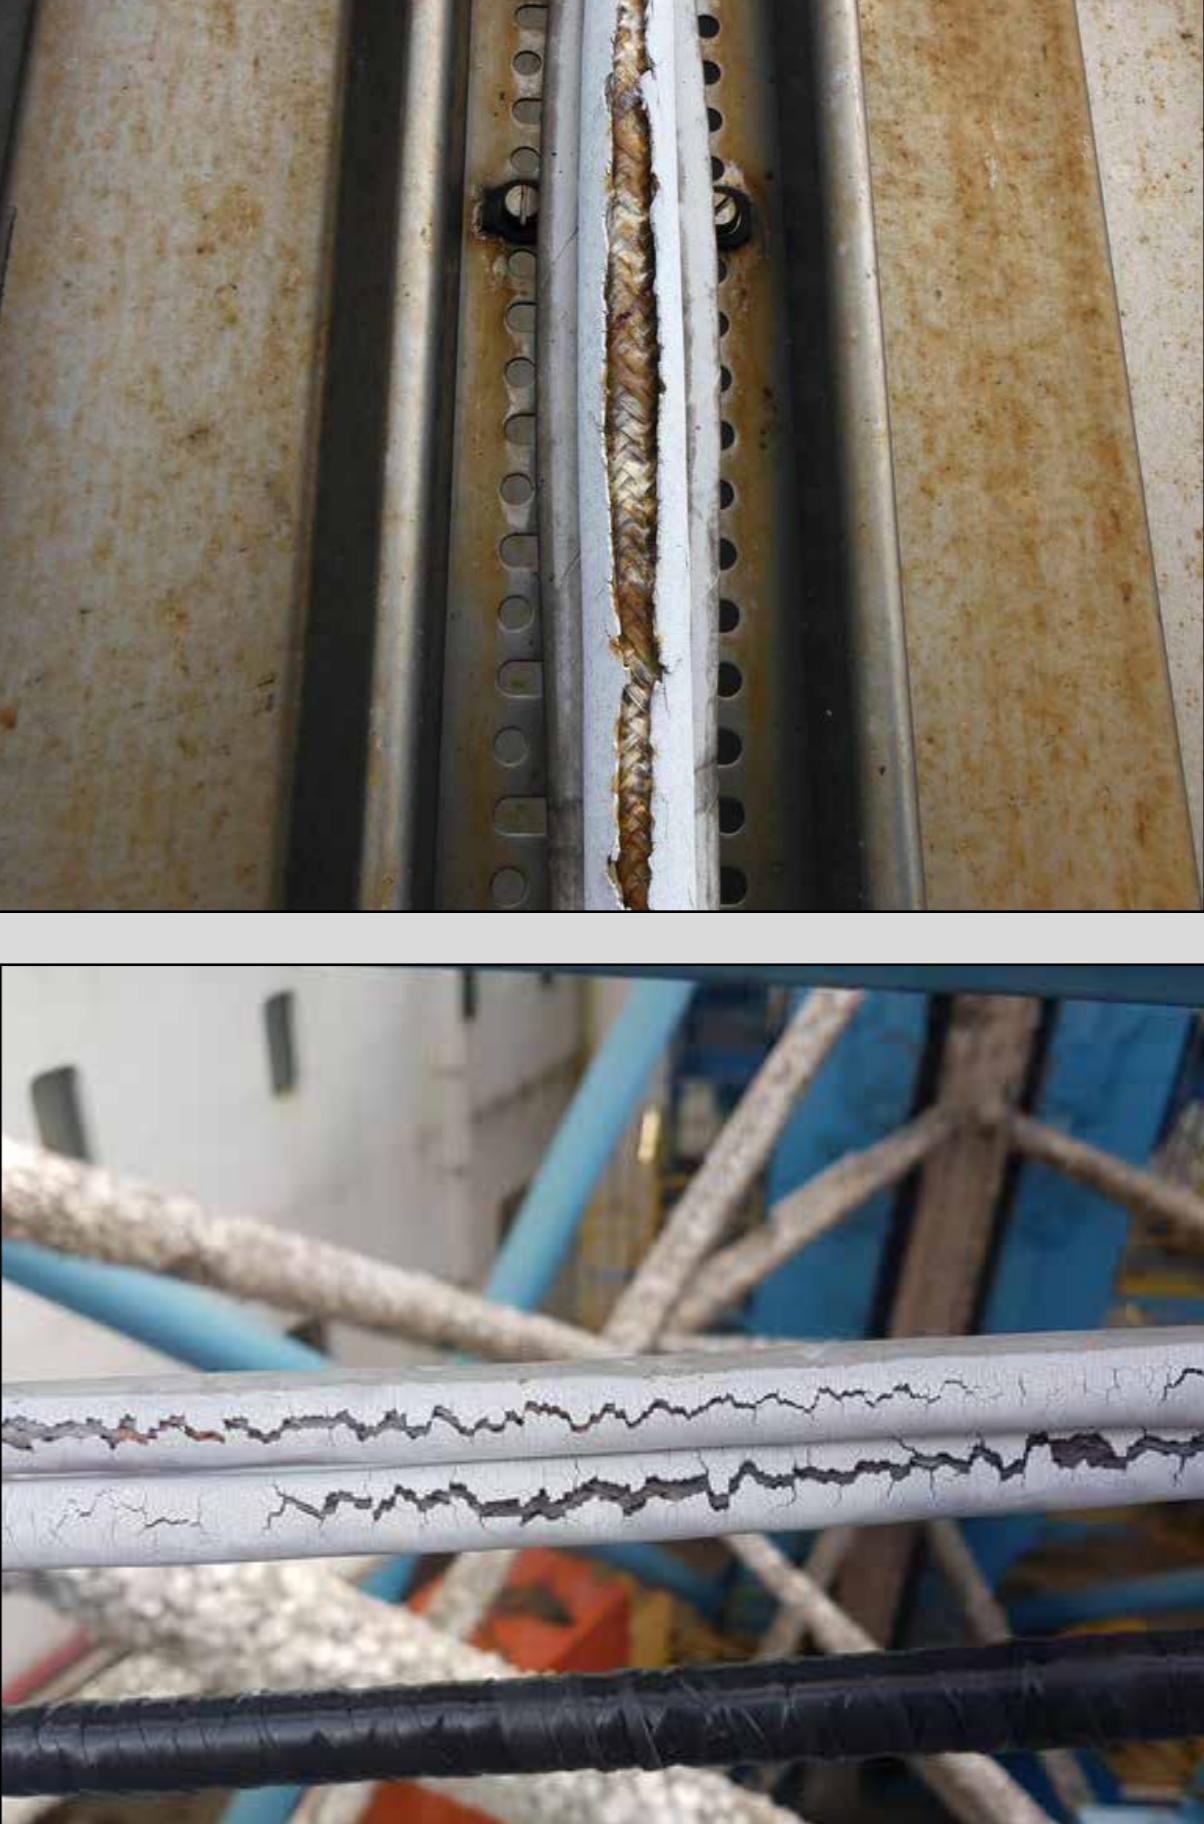
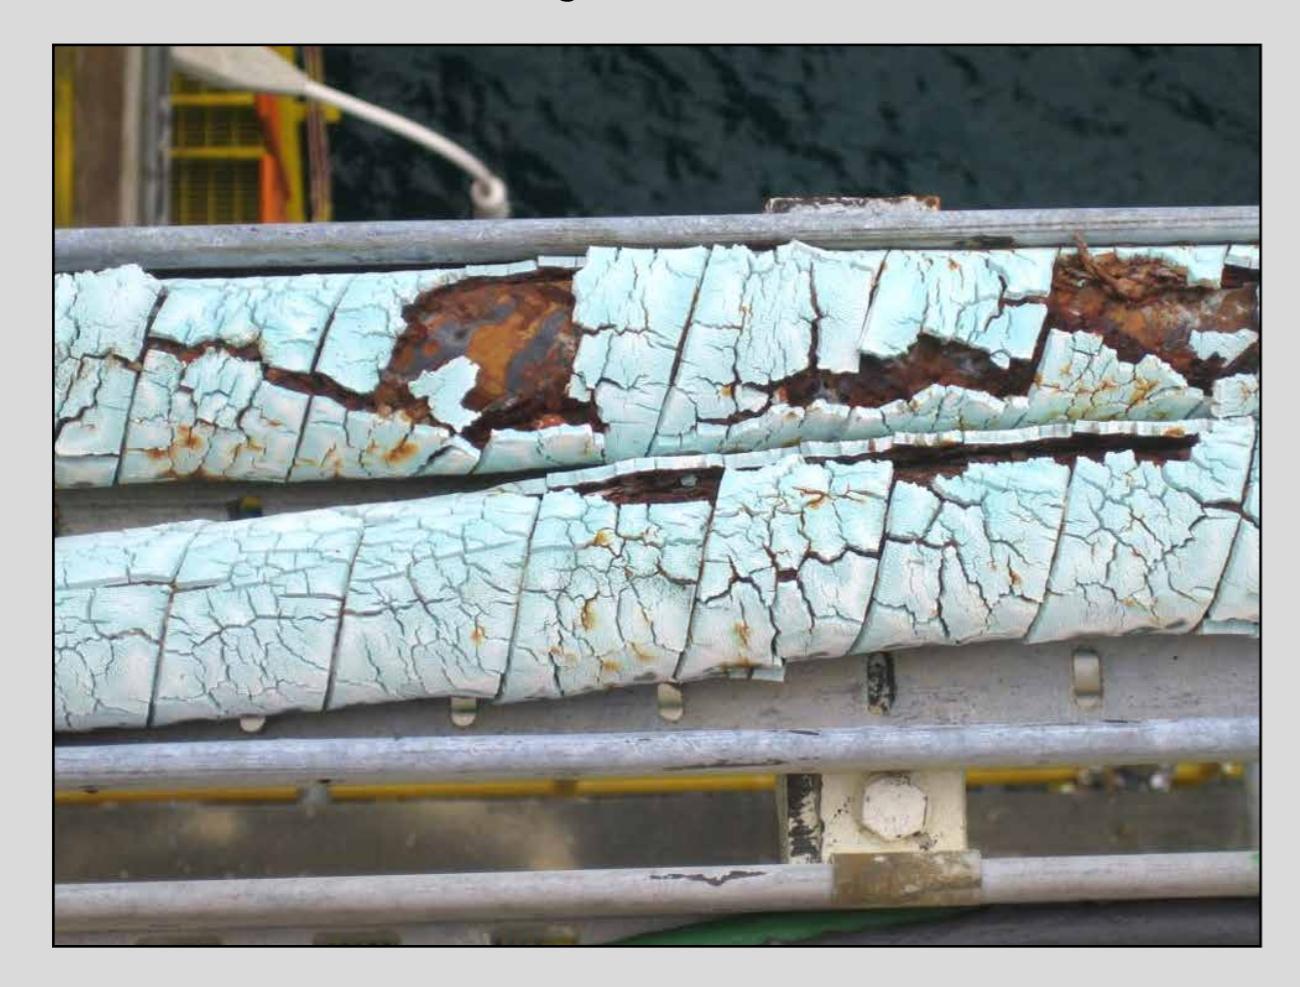
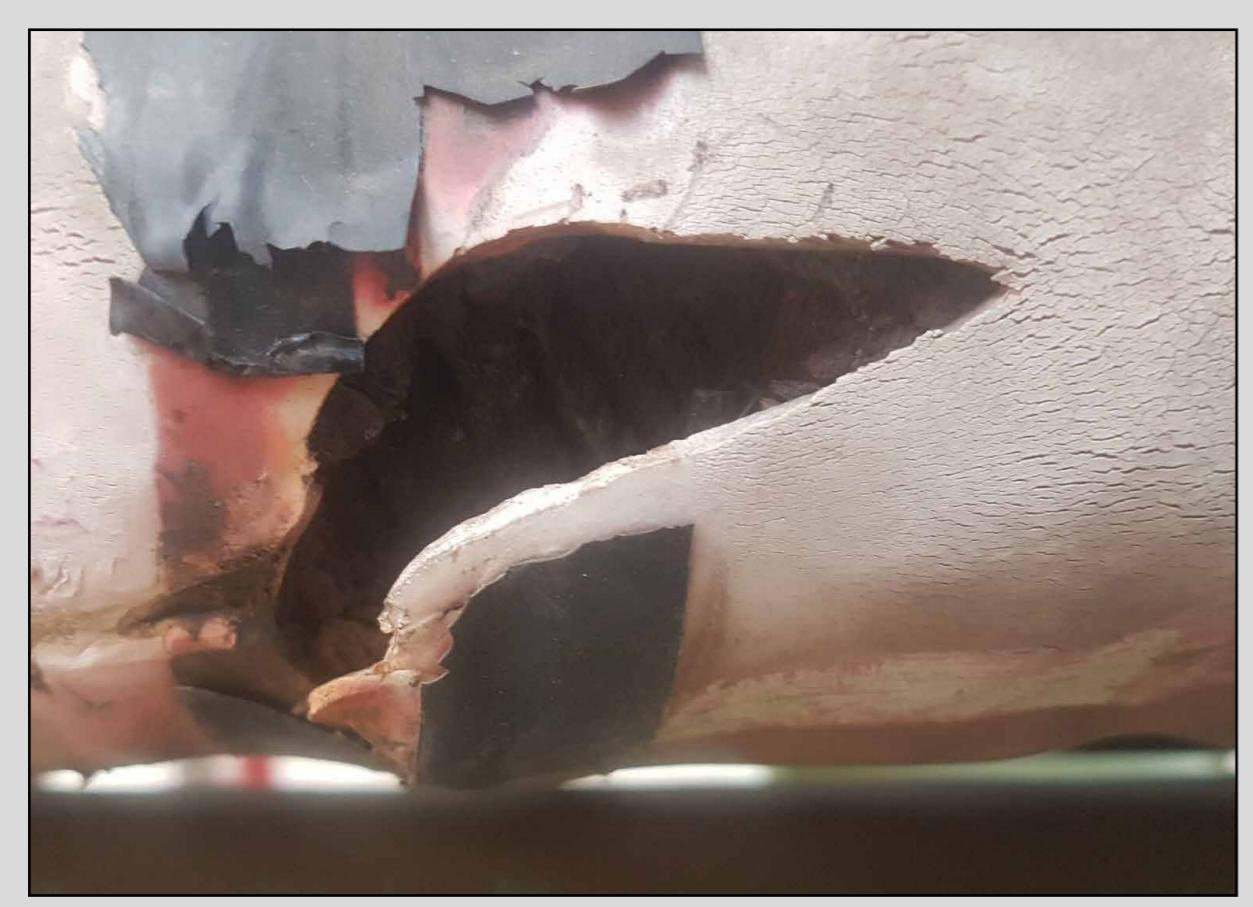
UV6 Cracked sheath, rusting armour

Inner armour or inner sheath (if present) is now exposed and the cable is now a major safety concern for hazardous (gas) areas. Rust streaking may be noted on the cable sheath and possible bulging of the sheath near cracks due to the rust expanding. Fire Security offers various repair options at this stage depending upon site conditions and operational constraints.

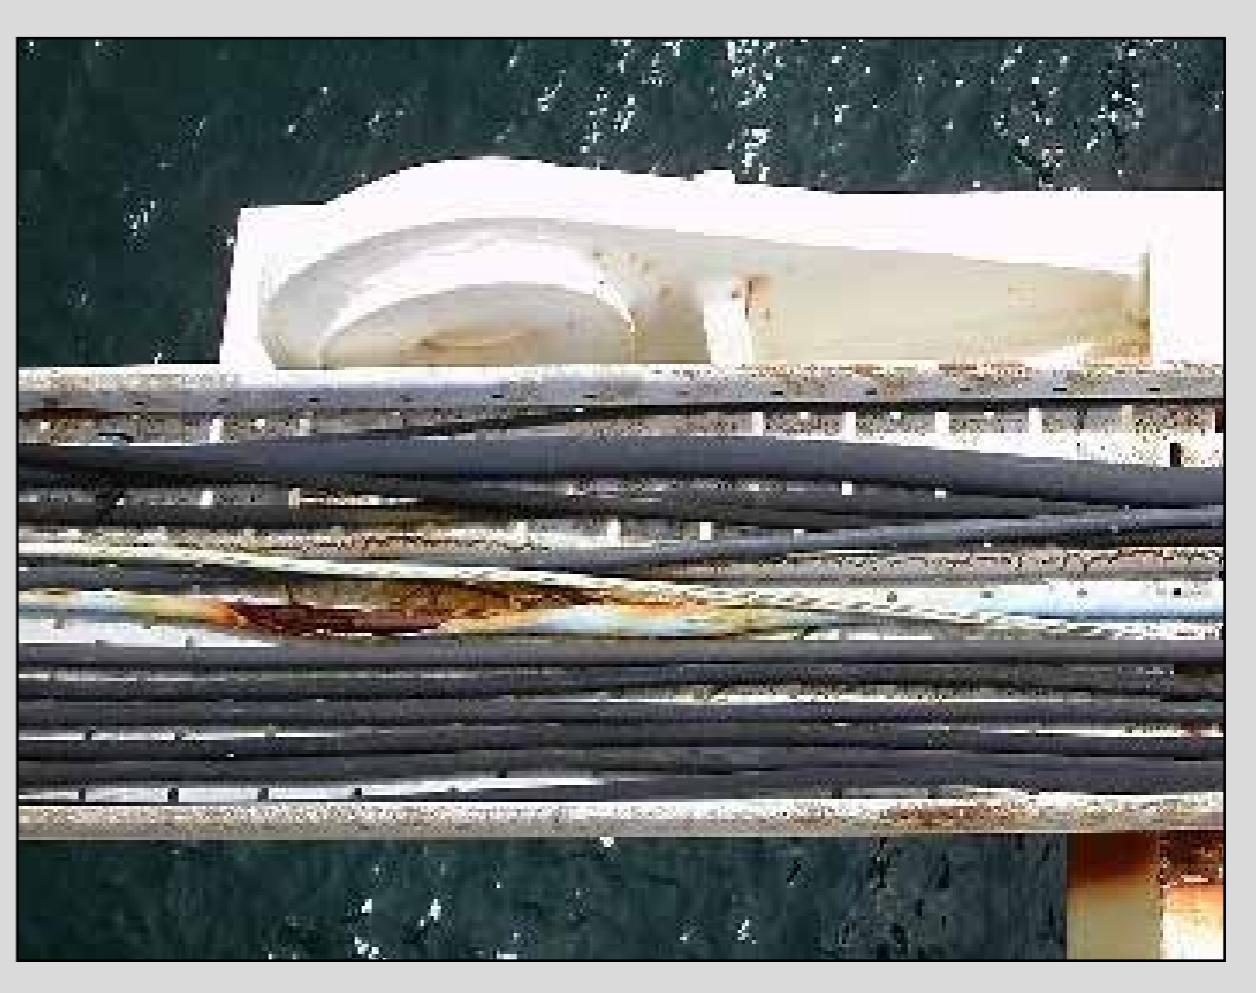
UV7 About to expose inner core

Fully failed outer sheath, stained with rust (if armour is present), and exposed inner core. At this stage, an HV cable should be considered beyond repair. If the client carries out megger testing and is happy with the results, then LV or Instrumentation/ control cables could be repaired (Not recommended for plant shut down or other critical operational cables).

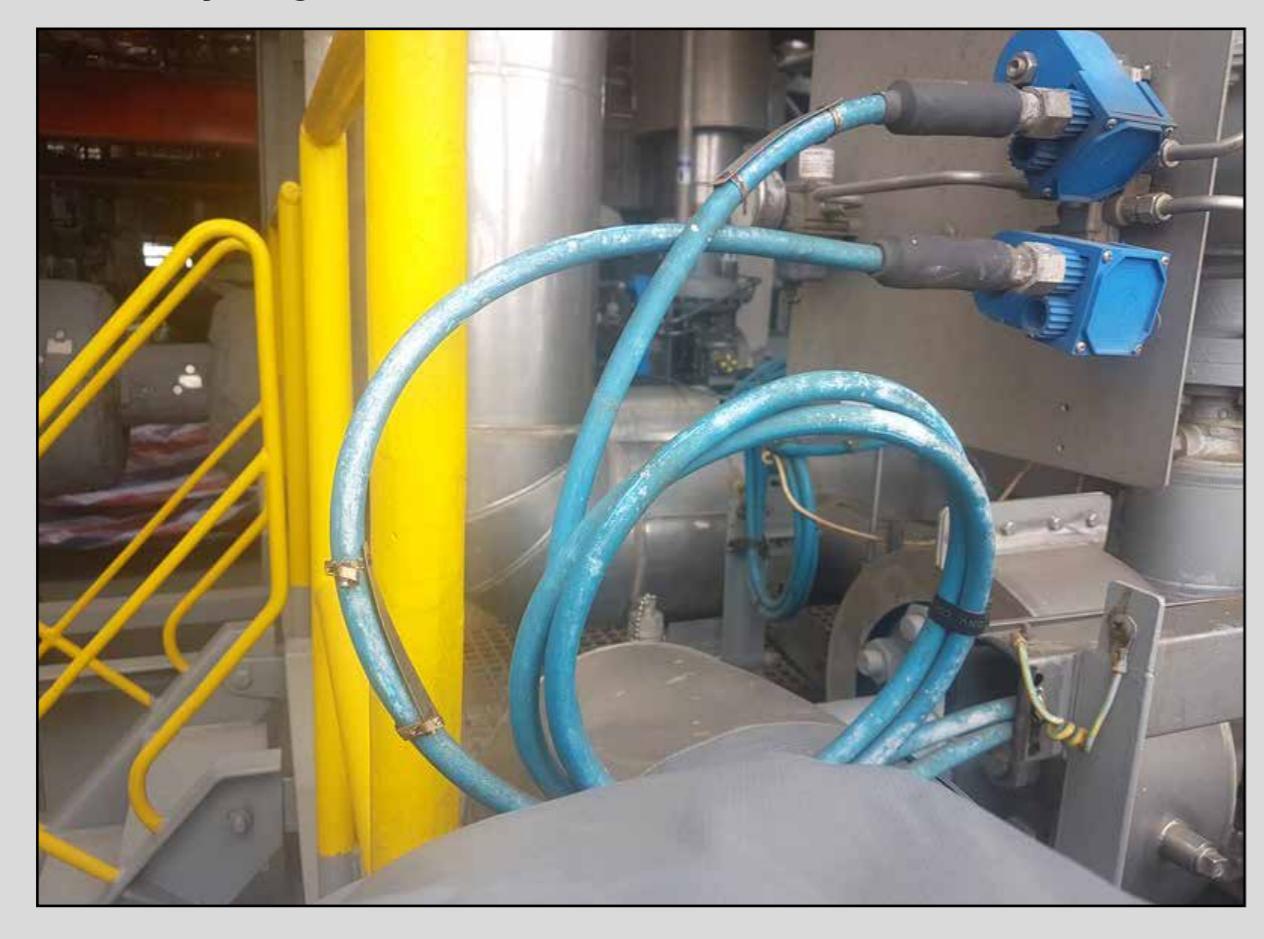
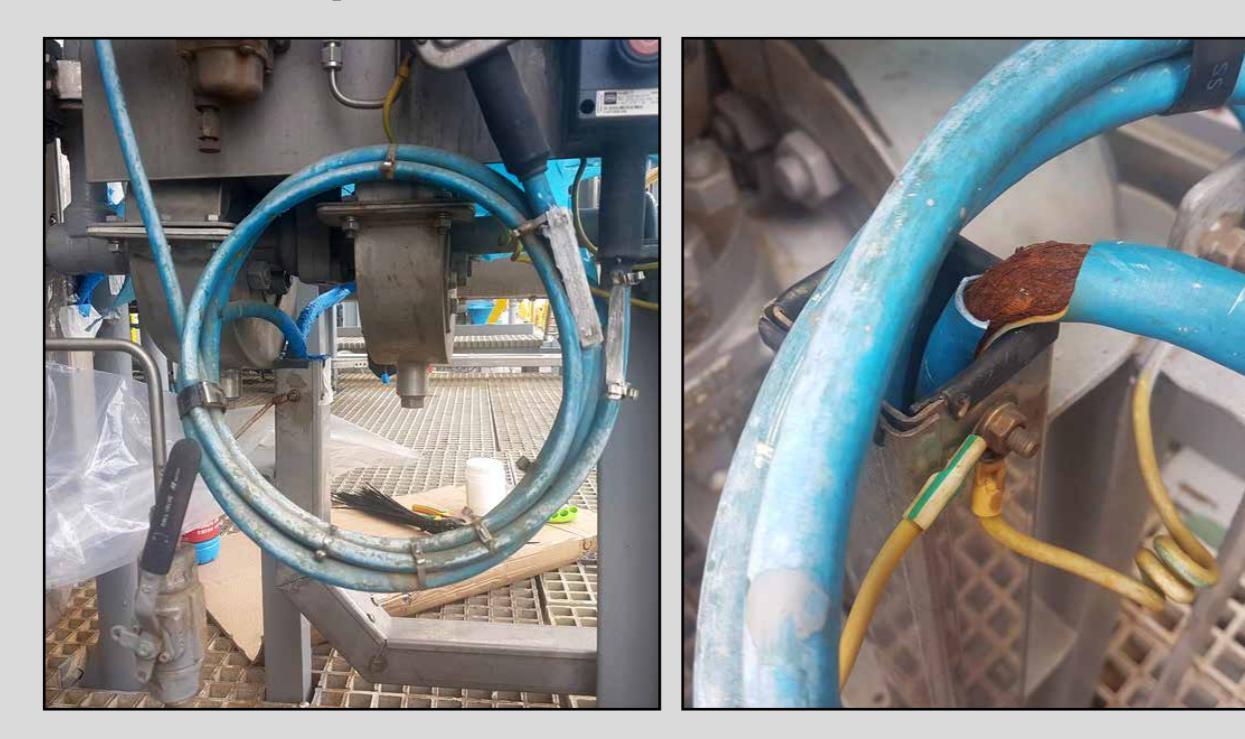
QC1 Early ageing cable due to manufacture mishap, UV Exposed, may be graded on UV 1-7 scale

Fire Security offers various repair options for this, depending upon the extent of aging, site conditions and operational constraints.

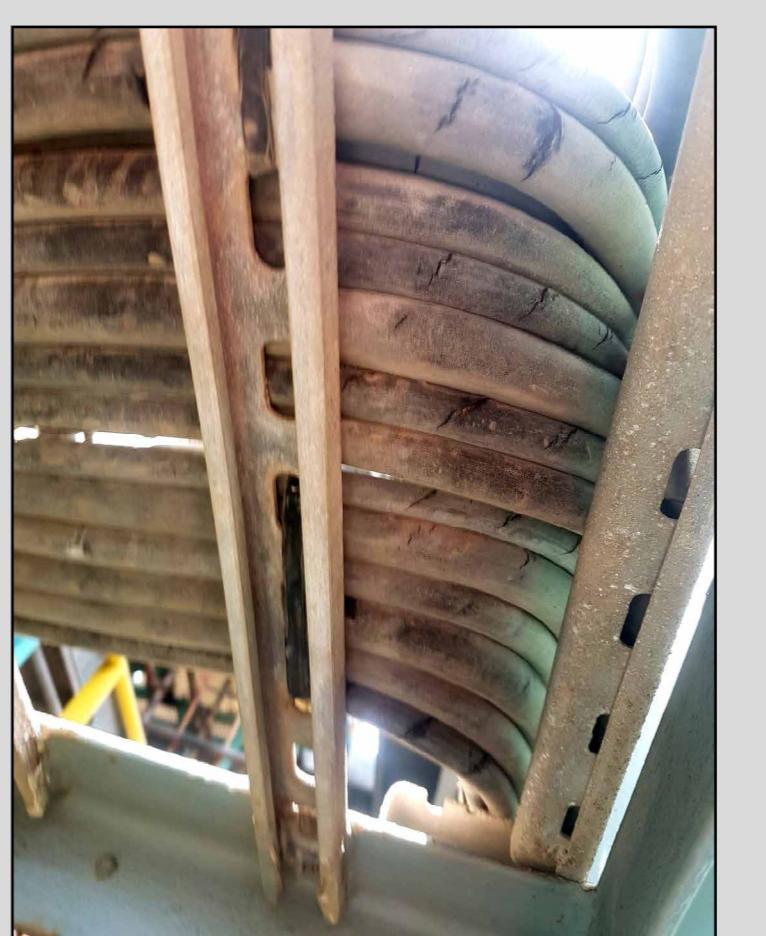
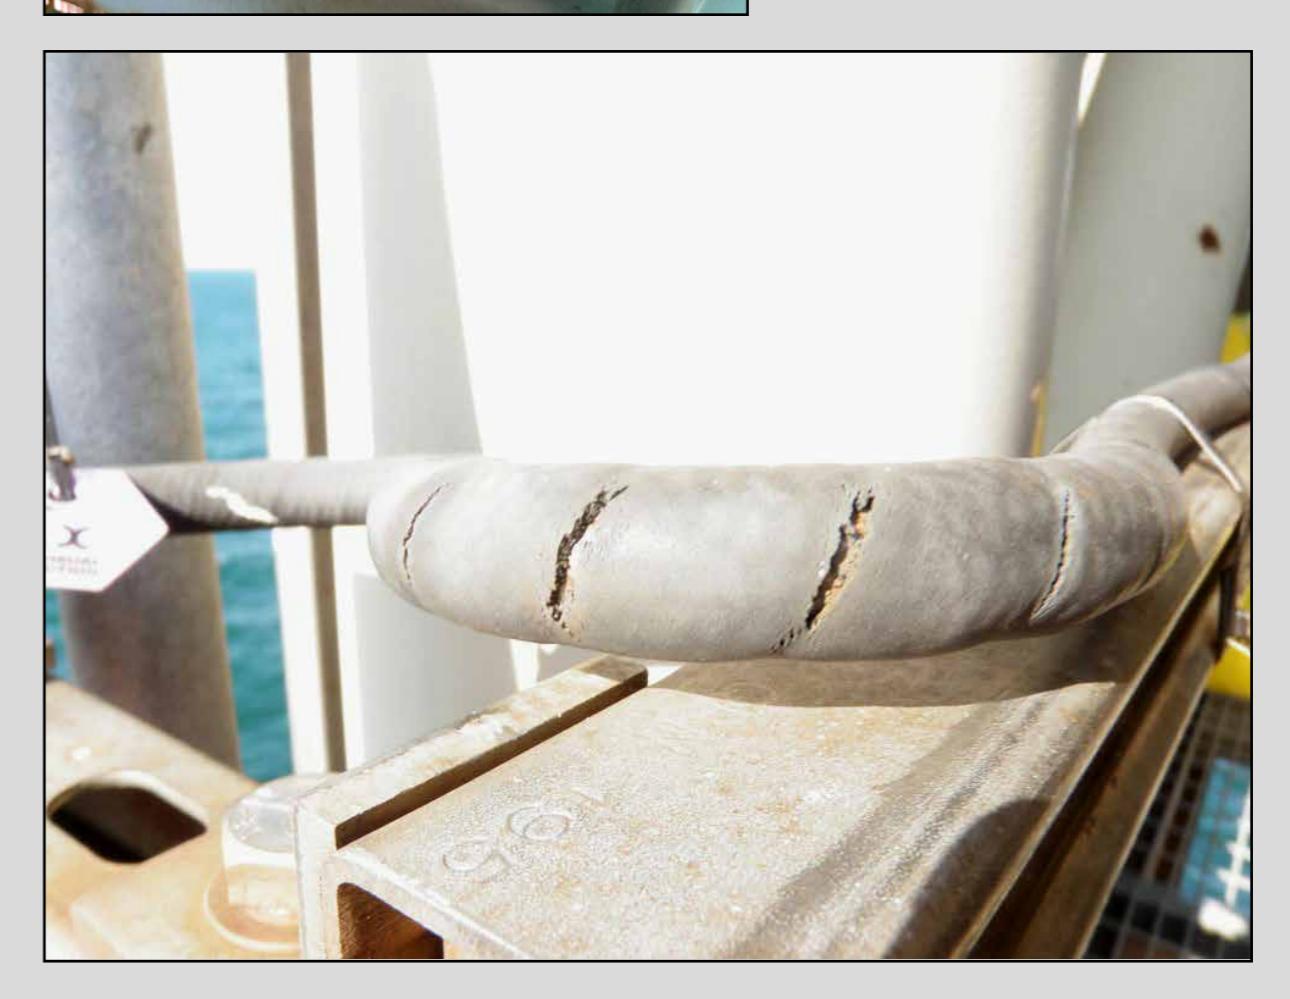
QC2 Stress cracking, mostly on tight bends (Usually Transverse)

Transverse cracking normally found on the outside of cables on tight bends.

For small diameter cables; Cover with FS17 Tape, coat with FS5.

For large diameter cables, Fill with FS21, repair with FS17 Tape, coat with FS5.

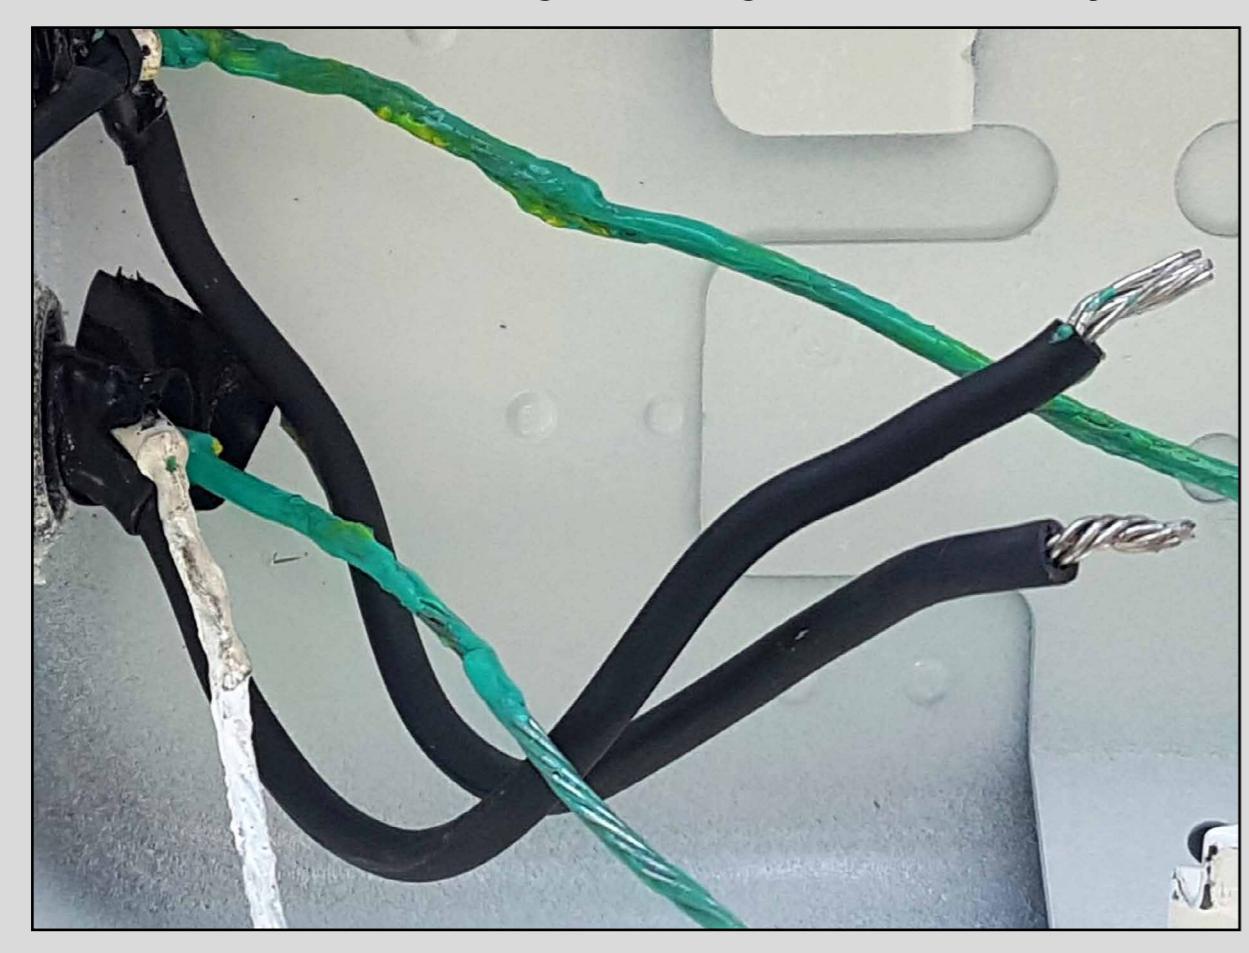
QC3 Sheath material turning to a soft 'gum' like consistency

Similar to chemically affected cable sheath, the material can be 'pinched' and even 'picked' off the sheath, and sticks like chewing gum to the fingers.

FS has so far only come across this type of breakdown on exposed inner core wire sheaths at termination points. Options include coating the area with FS5 or slipping a pre-prepared colour coded sheath over the affected section.

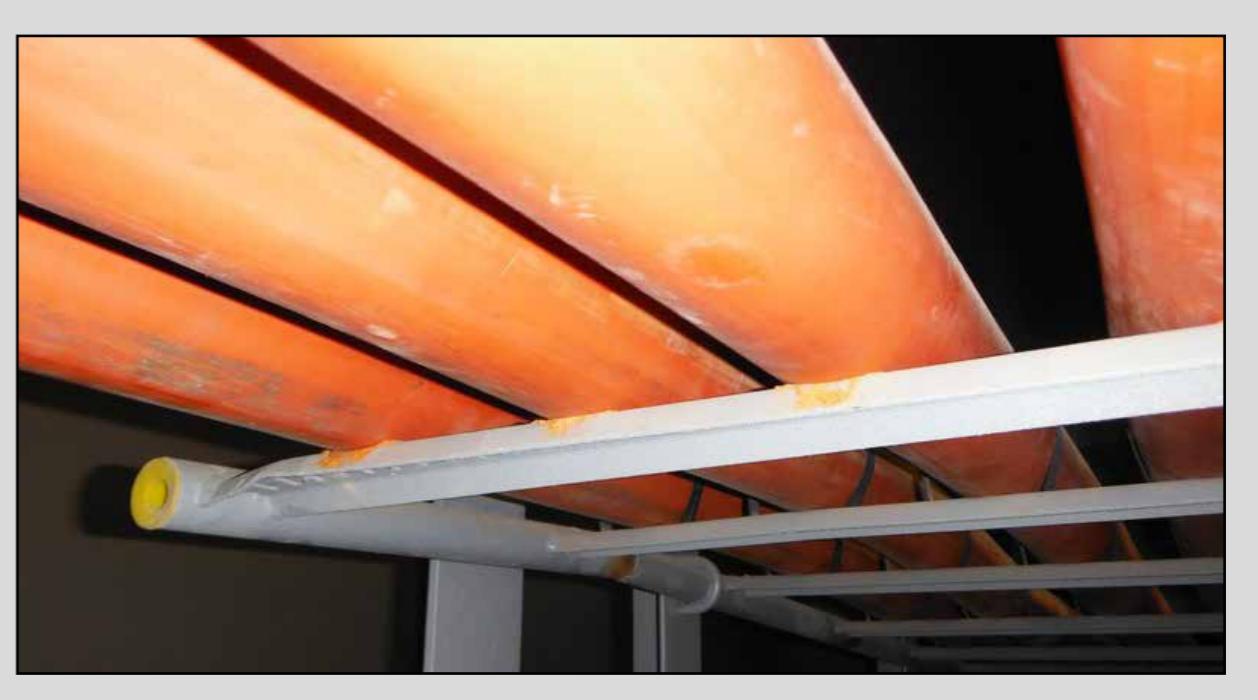
Impact / Chaffing (mechanical damage) damaged outer sheath **M1**

Cable sheath is either split by impact or worn down by repeated rubbing (chaffing) of the cable against a hard surface. FS17 Tape repair of area and coating with FS5. Friction protection in the form of rubber mats or Teflon sheeting to be installed to prevent further chaffing.

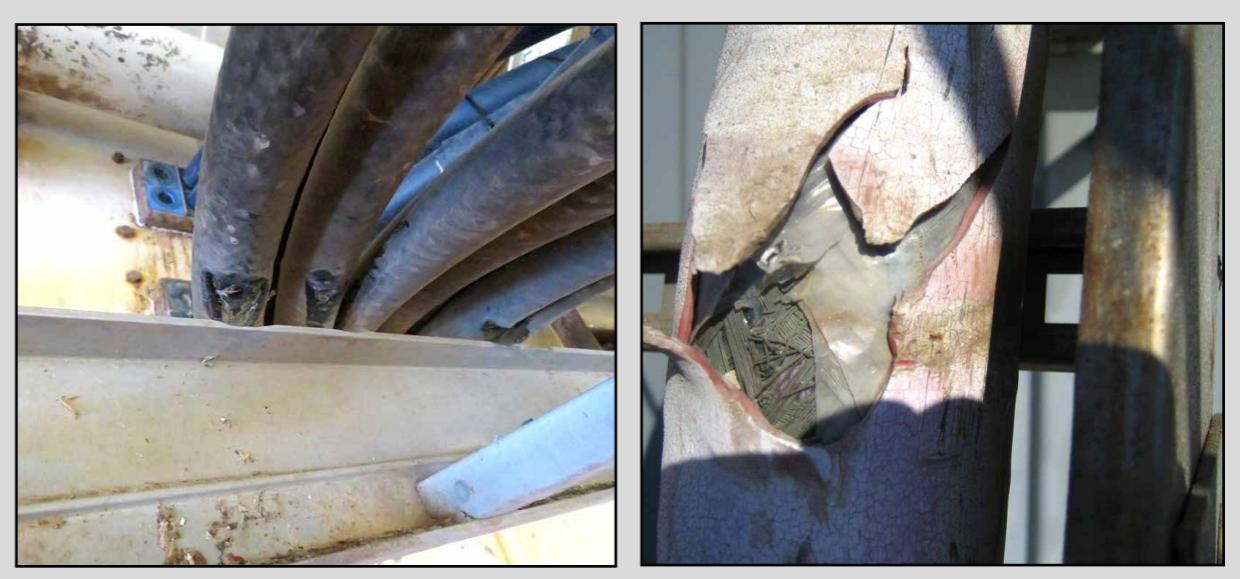
M2 into armour

Cable sheath is either split by impact or worn down by repeated rubbing (chaffing) of the cable against a hard surface, the damage has extended to the armour, but the inner core is still intact.

FS18 Shielding tape repair of armour, FS17 tape repair above this, and coating with FS5. Friction protection in the form of rubber mats or Teflon sheeting to be installed to prevent further chaffing.

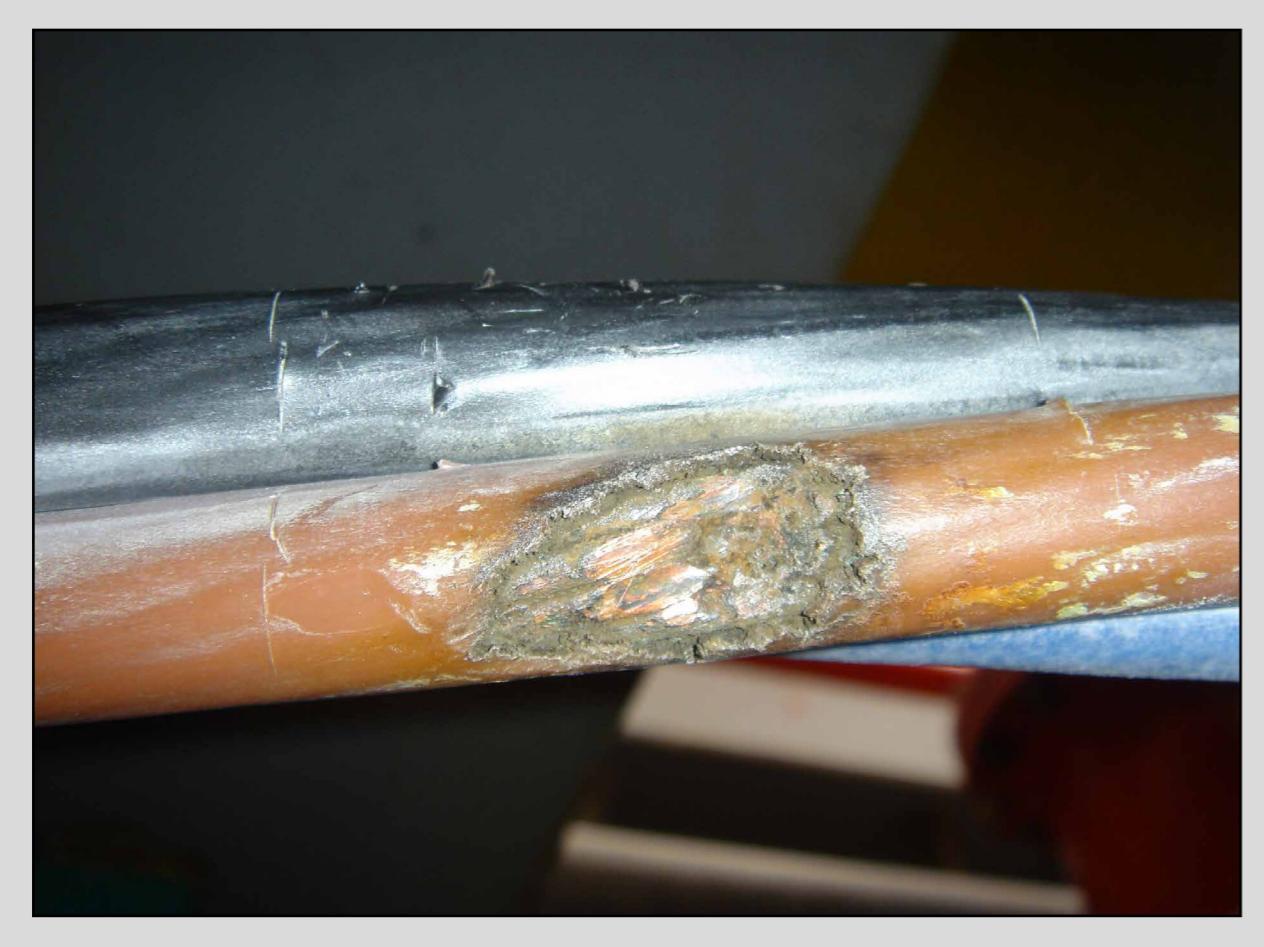
Impact / Chaffing (mechanical damage) into inner core **M3**

Cable sheath is either split by impact or worn down by repeated rubbing (chaffing) of the cable against a hard surface, and damage has extended past the armour and into the inner core.

If the client carries out megger testing of the cable and is happy with the results, then the repair of LV & instrumentation cables may be carried out as for M2 condition cables. This is not recommended for HV or Plant shut down / operationally critical cables.

FS18 Shielding tape repair of armour, FS17 tape repair above this, and coating with FS5. Friction protection in the form of rubber mats or Teflon sheeting to be installed to prevent further chaffing.

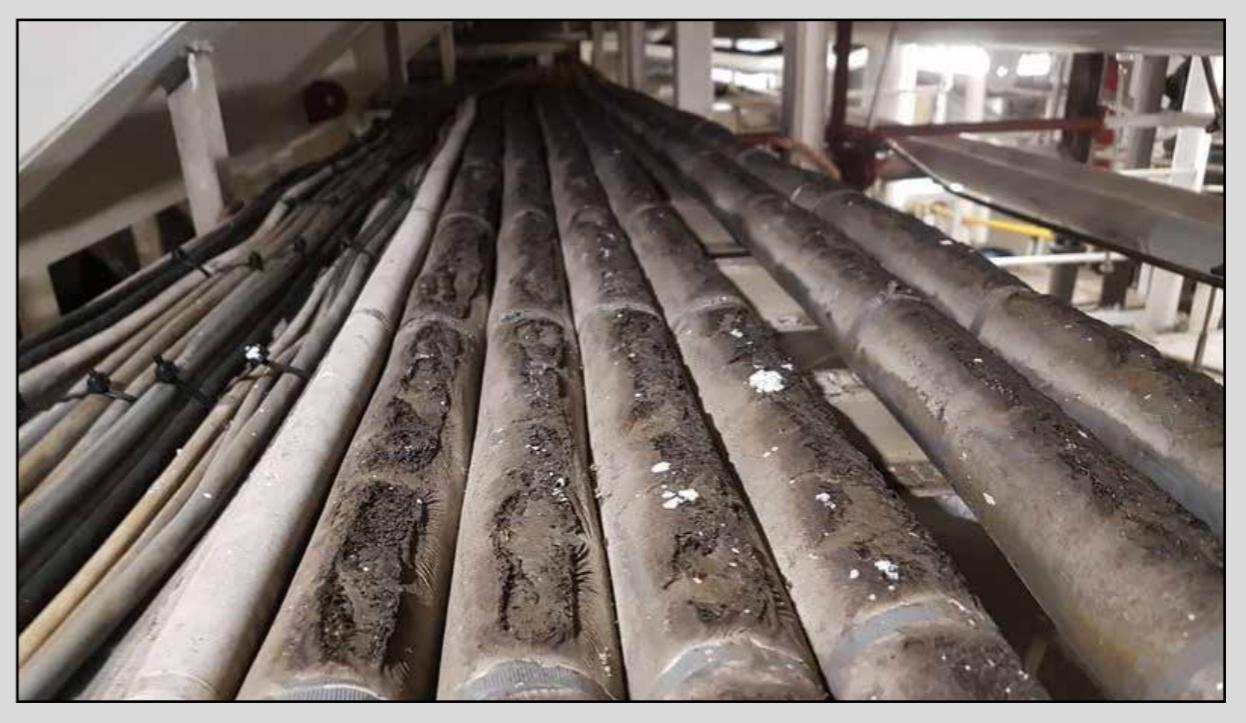
Heat affected cable, sheath is misshapen and / or brittle H1

Sheath material has partially melted and then re-hardened. If the client is convinced that the inner core is not affected, then repairs to the outer sheath can be carried out. FS17 tape repair and coating with FS5

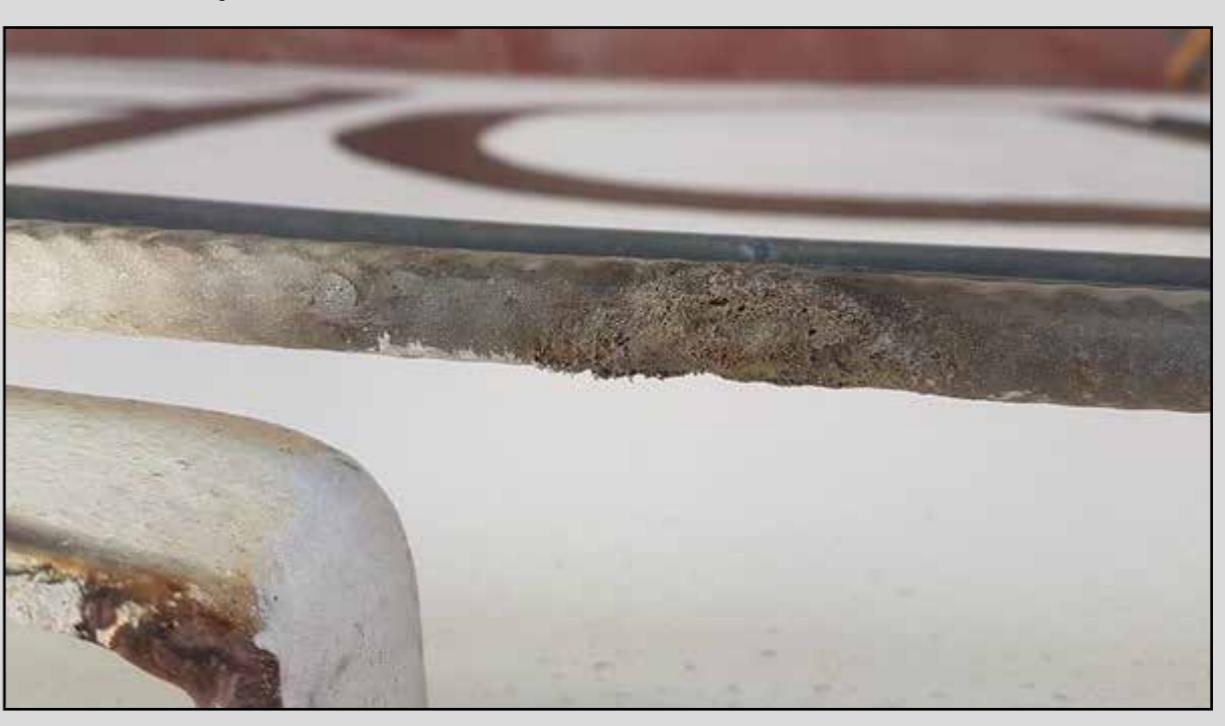
H2 thru spots to armour

Cables that have been affected by fire but are still capable of operation. FS17 tape repair and coating with FS5.

Heat affected cable, the sheath is charred, possibly with burn

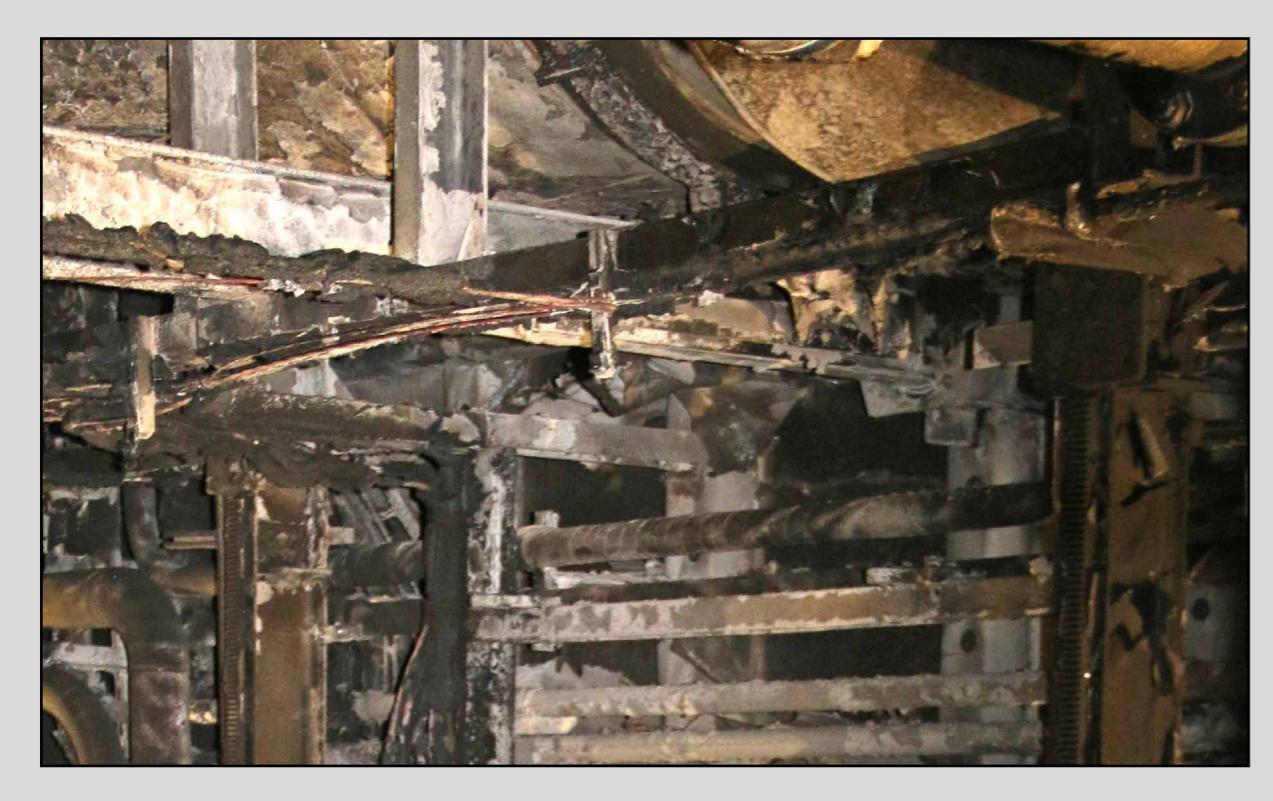
Heat affected cable, core exposed / fully failed sheath **H4**

Fully failed outer sheath, with exposed inner core due to external heat sources (for example cable near leaking exhaust). At this stage, an HV or instrumentation cable should be considered beyond repair. LV cables may be considered for repair. Various repair options are available depending upon site conditions and operational constraints.
